Defence
Safety
Authority

Service Inquiry

Loss of Watchkeeper
(WK043) Unmanned Air
Vehicle over Cardigan Bay
in West Wales

24 Mar 17

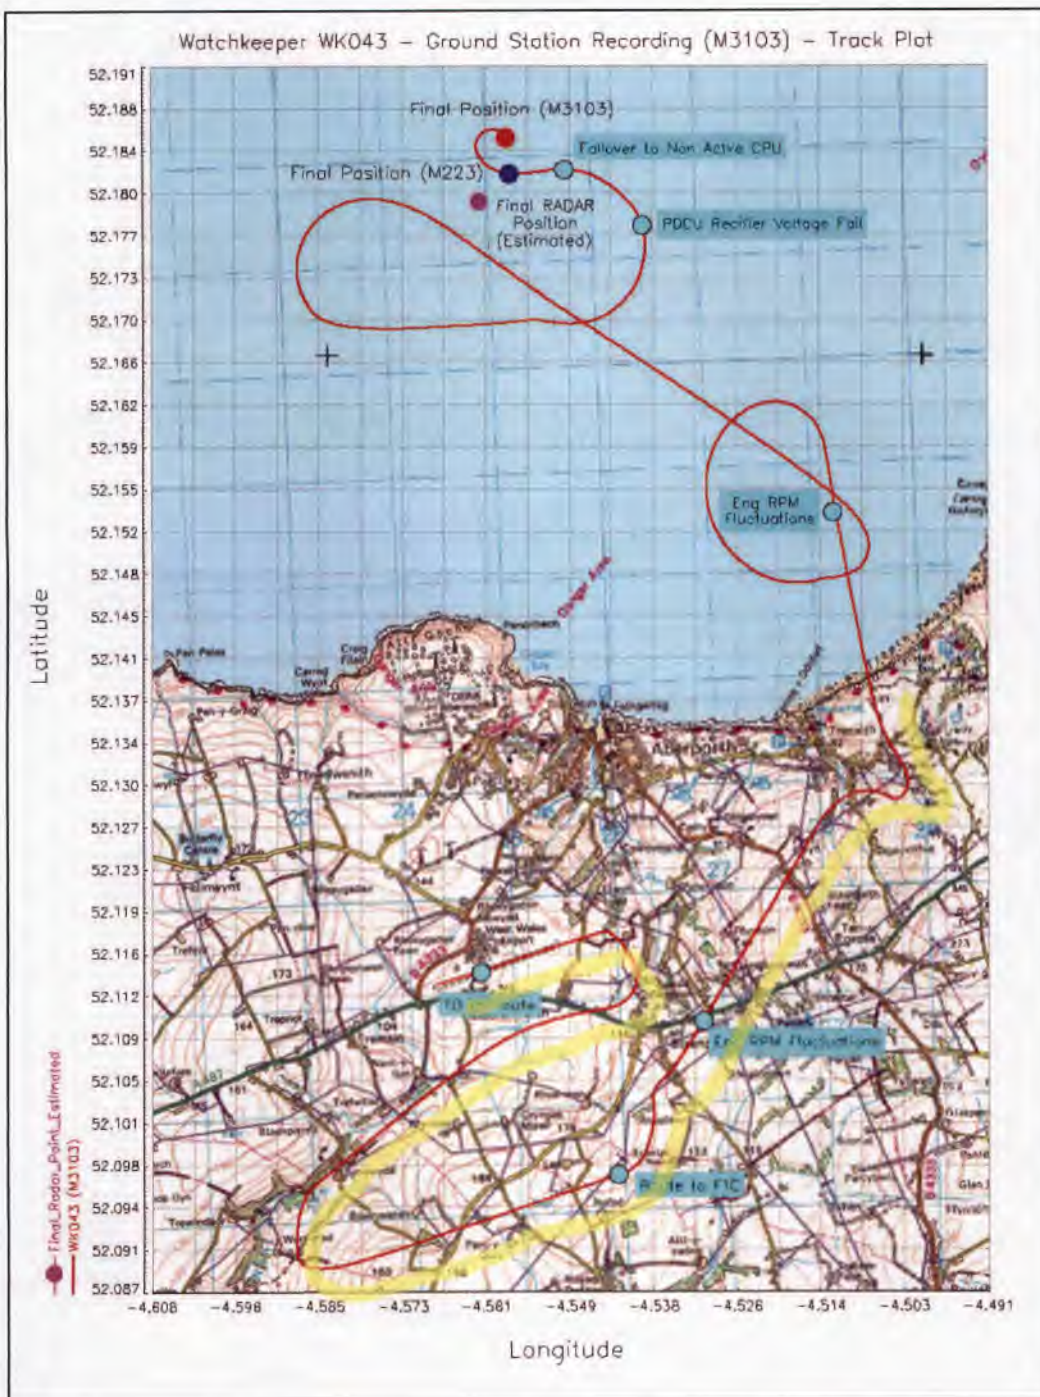
Figure 11 – VMSK flight data trace of WK043 from take-off to crash.

1.3.10. At 1043hrs and during the initial climb the P2 noticed that the reported payload footprint on the AV was inaccurate compared to the true heading, the P2 also noted that the FMV window displayed the opposite report of the payload mode; when Port was commanded, it displayed Starboard. The P2 and the UAV Cdr worked through the payload issues referring to Flight Reference Cards (FRCs) where required. Whilst climbing through 4000ft AMSL³, an *ECU Throttle Posn Difference* message was displayed. The FRCs stated that this caution may result in degraded engine performance, and that controllability checks should be conducted and the AV should land ASAP. Before the crew could conduct controllability checks, the caution cleared. The same caution was repeated 1 minute later and cleared in seconds. The next caution that appeared was *ECU Tacho Fail*, which the FRCs stated indicated that RPM was above 9000RPM or below 2000RPM, which may be the result of a RPM sensor failure or invalid reading. Concurrently the RPM displayed in the HCI was seen to fluctuate and the AV appeared to be unable to climb satisfactorily.

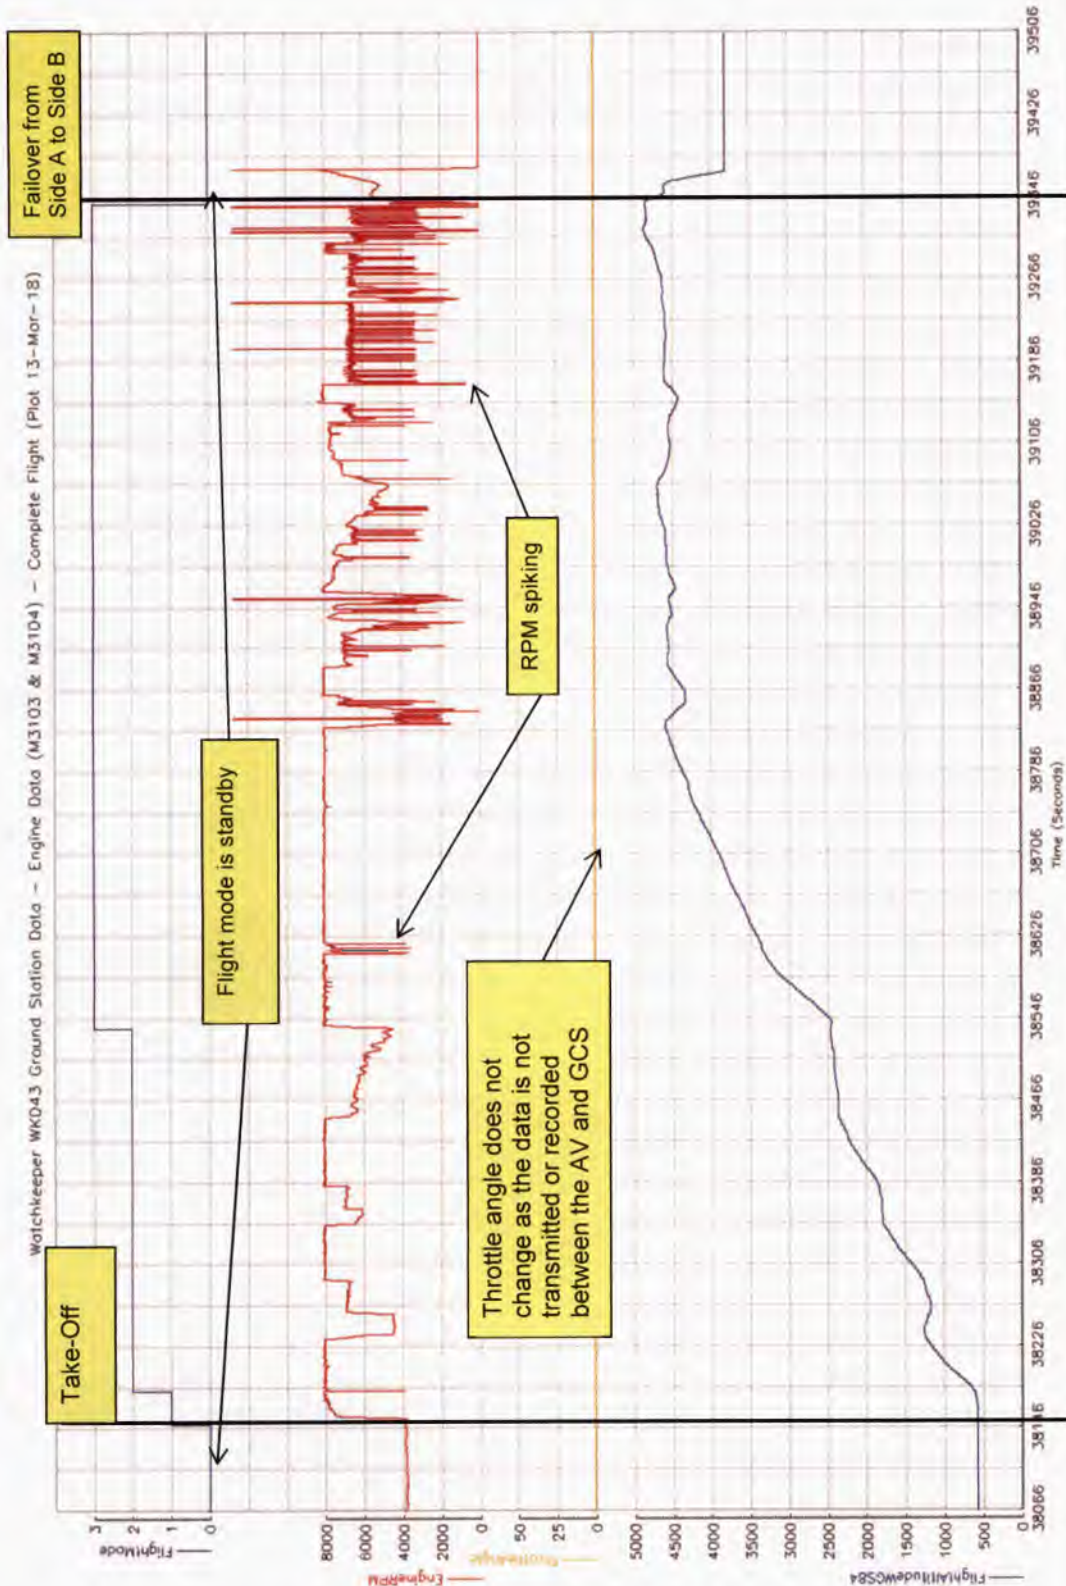
Figure 14 - General parameters plot.

1.4.26. **Flight Mode.** Figure 14 shows the flight mode, which changed during the various stages of the flight from standby, to take off, to fly to coordinate. At the time the VMSC Side A failed over to Side B, the flight data recorded that the flight mode

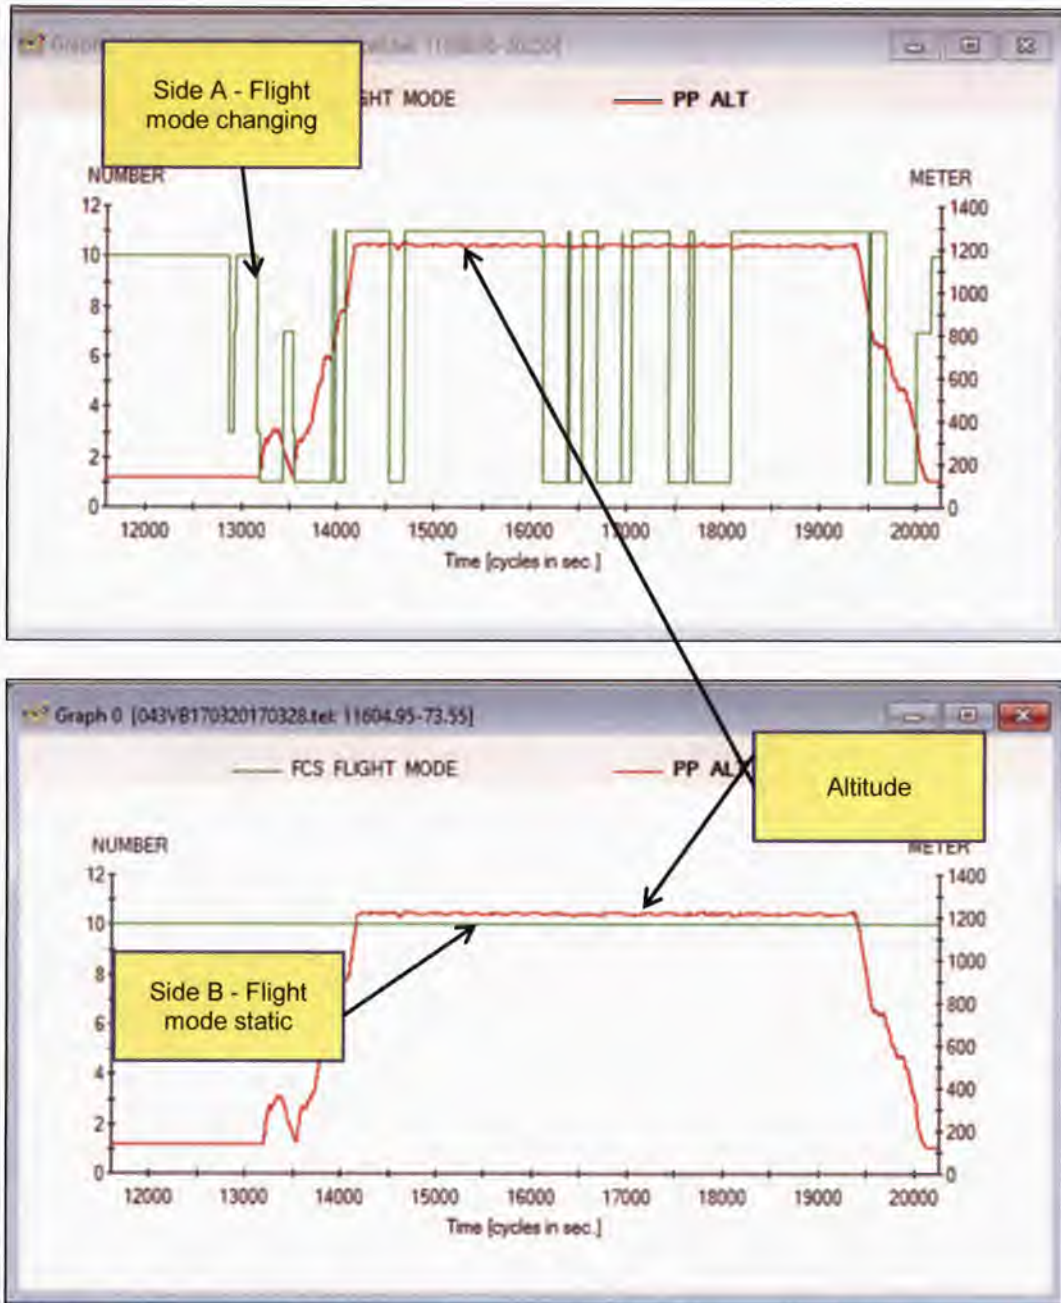
Figure 17 – VMSC Mode and Altitude against time from WK043 Flight 607.

altitude profile recorded is identical, but Side B does not change mode for the duration of the flight.

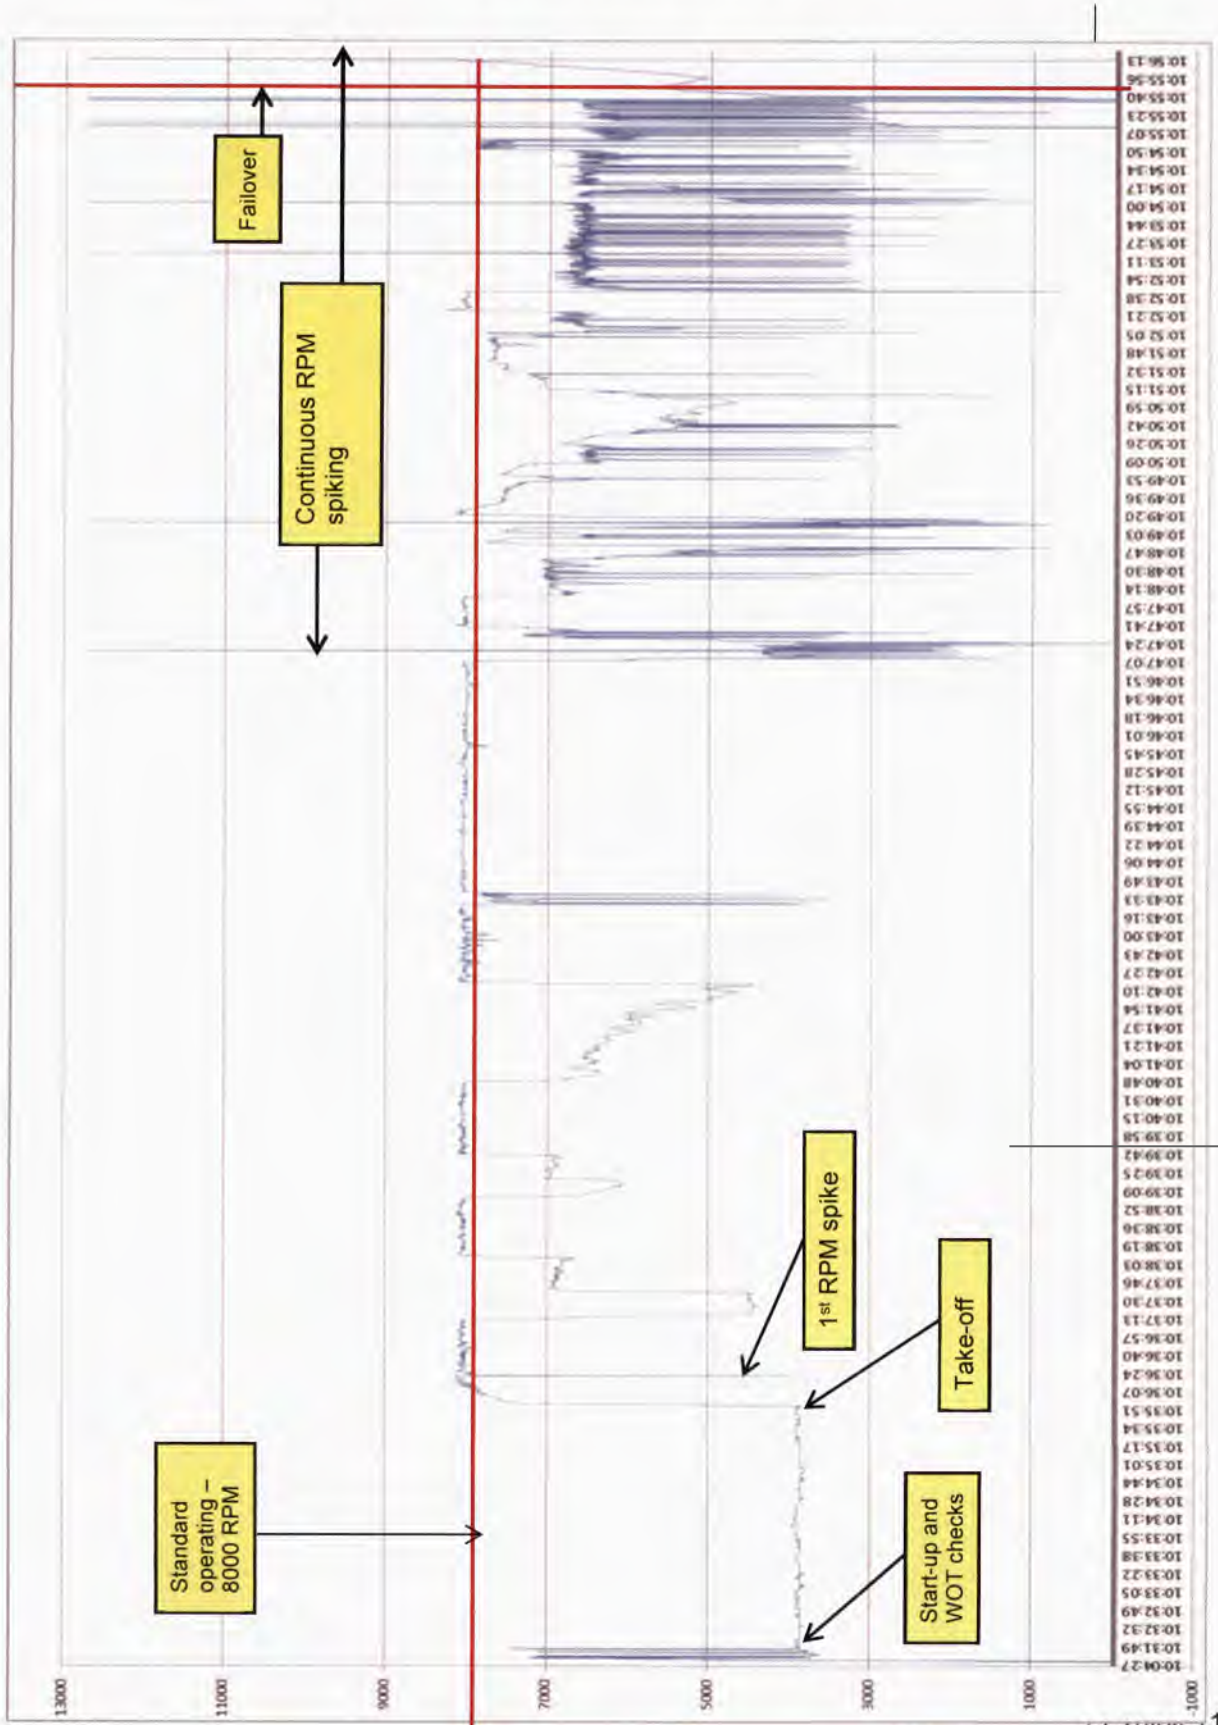
Figure - 19 Full RPM plot from Flight 611 on 24 Mar 2017.

1.4.77. The majority of other WK flights with RPM spikes were limited to only a few spikes per flight. For WK043 the majority of the RPM spikes over its operational history were not sufficient to generate a caution in the GCS to alert the crew; only RPM above 9000 or less than 2000 will generate a caution. As there was no historical indication of a fault, there was no investigation and no trend analysis. The RPM data from 24 Mar 2017 (Figure 19) clearly shows that some of the spikes are high (over 9000) or low (under 2000) enough to cause a WCA, which were subsequently displayed to the GCS crew during Flight 611 and recorded in the flight data. Figure 20 shows the engine from start-up and WOT checks, to idle during towed taxi, to take-off. The first RPM spikes are seen at 1036hrs, shortly after take-off and again at 1043hrs before becoming the main feature of the RPM profile from 1047hrs.

1.4.78. In depth analysis of the flight data from the GCS shows continued abnormal behaviour of the RPM from approximately 12 minutes into the flight. Some of the reported spikes' amplitude and frequency are outside of normal engine operating parameters; it is not physically possible for the engine to go from 0 to over 12000 RPM in milliseconds. It is impossible for the engine or propeller speed to match the reported RPM spikes. The video captured by the EOP does not have the frame rate or resolution to confirm propeller RPM.

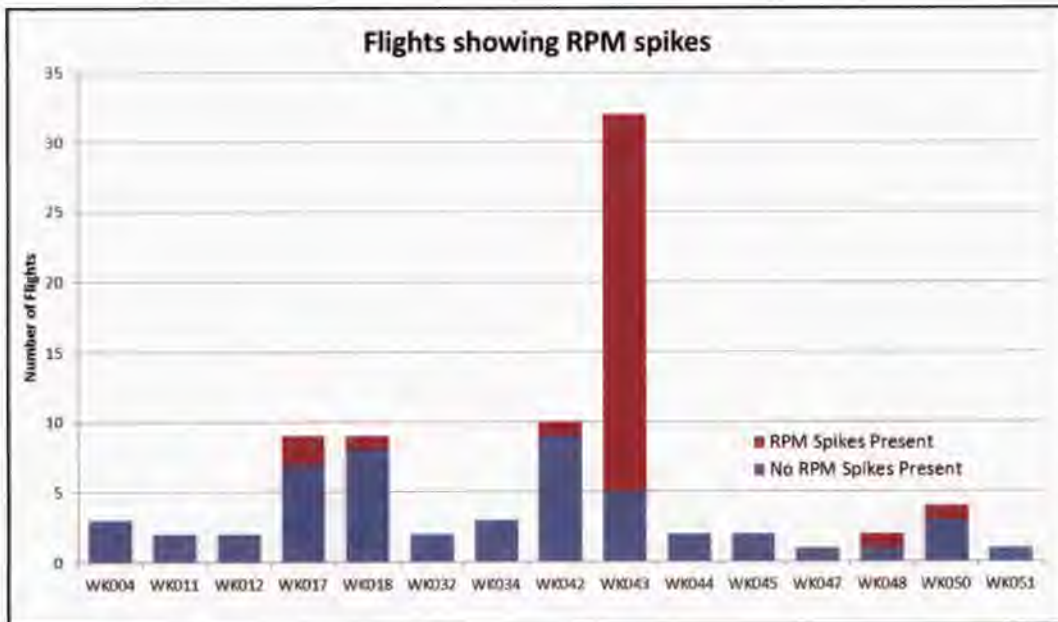
Figure 20 – Comparison of WK043 RPM spiking events with other tail numbers.

1.4.80. The RPM spiking, whilst not unique to WK043 was most prevalent on that airframe. Analysis of data from 83 flights of 15 different AVs provided by Thales shows 6 flights with single spikes on either Side A or Side B. By comparison, WK043 had 27 of 32 flights with RPM spikes recorded (see Figure 20). Half of the single incidents of spiking seen on other airframes were seen 0, 1/2 and 1/3 of the standard RPM range. The remaining 3 flights had momentary spikes of RPM above the maximum value of 8500 RPM.

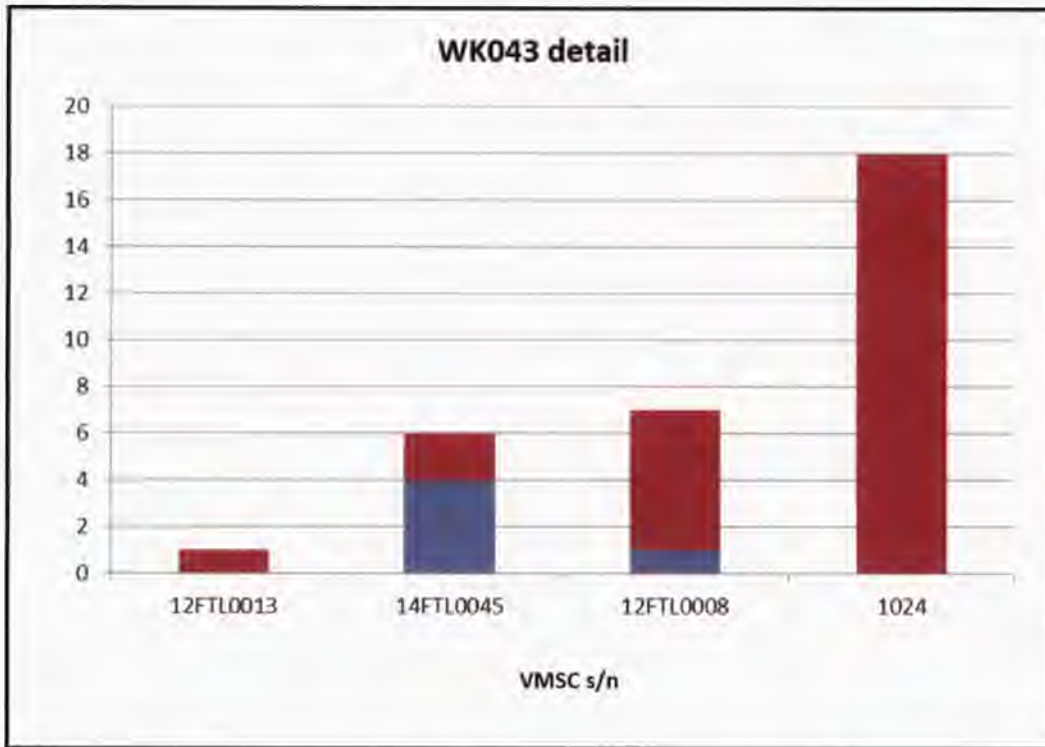
Figure 21 –The VMS computers that had been fitted to WK043 with the number of flights with RPM spiking.

1.4.81. WK043 experienced RPM spiking from its production flight through to the crash on 24 Mar 2017; the magnitude and frequency of spiking worsening over time. The first WK043 RPM spike was recorded on 16 Jun 2016, and the AV continued to have single occurrences of RPM spiking until 1 Nov 2016. There was a short gap in flying, and the next WK043 flight on 24 Jan 2017 showed 3 RPM spikes; the following flight on 31 Jan 2017 had multiple spikes. There was another VMSC change from serial number 12FLT0008 to serial number 1024 on 9 Jan 2017; the same serial

number of the VMSC that was the subject of the original F760 in 2013. However, there was no correlation between a single VMSC or build standard; the RPM spiking was seen on all four VMSCs fitted to WK043 at both OCU and ES2 builds (see Figure 21).

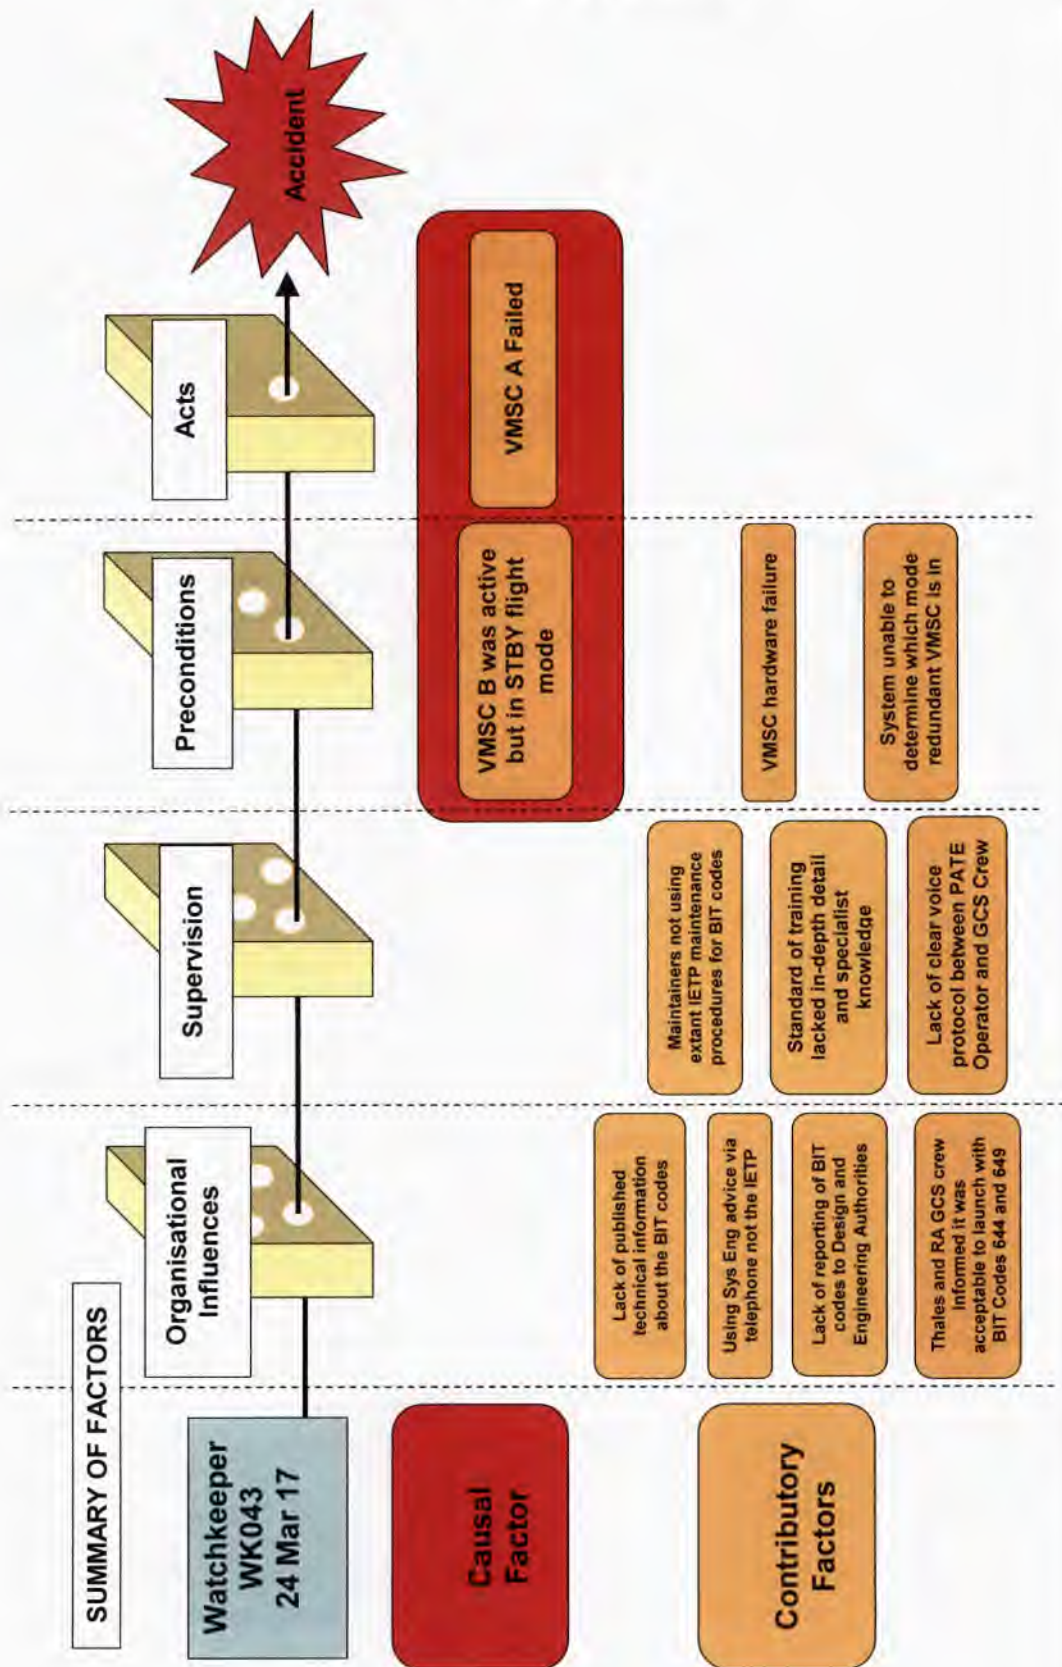
Figure 27 – Swiss Cheese Analysis of WK043 crash.

1.4.278. In this instance, the levels are organisation, supervisions, preconditions and acts. The key point is normalising the acceptance of BIT codes with no auditable procedure or reference, which led to the VMSC Side B being in STBY flight mode. Although VMSC Side A failed over, the redundant Side B should have been available to take active control and it was not; this is why the AV crashed.
