ROYAL AIR FORCE

WORKING PAPER 08/03

RAF SCAMPTON LAND QUALITY ASSESSMENT PHASE 1 - DESK STUDY

VOLUME 1 (OF 2): REPORT

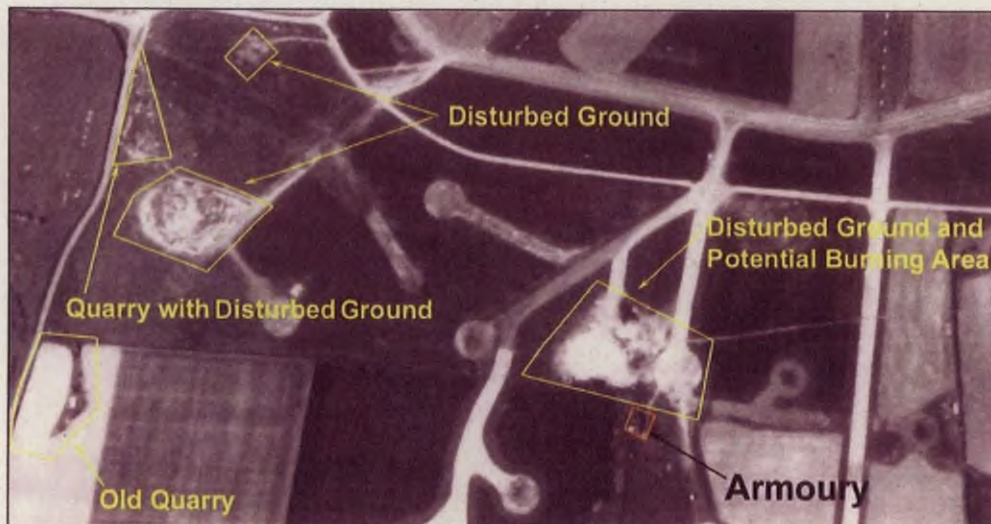
79. Two 1948 Aerial Photographs (Figures 14 and 15) clearly show ground disturbances in the south-west of the site (presently F- dispersal). Figure 14 highlights an area of ground disturbance on several WWII dispersals and in the old quarries. There are also blackened areas visible on the WWII dispersal that could be indicative of burning.

Figure 14. Aerial photograph of southern dispersals dated May 1948, showing areas of ground disturbance and potential burning.

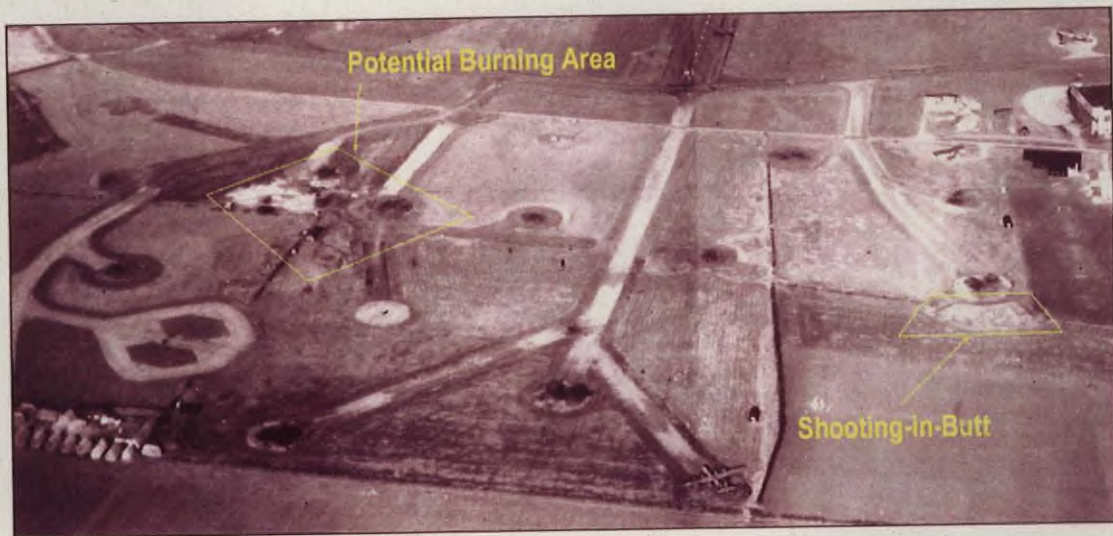
80. Figure 15 shows a black colouration on several of the dispersals, which could be attributed to a number of factors, for example, burning or staining from oil or tyres.

Figure 15. Aerial Photograph (Oct 48), showing potential burning activity.

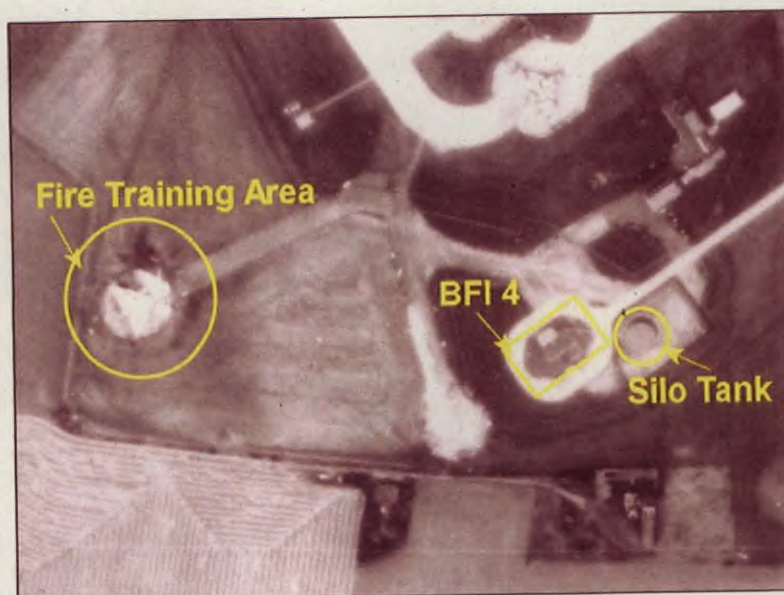
90. Evidence of aircraft burning is visible on a WWII dispersal just south of F-Dispersal (Figure 20). The aerial photograph from 1977 also shows the vertical cylindrical fuel tank (locally referred to as a silo tank) adjacent to BFI 4, that is also present on the December

Figure 20. Evidence of burning activities and the vertical fuel tank at BFI 4 in 1977.

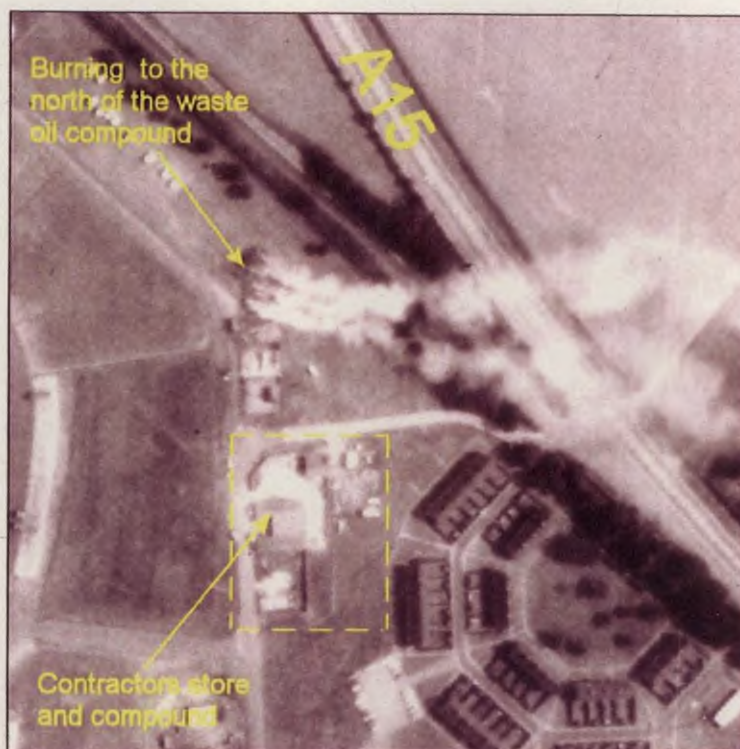
92. Further evidence of burning on site is provided by the 1983 aerial photograph as a large plume of smoke rises into the air from an area near to the waste oil compound and the contractors compound.

Figure 22. Evidence of a burning to the north of the waste oil compound in 1983.

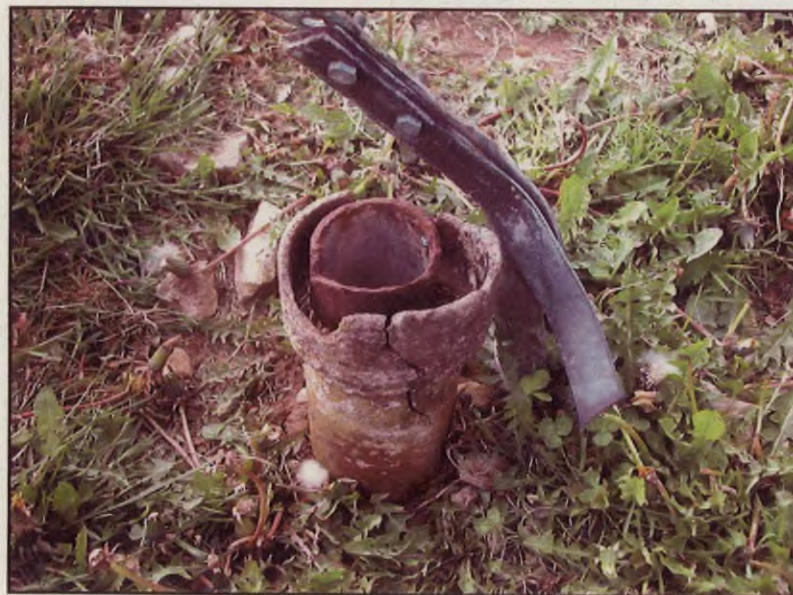
102. During the site visit it was noted that most buildings within the SSA contain asbestos, either in roof tiles or rainwater fall pipes. These buildings display asbestos hazard warnings. However, the silo bay complex (Bldg No 409) contains an asbestos type material as a sleeve surrounding a vent pipe protruding from the top, which is not recorded on the Asbestos Materials Register (Figure 24).

Figure 24. Asbestos type material forming a sleeve around a vent pipe.

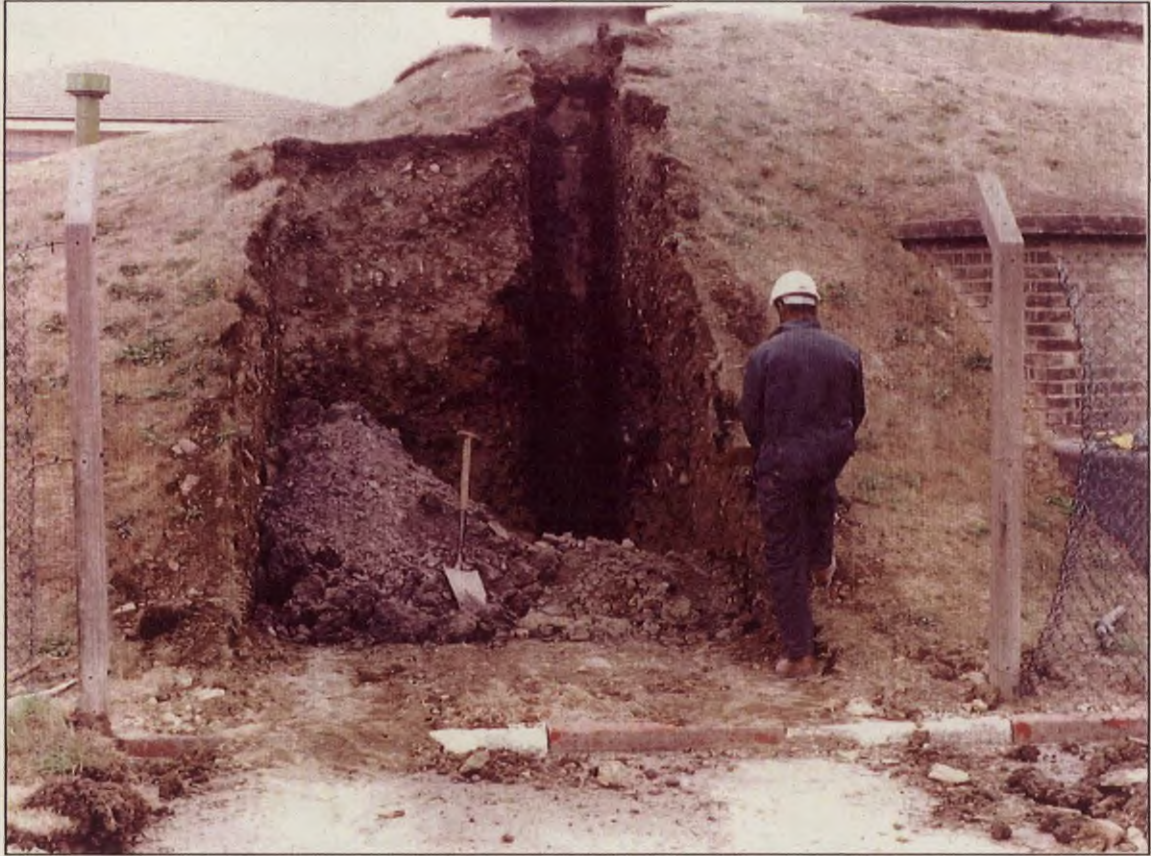
Figure 26. Removal of BFI 1 – trial pit showing concrete ring structure extending vertically.

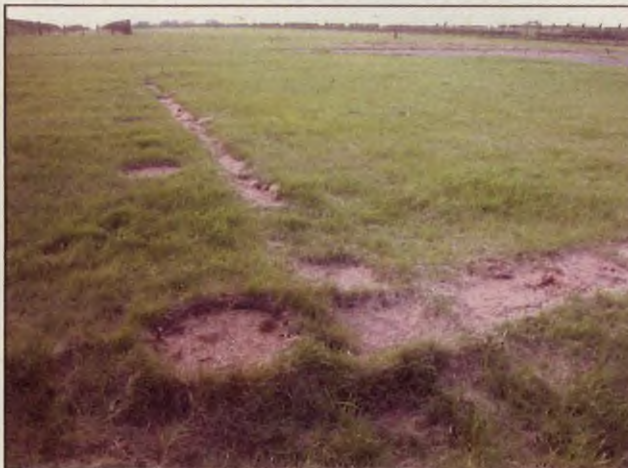
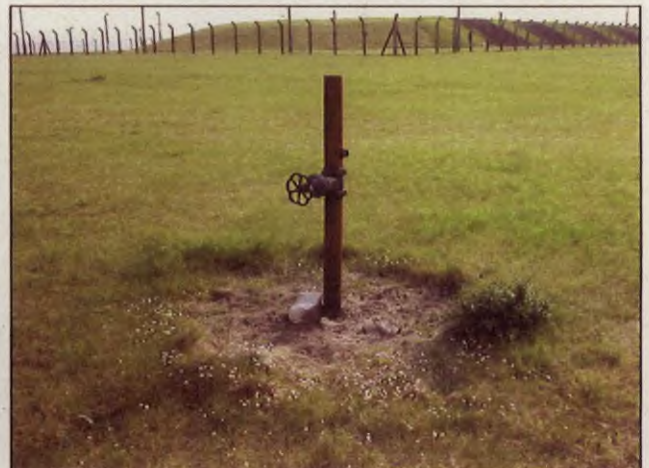
129. BFI 3. During the site investigation it was noted that some of the pipe infrastructure at BFI 3 that fed D Dispersal still remains in the ground (Figure 27). The pipeline has reportedly been made safe and filled with RG22 Neutrofoam Foam.

Figure 27. Remnants of cross base pipeline and BFI 3.

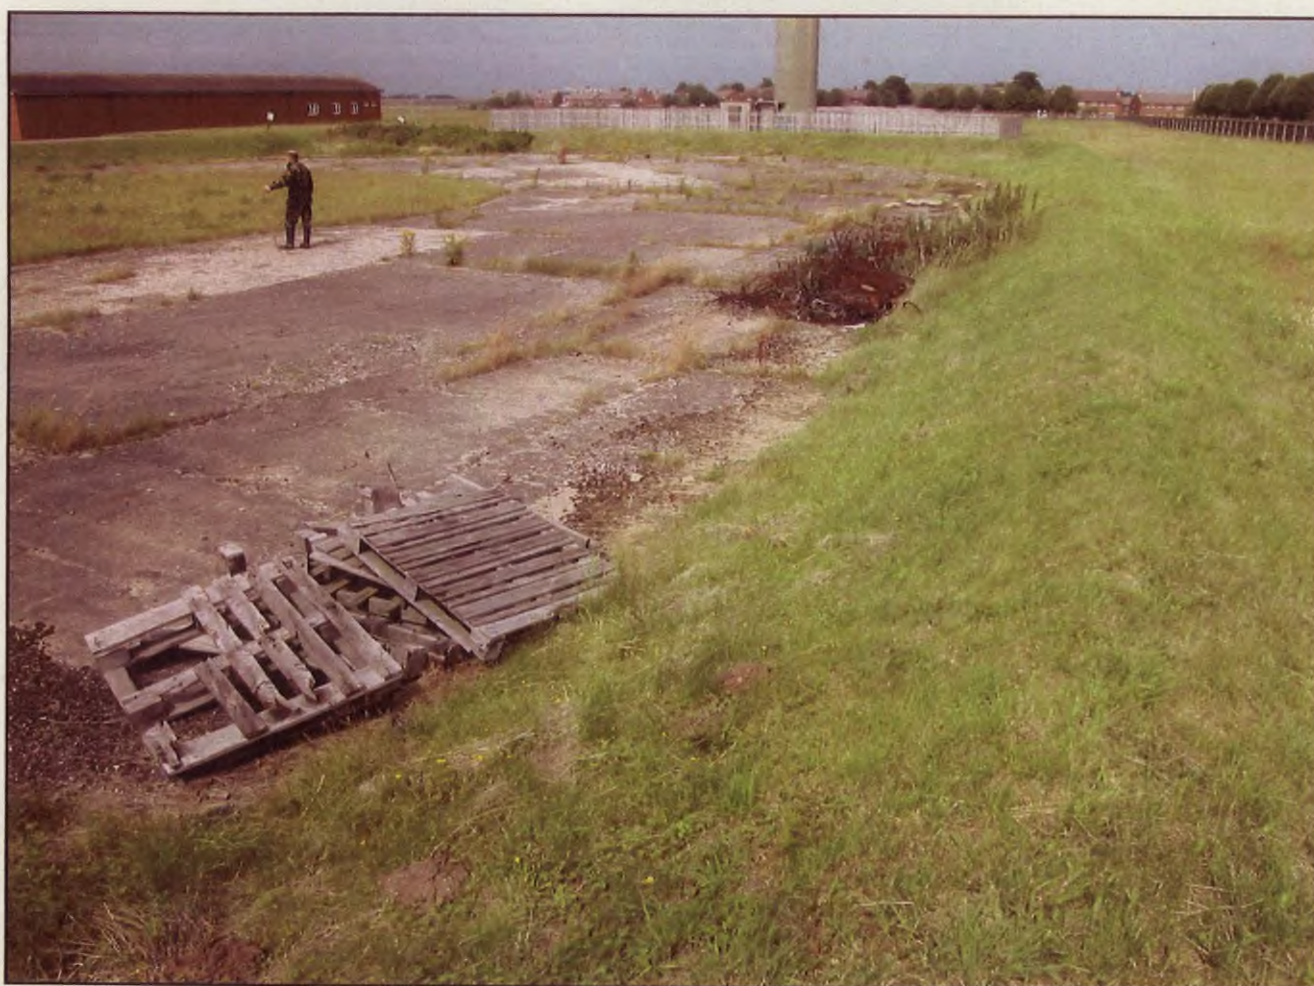
134. There was a spill from the vertical cylindrical fuel tank, a temporary BFI located near BFI 4 (Figure 29). The tank was installed in 1973/4, but removed in 1984 because it was found to be leaking. The volume of fuel lost from the leaking tank could not be established, as it was not recorded. The tank rested in close contact with the ground, providing a direct pathway for fuel to migrate through the thin soil and potentially down to bedrock and into the groundwater system. The secondary containment system surrounding the tank consisted of an earth bund. It is unknown whether any soil sampling was carried out to assess the degree of contamination and whether any subsequent remediation took place.

Figure 29. Area of former fuel tank with open grass in the centre and earth bund.

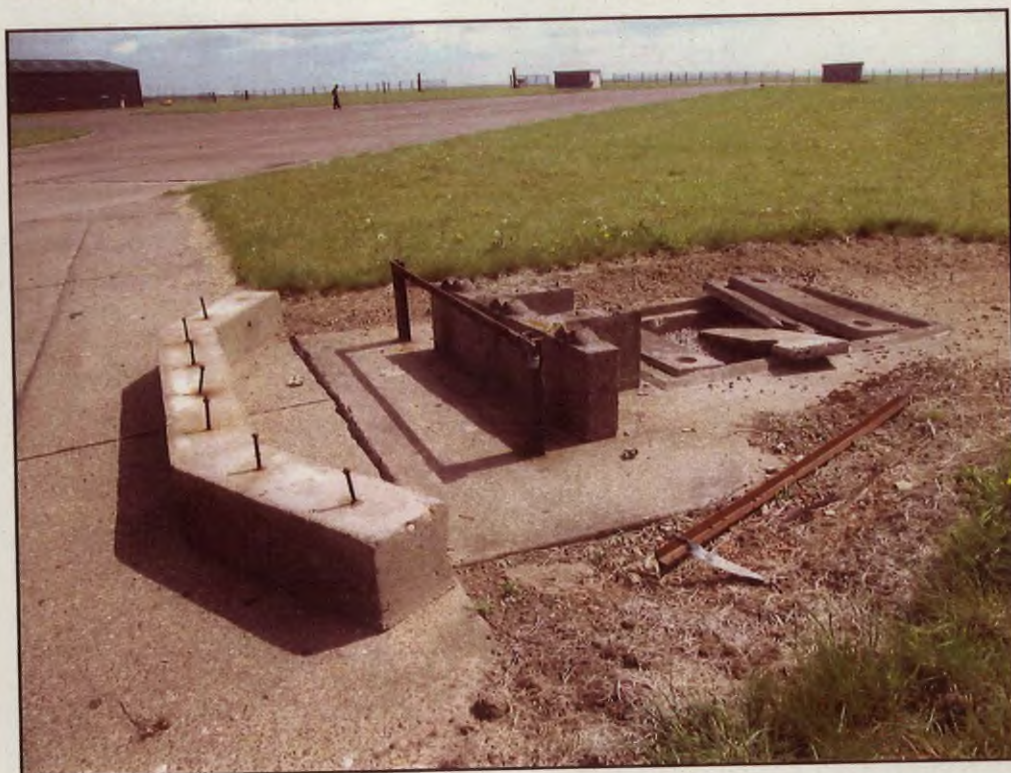
sections that ran beneath hardstandings were also filled with foam by reverse injection. The pipelines were left in situ. A visual inspection noted that some of the fill point infrastructure still exists at a number of dispersals (Figure 30).

Figure 30. Remnants of a fuel fill point at C Dispersal.

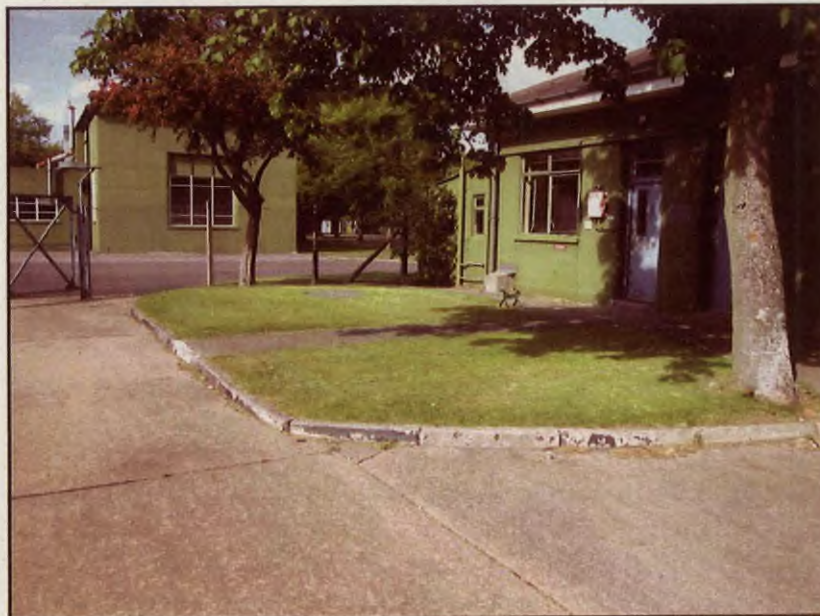
155. Historical MT Fuel Installations. Historically the MT section was located in the south of the technical site. The old MT section had a bulk petrol installation (Bldg No 163) with a capacity of 5 000 gallons. The single tank was buried and probably installed in the late 1930s during original site construction. It is thought that the tank was decommissioned in 1965. It is unknown whether the tank still remains in the ground and no documentary evidence was found indicating whether any soil sampling, laboratory analysis and subsequent remediation of the ground had been carried out at the location of the underground tanks. The area is now grassed and no evidence remains of the former installation (Figure 36). It must be noted that the hardstanding which vehicles were filled on has never been intercepted and so it is highly possible that spilt fuel could have entered the surface water drainage system. The site investigation noted that the drains appeared to be free from visible contamination.

Figure 36. Site of old MT Bulk Petrol Installation (Bldg No 163).

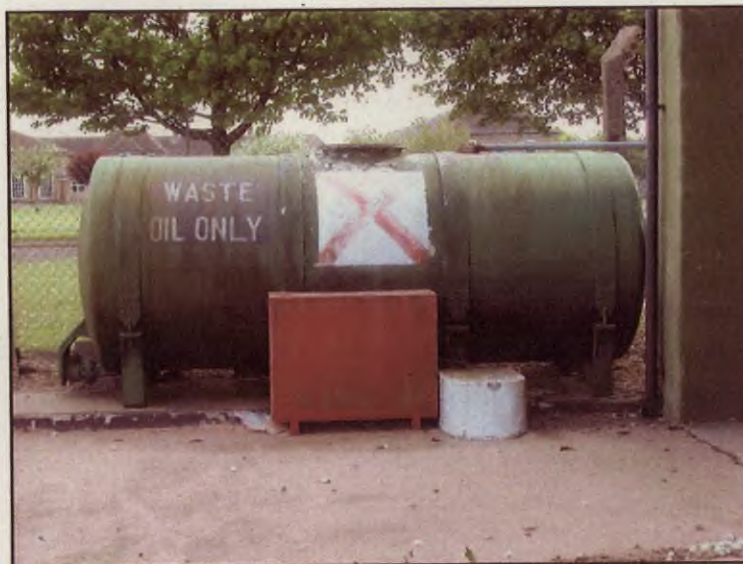
156. At the old MT section there is an above ground waste oil tank of 3 500 litres capacity (Bldg No 161). Station personnel state that the tank is now empty. The tank is linked to a sump collection system at the MT servicing bays, which collected waste oil from the inspection pits/sumps and pumped it into the tank. On visual inspection the tank appeared structurally sound, but has never been bunded and lies halfway over the bare ground (Figure 37).

Figure 37. Waste oil tank next to Bldg No 161 at the MTSS section.

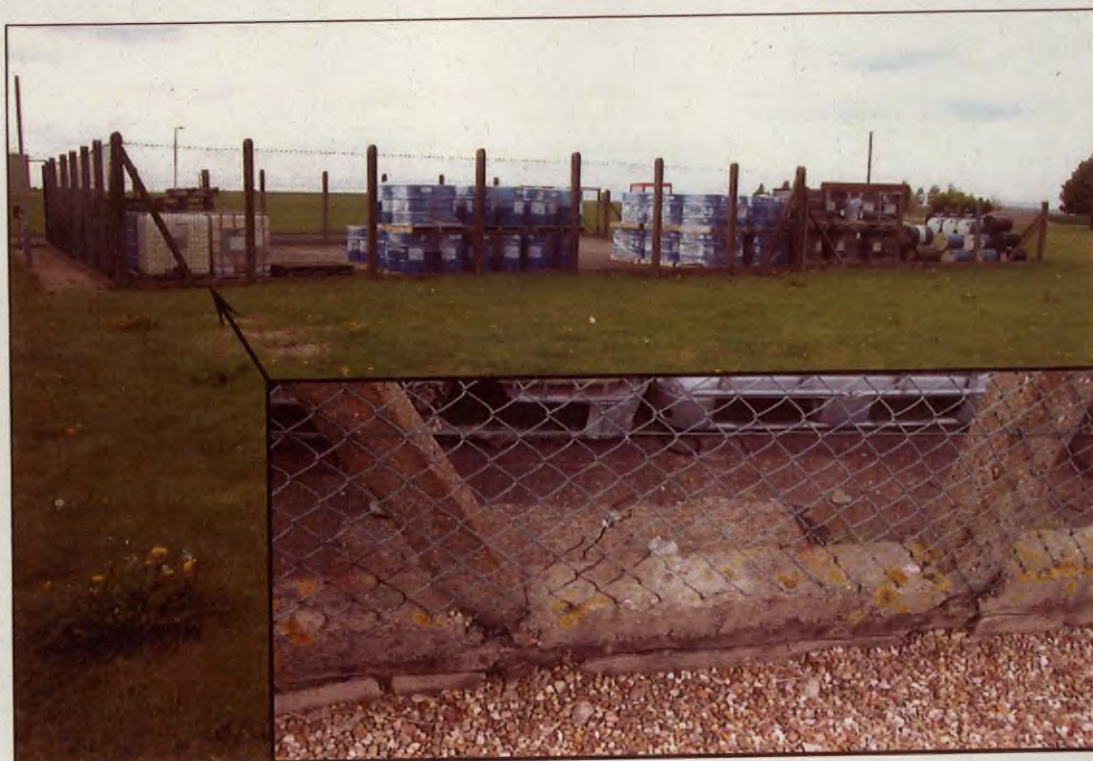
Figure 41. Waste oil compound (Bldg No 498) showing cracked bunding around the edge and on the compounds concrete base.

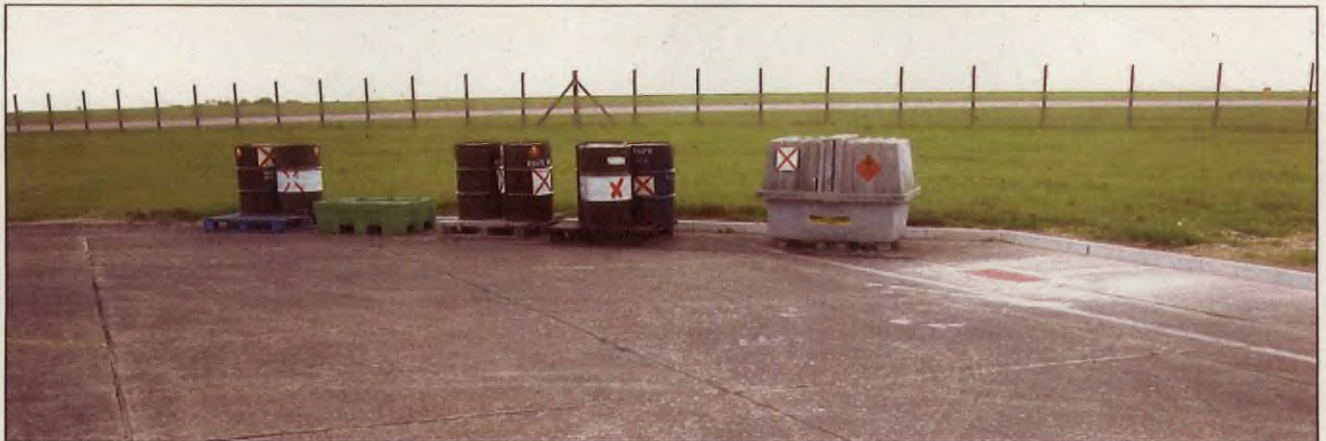
Figure 42. Storage of waste AVTUR and other waste substances at the edge of No 17 hardstanding, E Dispersal.

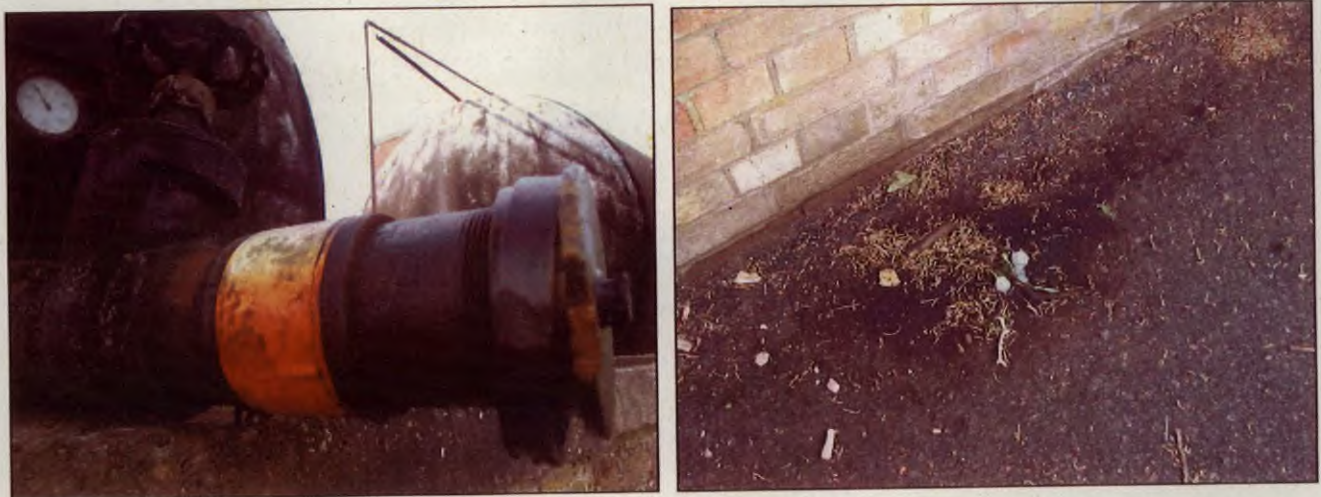
Figure 43. Diesel found dripping from a Standby Set House (Bldg No 157) tank fill point (left) onto the tarmac road (right).

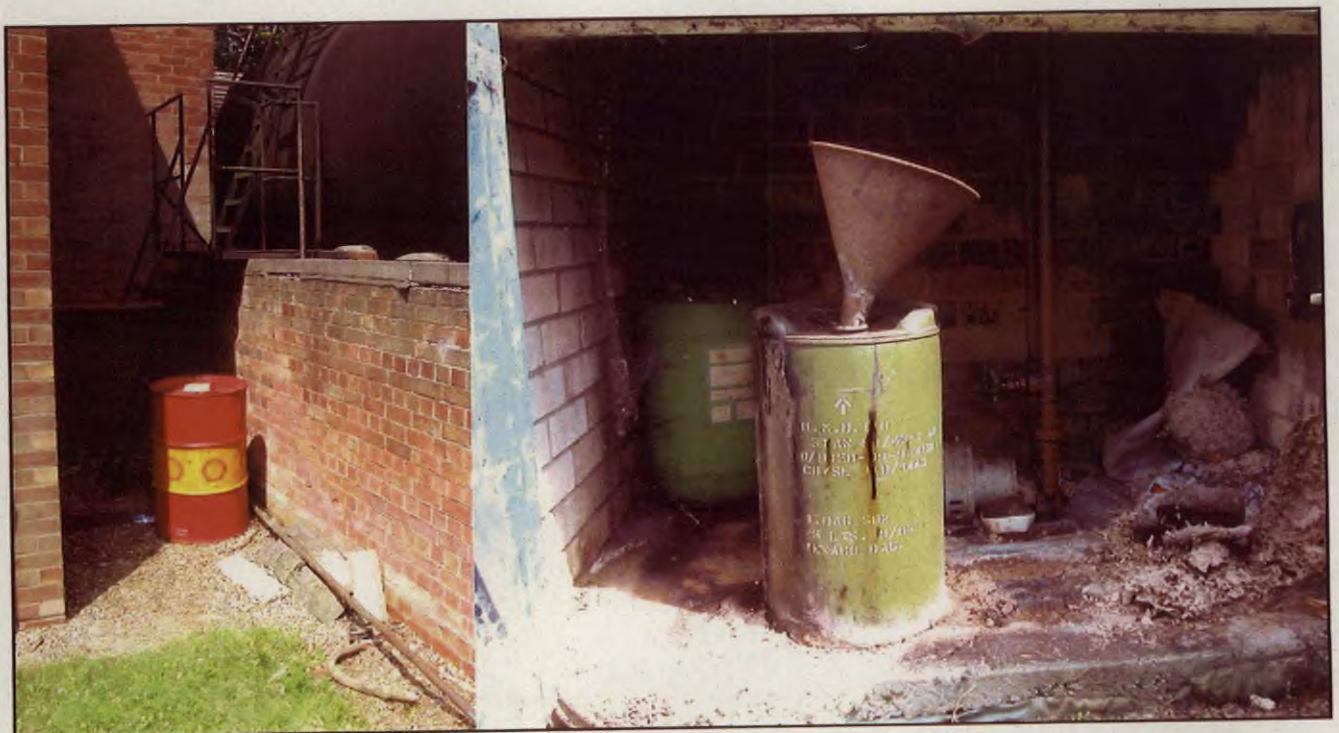
Figure 44. Transformer oil drum and miscellaneous oil cans at the back of the Standby Set House.

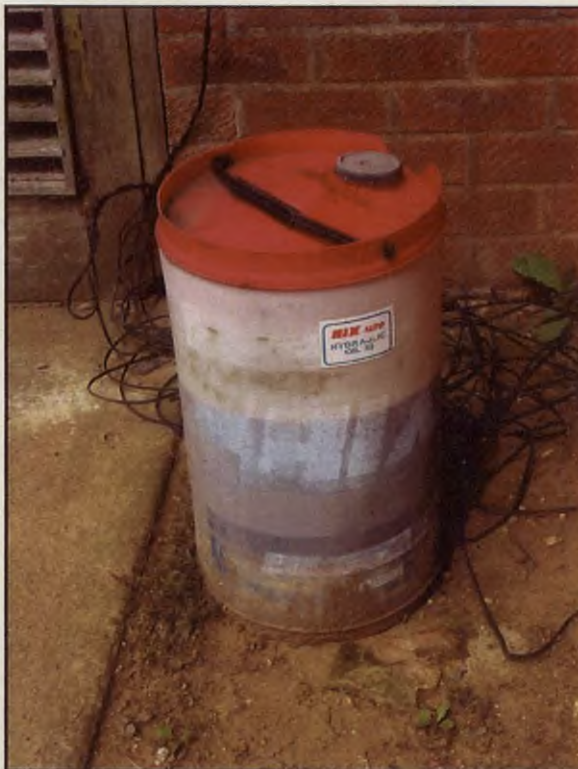
Figure 45. Half full drum left at the ESA/SSA.

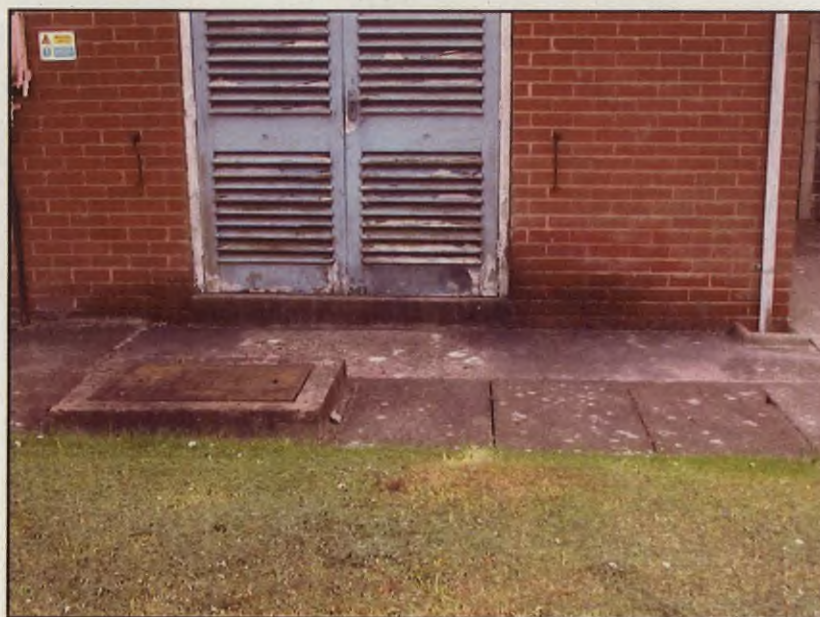
Figure 46. Staining at MTSS Spray paint bay

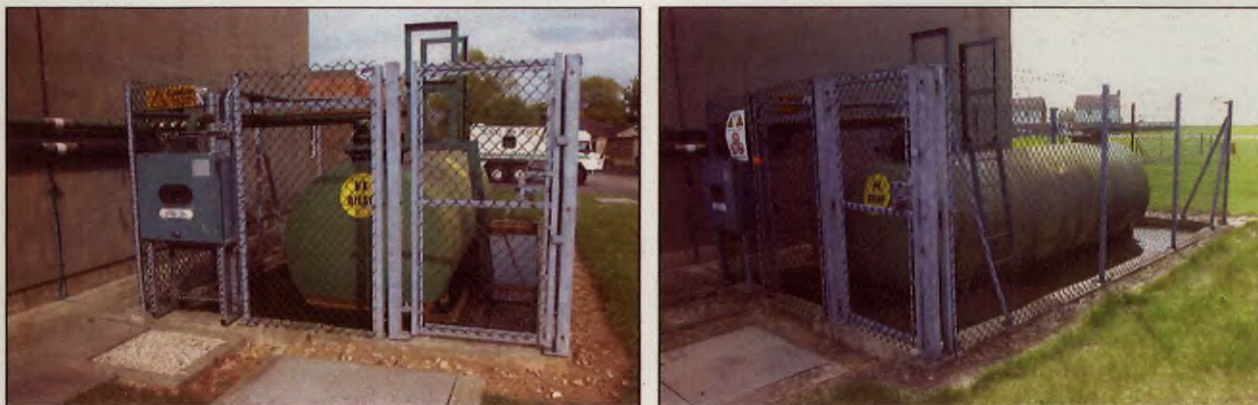
Figure 47. Water filled bunds at Uniter NUB 1 & 2 (Bldg Nos 601 and 602).

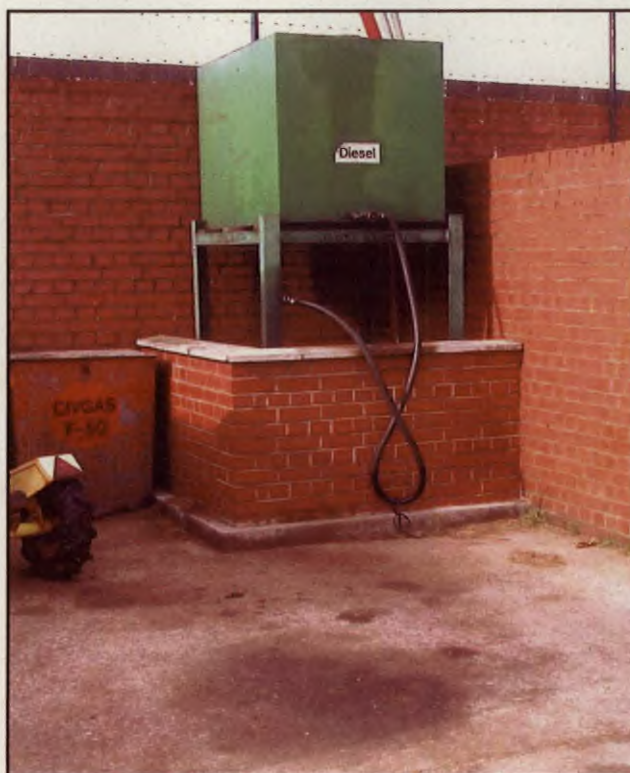
Figure 48. Staining on diesel tank and fill area at Bldg No 65.

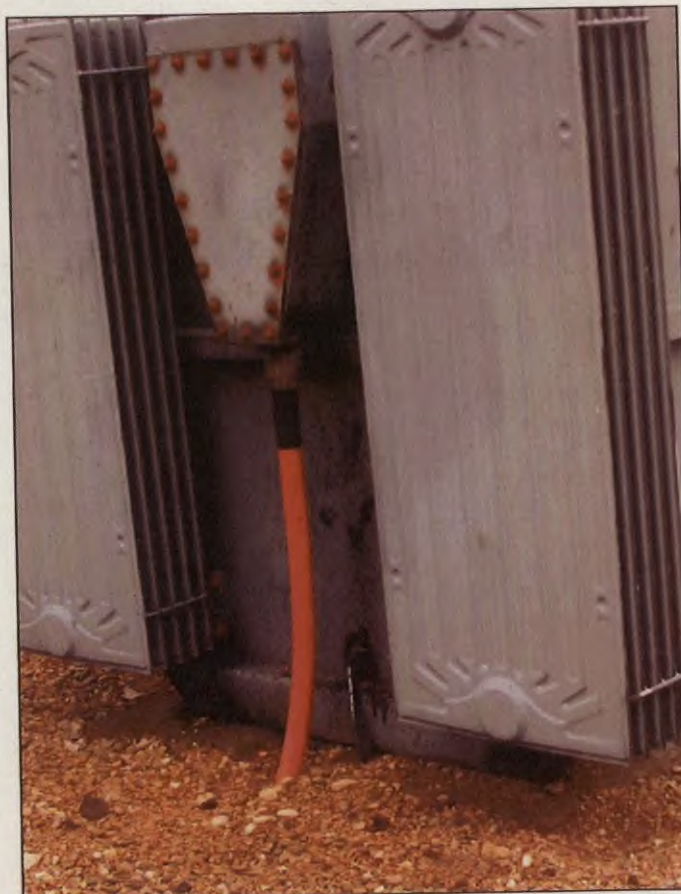
Figure 51. DSS AA, showing signs of past leakage.

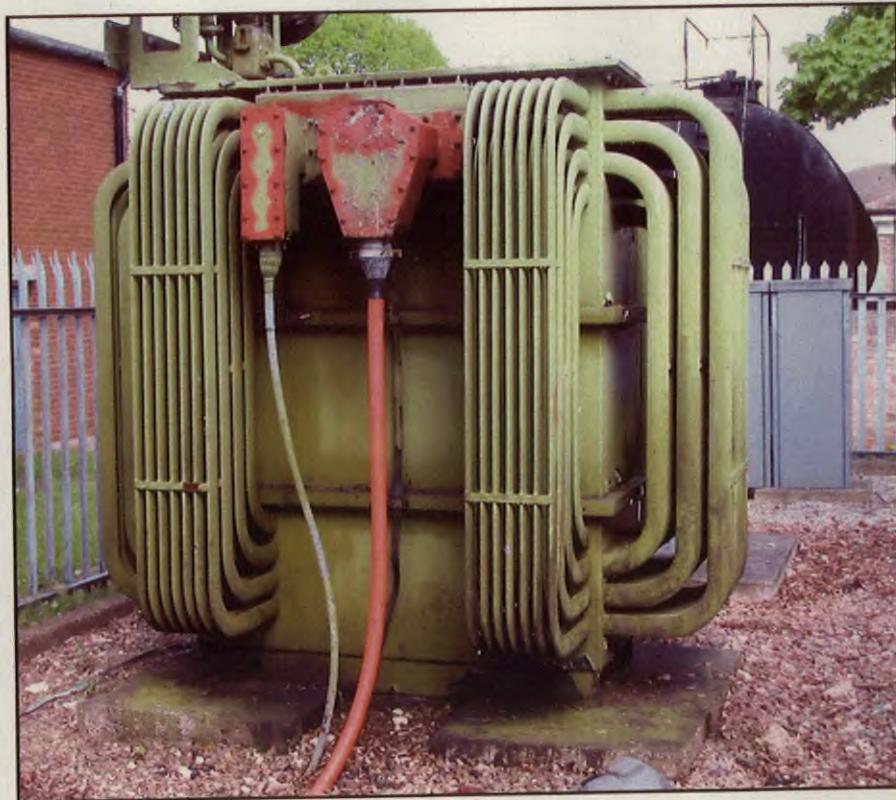
Figure 52. Leaking transformer at the standby set house (Bldg No 157).

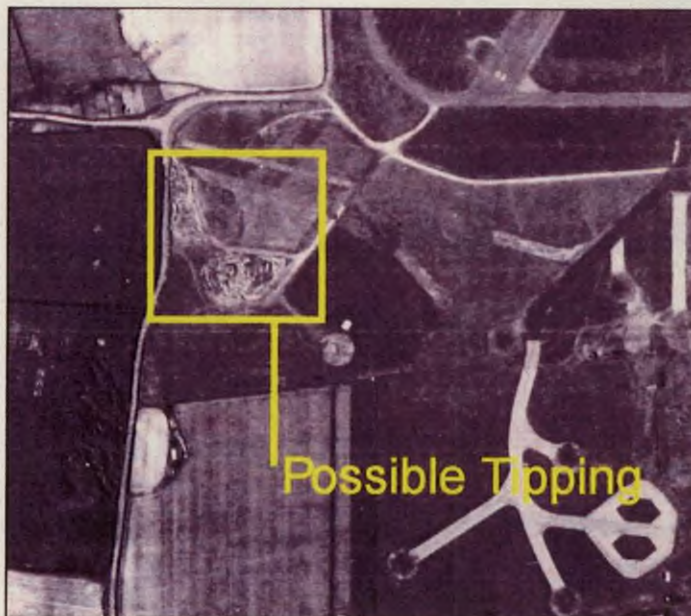
Figure 58. Possible tipping activities to the south-west of the site.

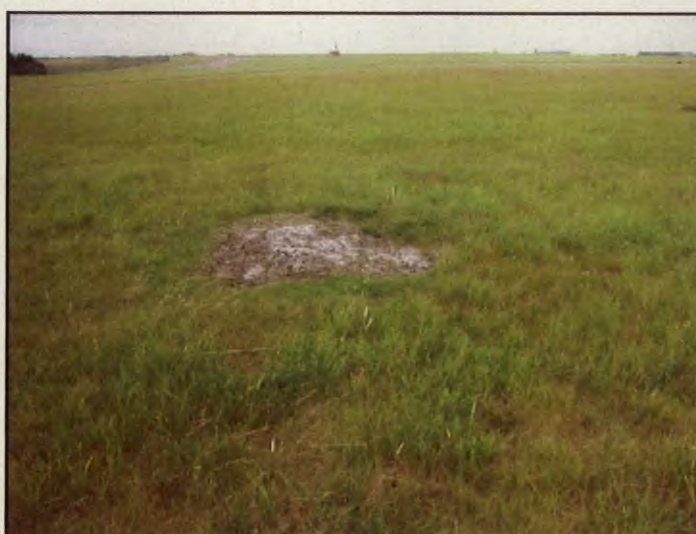
Figure 59. Exposed weathered concrete in area of slightly raised ground to the south-west.

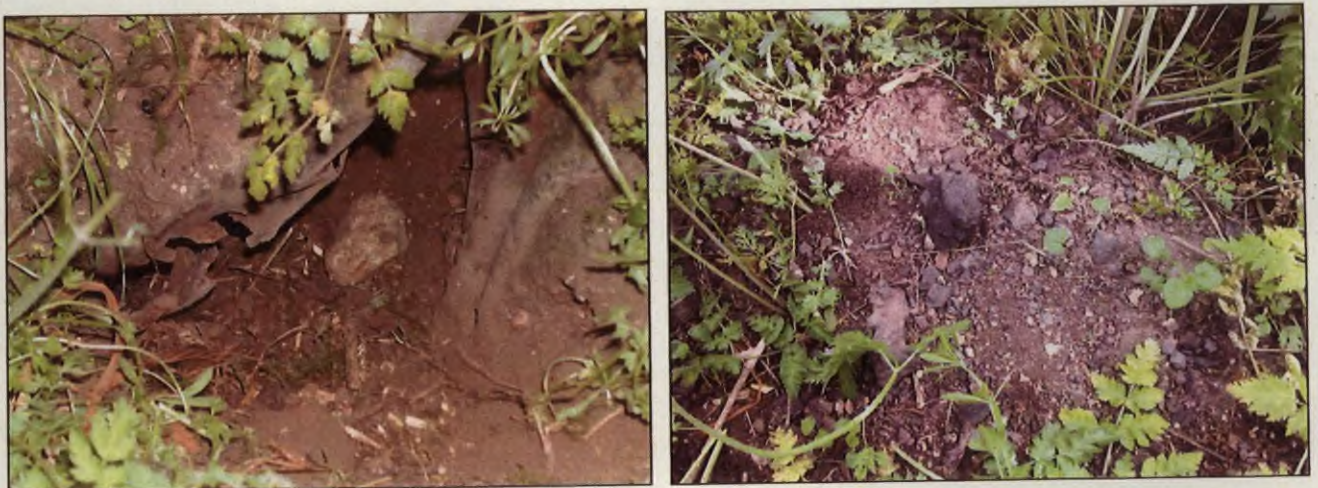
Figure 61. Evidence of tipped material in the wooded area to the west of the station.

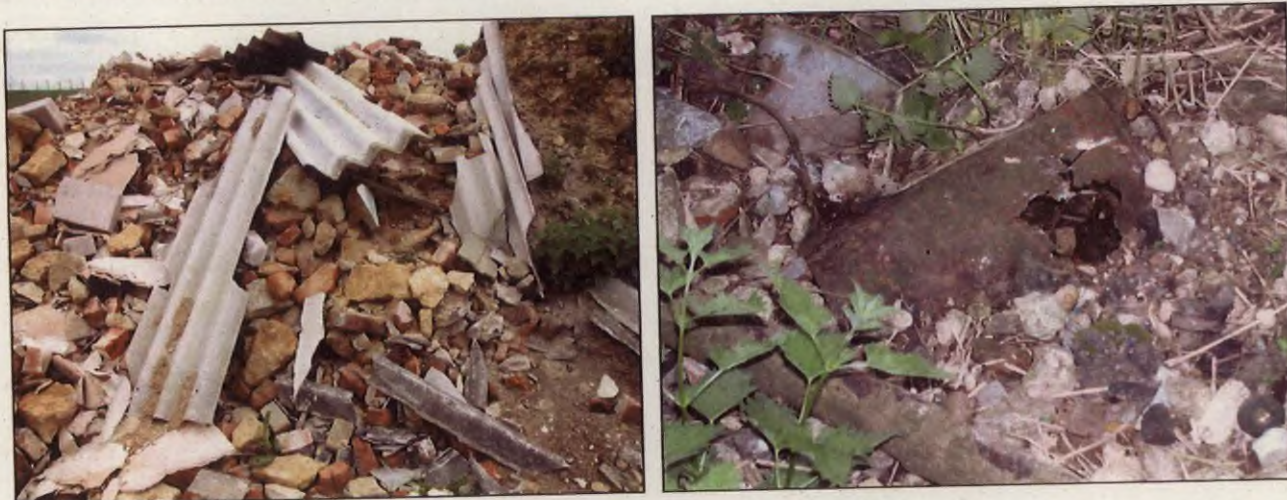
Figure 62. Further tipped materials in a quarry.

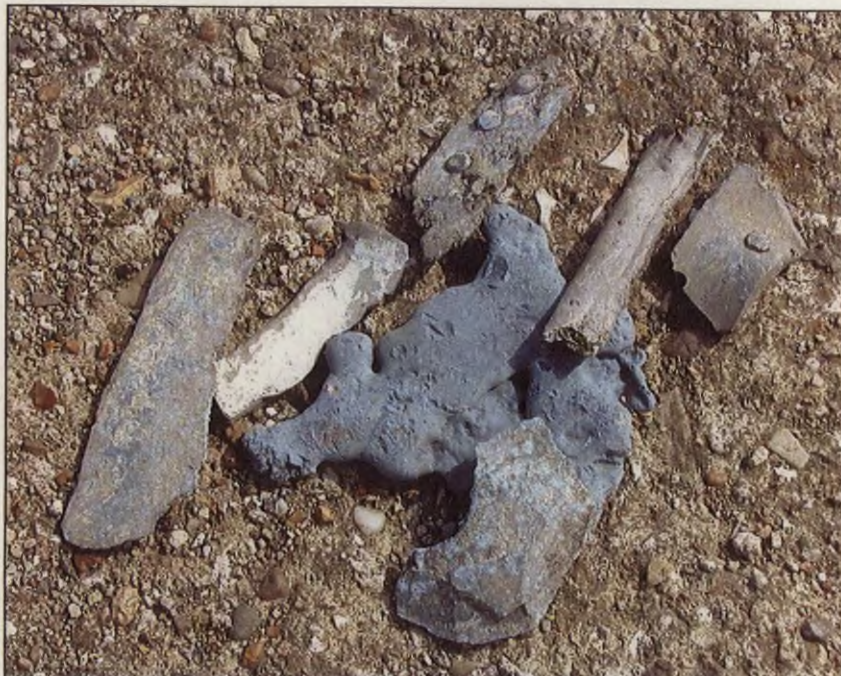
Figure 64. Recovered burnt material at dispersal.

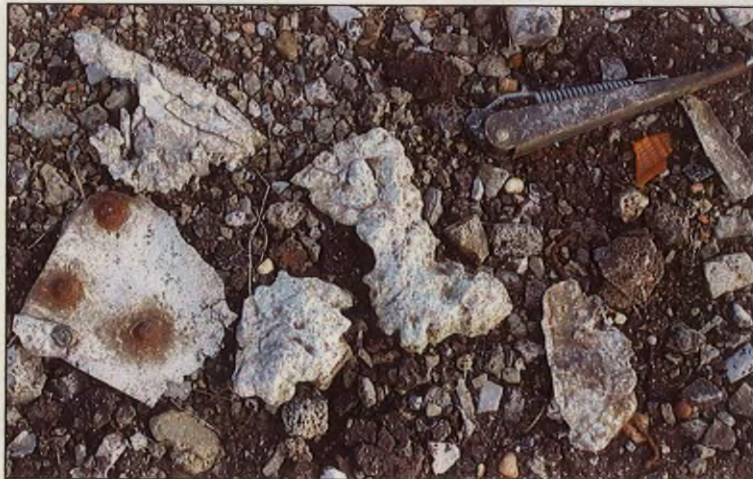
Figure 65. Melted metal and other scrap materials at the fire training area.

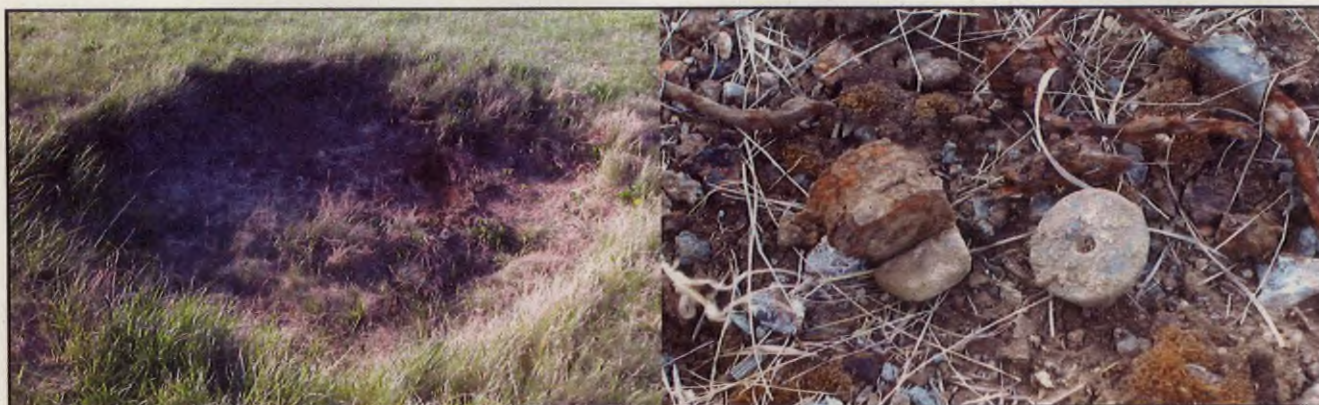
Figure 73. The EOD burning pit and contents.
