Rail Accident Investigation Branch

# Rail Accident Report

## **Derailed at Grayrigg 23 February 2007**

# Derailment at Grayrigg, 23 February 2007

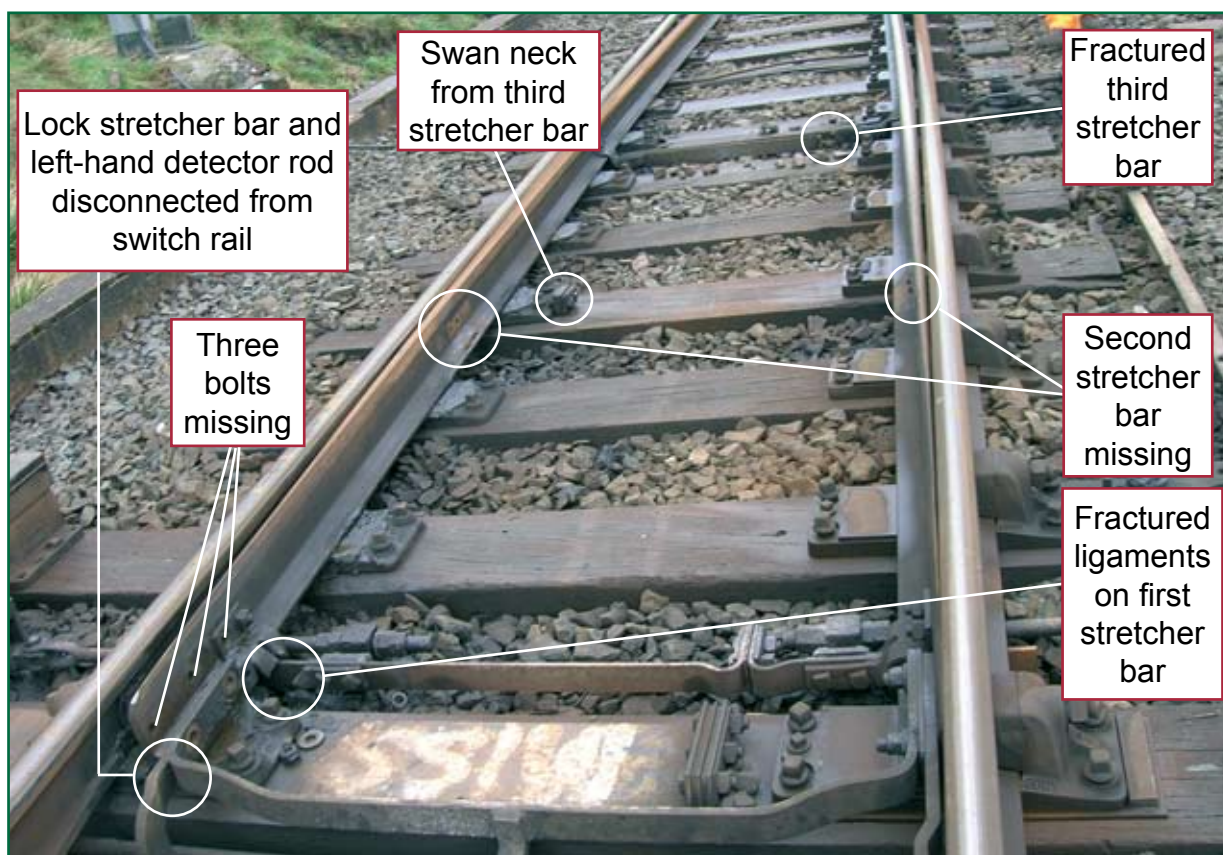
Figure 7: 2B points on 24 February 2007

111 Figure 7 shows the state in which the points were found immediately after the accident.

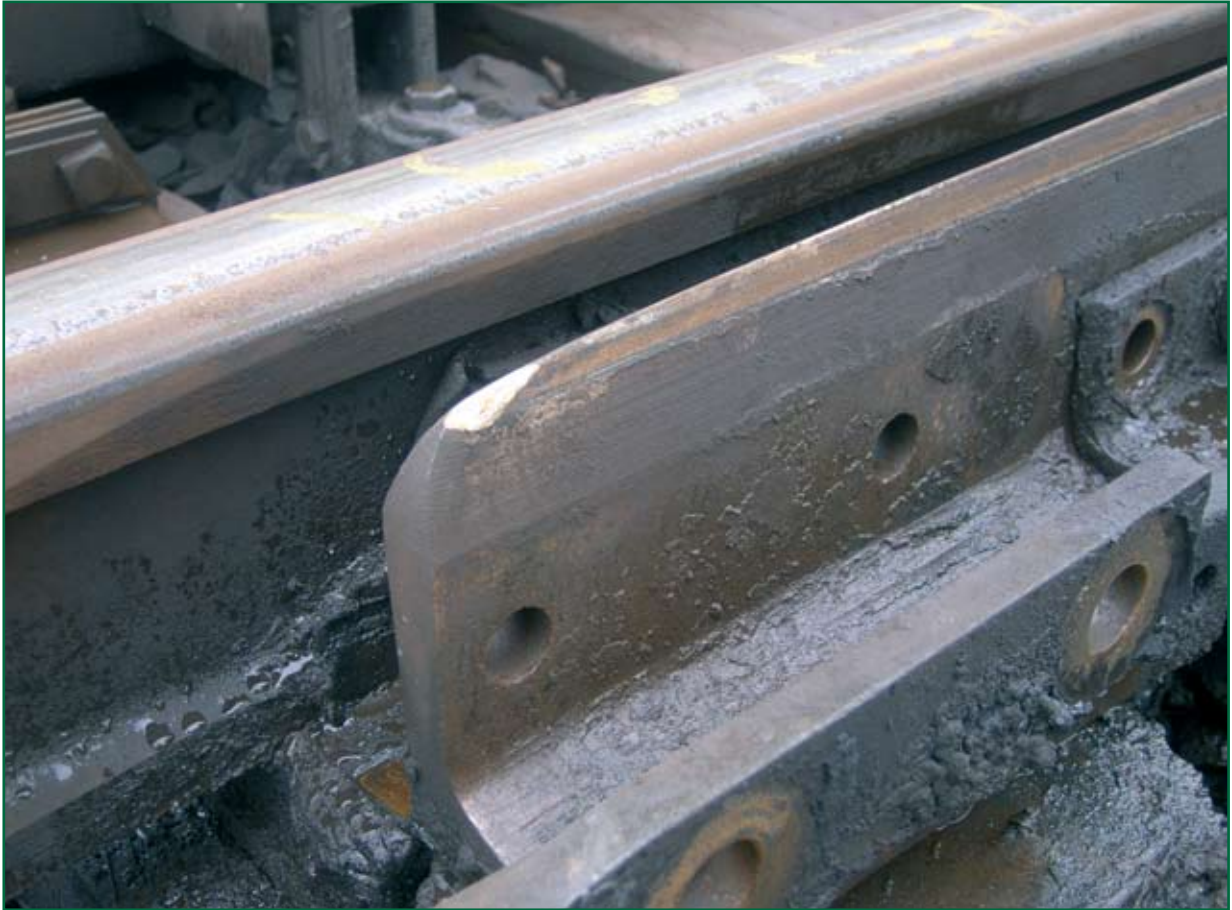
113 There was bruising on the tip of the left-hand switch rail (Figure 8) caused by impact with more than one train wheel as the wheels passed to the *gauge-side* of the left-hand switch rail during the derailment. There were wheel marks on the *field-side* face of the left-hand switch rail starting close to the switch toe and running along it, through to and beyond the third permanent way stretcher bar position (Figure 9). There were no marks indicating that any wheels had passed between the right-hand switch and stock rails from the toe to the third permanent way stretcher bar. There were flange climb marks on both switch rails in the vicinity of the third permanent way stretcher bar, and three of the left-hand *slide chairs* had fractured during the derailment because of forces tending to widen the gauge.

Figure 8: Bruise to the tip of the left-hand switch rail

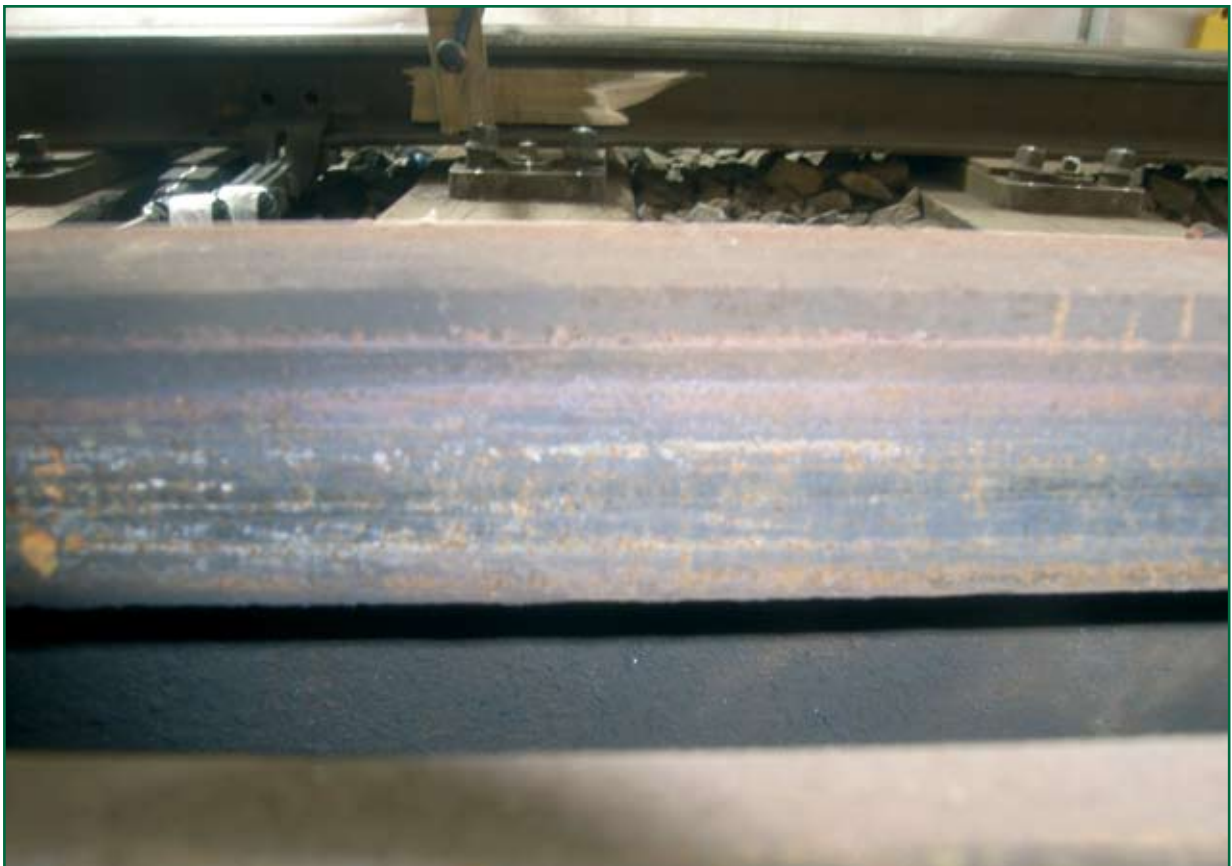
Figure 9: Wheel marks on the field side face of the left-hand switch rail

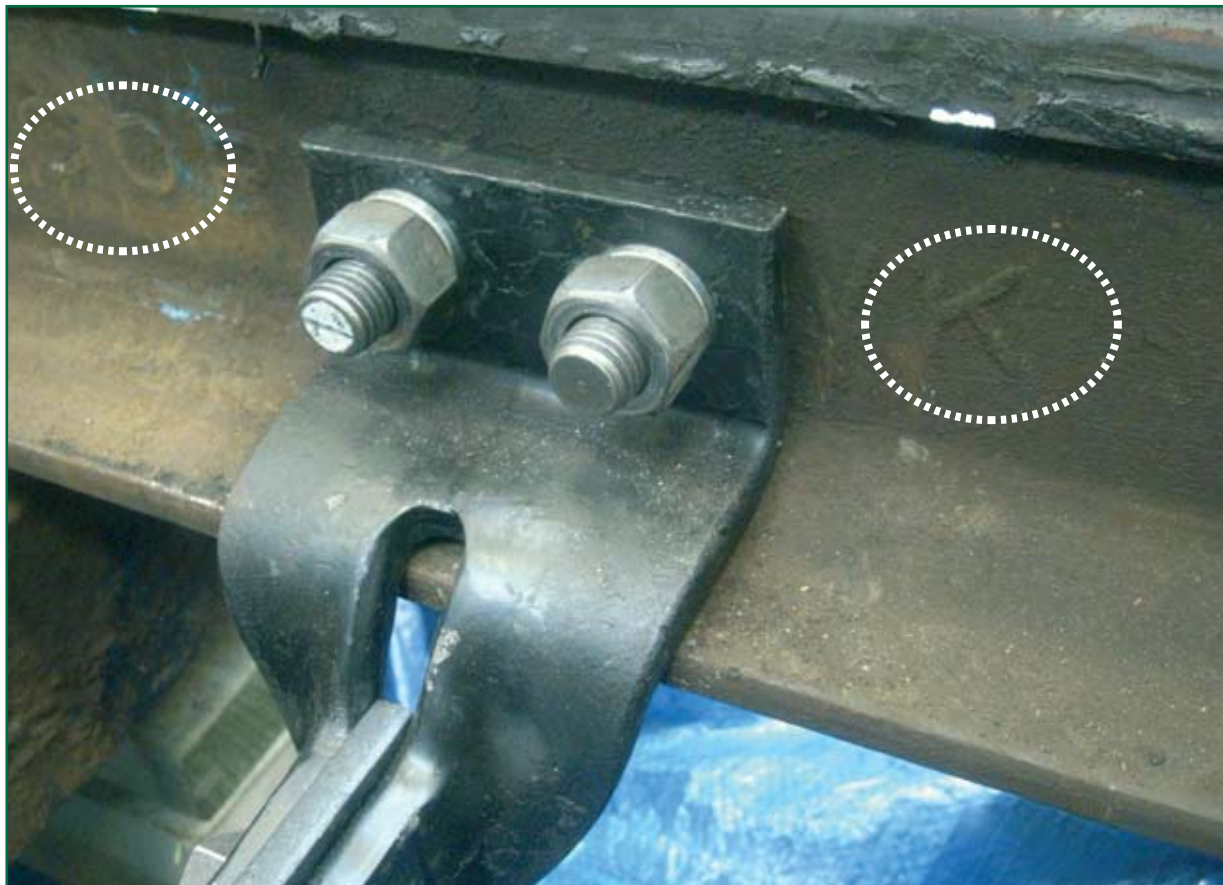
114 *Rail branding* was present on the *four-foot* side of the right-hand side switch rail where the second and third permanent way stretcher bar brackets had been attached (Figure 10). *Branding* was also present on the field-side of the left-hand switch rail where both bolt heads of the first permanent way stretcher bar and the north bolt head of the *lock stretcher bar* had been seated (Figure 11).

Figure 10: Rail branding on right-hand switch rail (Note: a new bracket has been added for testing purposes)

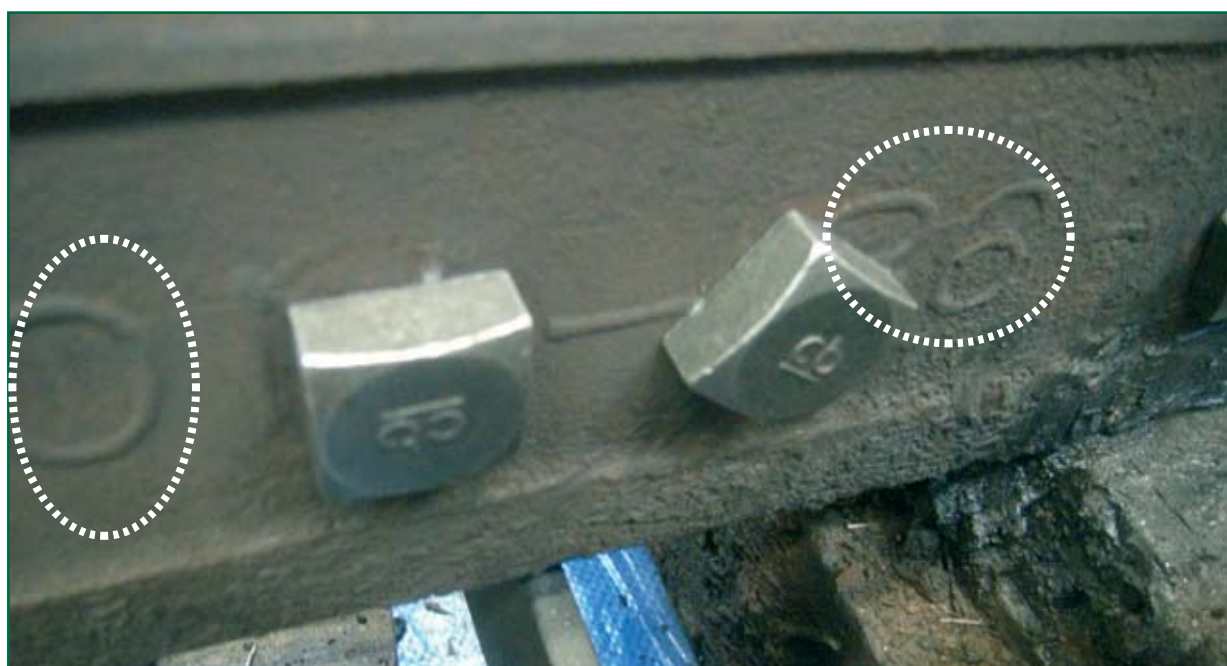
Figure 11: Rail branding on left-hand switch rail (Note: new bolts added for testing purposes)

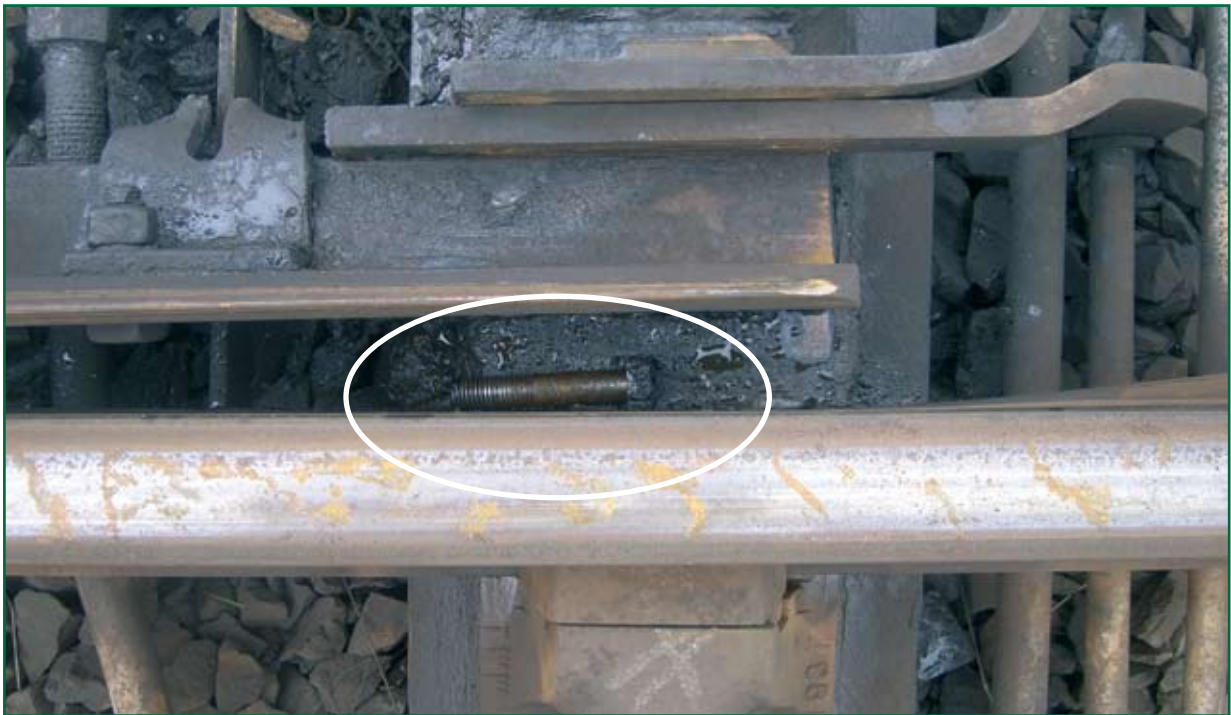
115 The lock stretcher bar was detached from the left-hand switch rail because the two fasteners were not in place. These fasteners were  $\frac{3}{4}$  inch Whitworth bolts with *prevailing torque* nuts. The bolts were made from mild steel, equivalent to grade 4.6 to British Standard 3692:2001, commonly known as black bolts, in accordance with Network Rail's specifications. All of the detached fastener components were lying in the vicinity of the switch toes, with the exception of one of the bolts which, despite an extensive search, was not found. The other lock stretcher bar bolt was recovered from the left-hand slide chair at the point toes, between the left-hand switch rail and its adjacent stock rail (Figure 12). There were markings on the bolt head (Figure 13), and the feet of both rails, consistent with the bolt having been trapped by the closing of the left-hand switch rail.

Figure 12: Lock stretcher bar bolt between left-hand switch and stock rail at toe

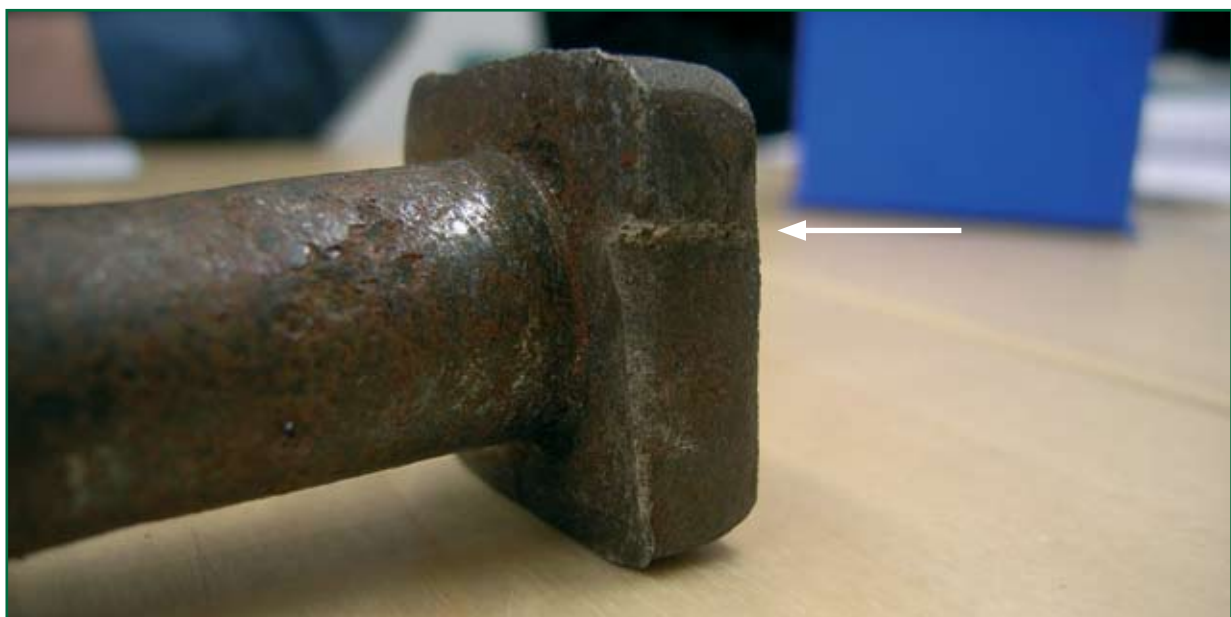
Figure 13: Indentation in lock stretcher bar bolt head

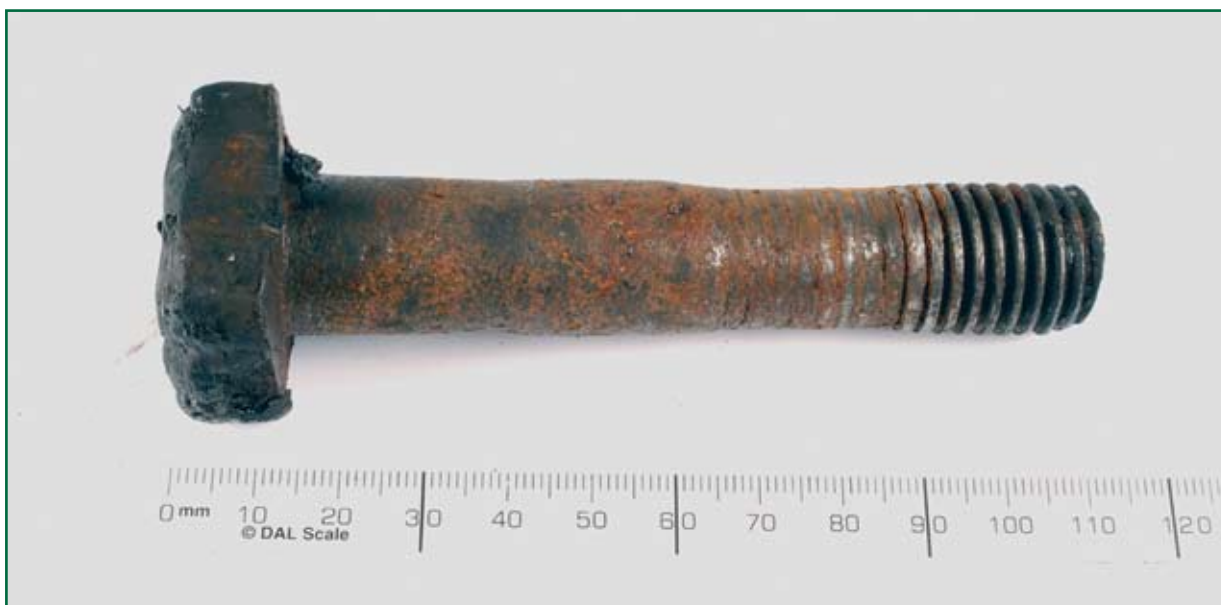
116 Examination of the one detached lock stretcher bar bolt (paragraph 115) indicated that the fastener had loosened and the nut had progressively wound off the bolt. The gradual unwinding of the nut is apparent from the decreasing flattening of the crowns of the threads towards the tip of the bolt (Figure 14).

Figure 14: Lock stretcher bar bolt showing progressive thread damage

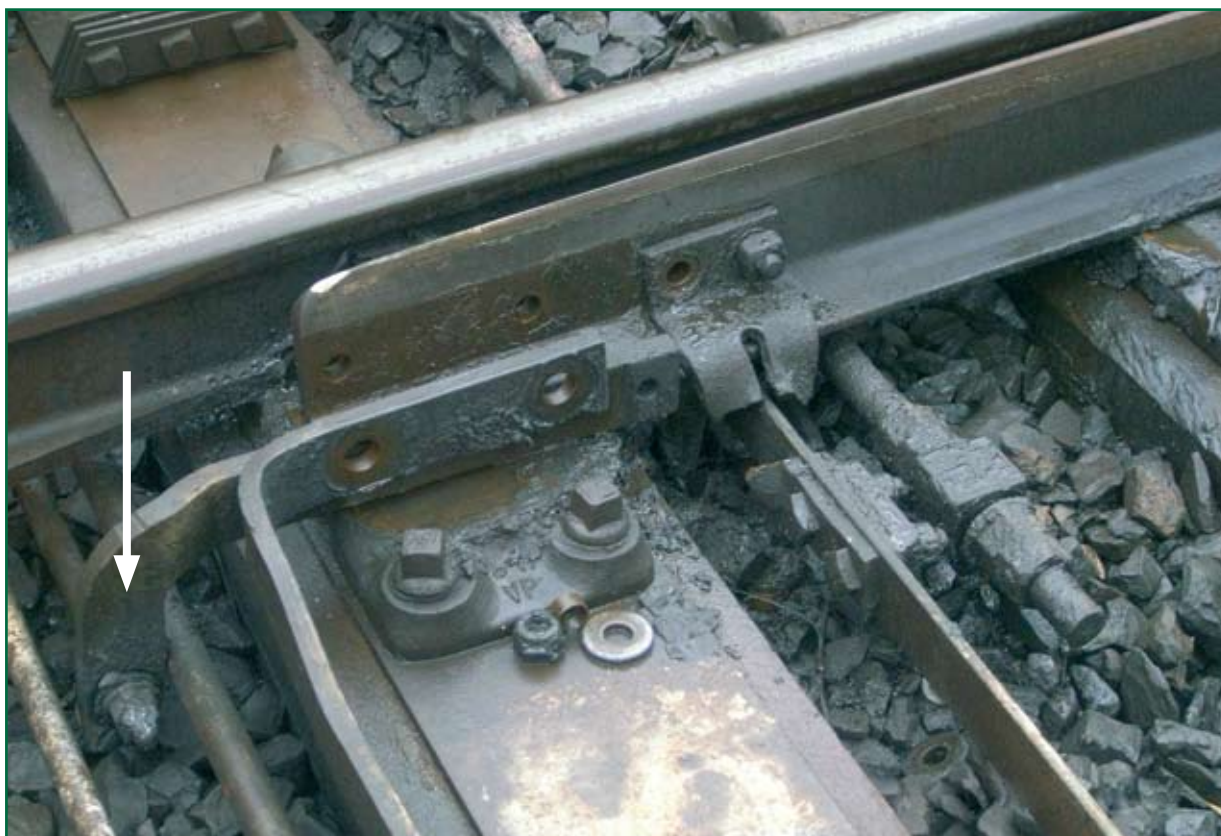
117 The left-hand *switch rail extension piece* (Figure 15), to which the *detector rod* was attached, was also detached from the left-hand switch rail because its fasteners were common with those of the lock stretcher bar.

Figure 15: Left-hand switch rail toe showing switch rail extension piece (arrowed)

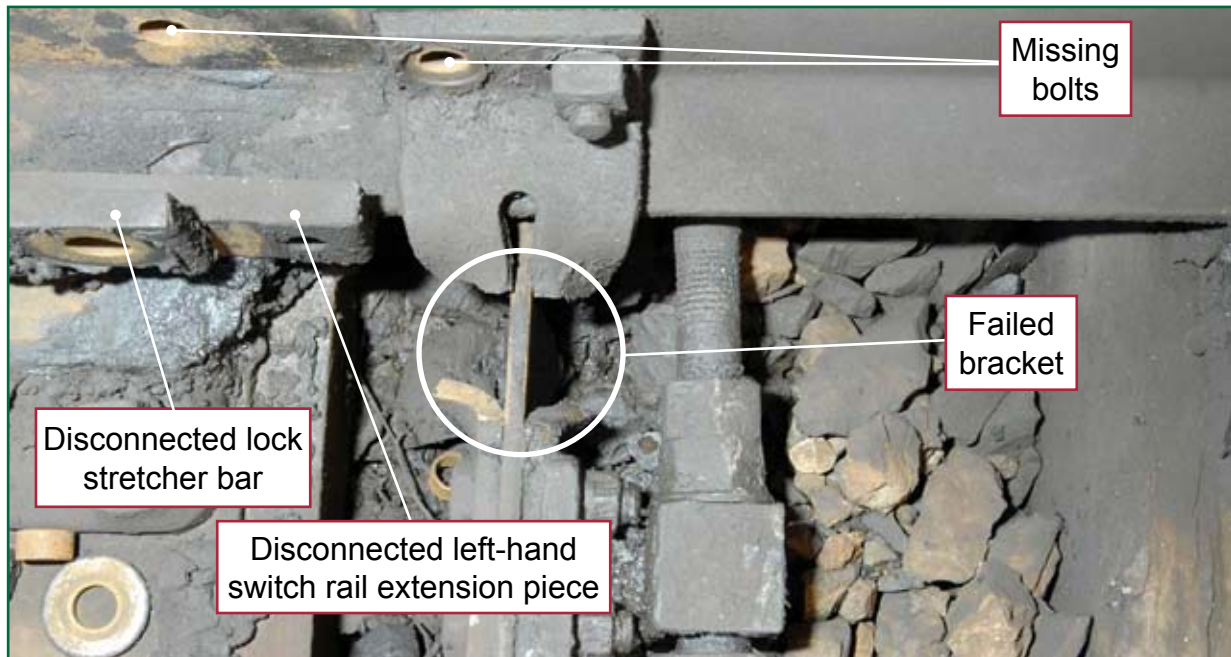
Figure 16: Failed bracket first permanent way stretcher bar

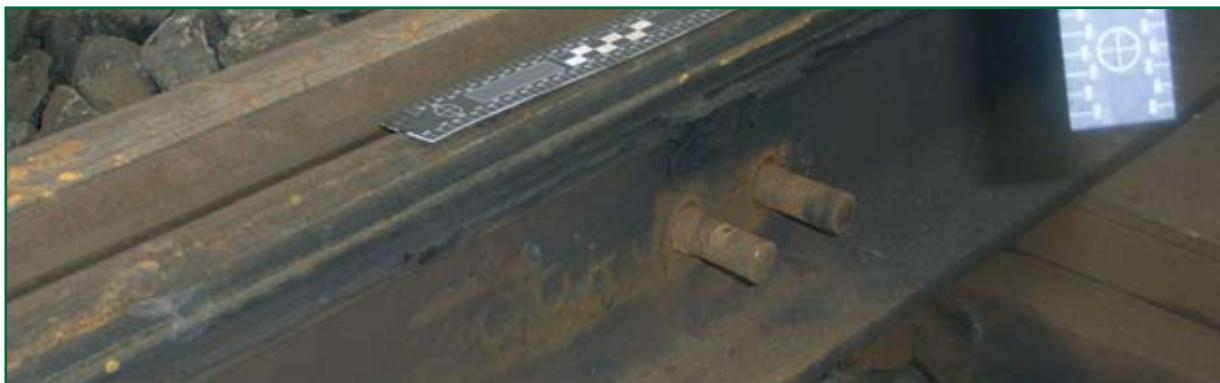
- 122 The second permanent way stretcher bar was missing from the points. All of its fastener components (bolts, nuts and spring washers) were present in the ballast in the vicinity of where the bar had been, with the exception of the right-hand switch rail bolts which were still within their attachment holes in the right-hand switch rail (Figure 17).
- 123 Two sections of stretcher bar (Figures 18 and 19) were found at two separate locations 50 metres and 150 metres north of 2B points. Their dimensions and metallurgy indicated that these were the sections of the second permanent way stretcher bar.

Figure 17: Right-hand switch rail at second permanent way stretcher bar position

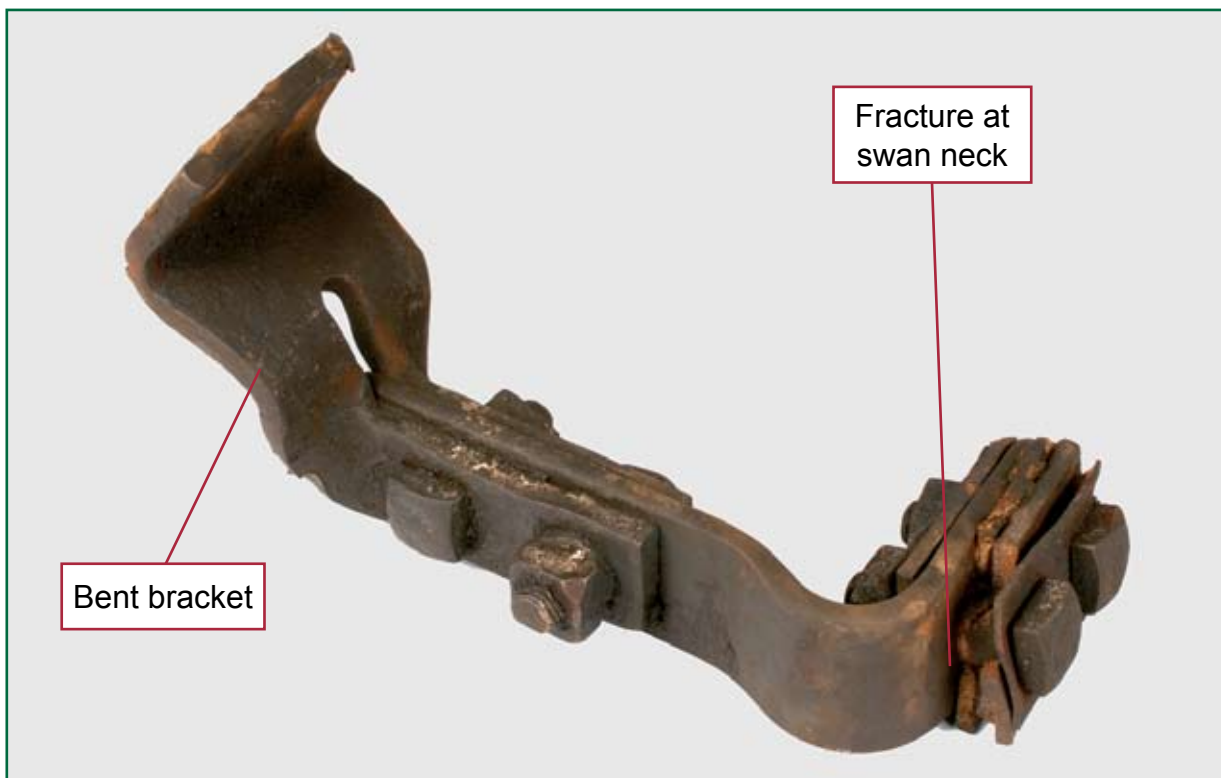
Figure 18: Short section of second permanent way stretcher bar

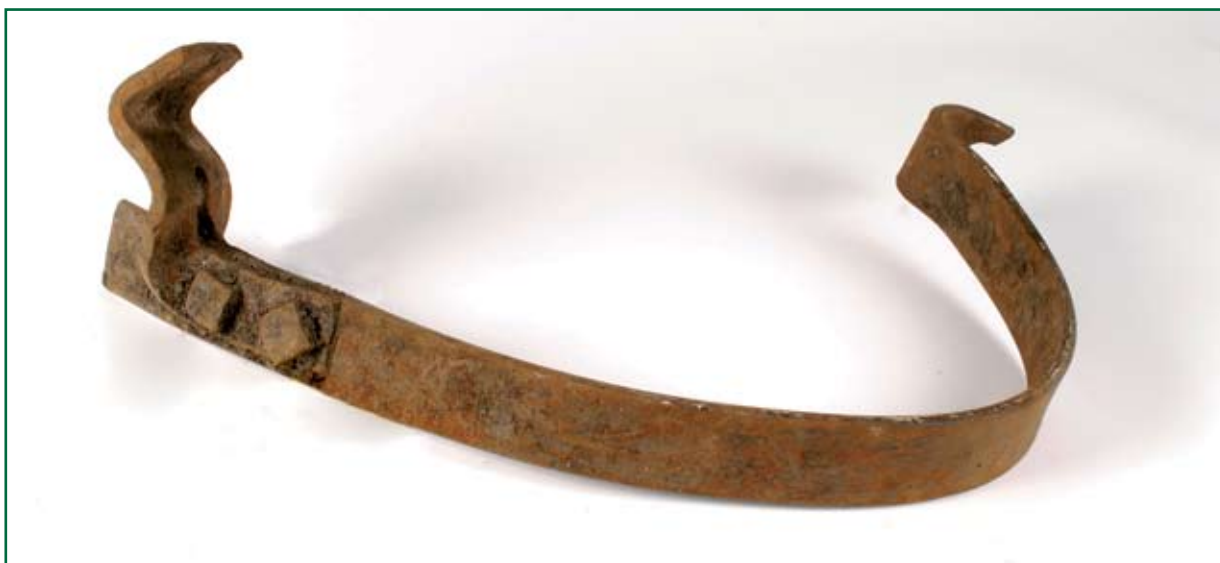
Figure 19: Long section of second permanent way stretcher bar

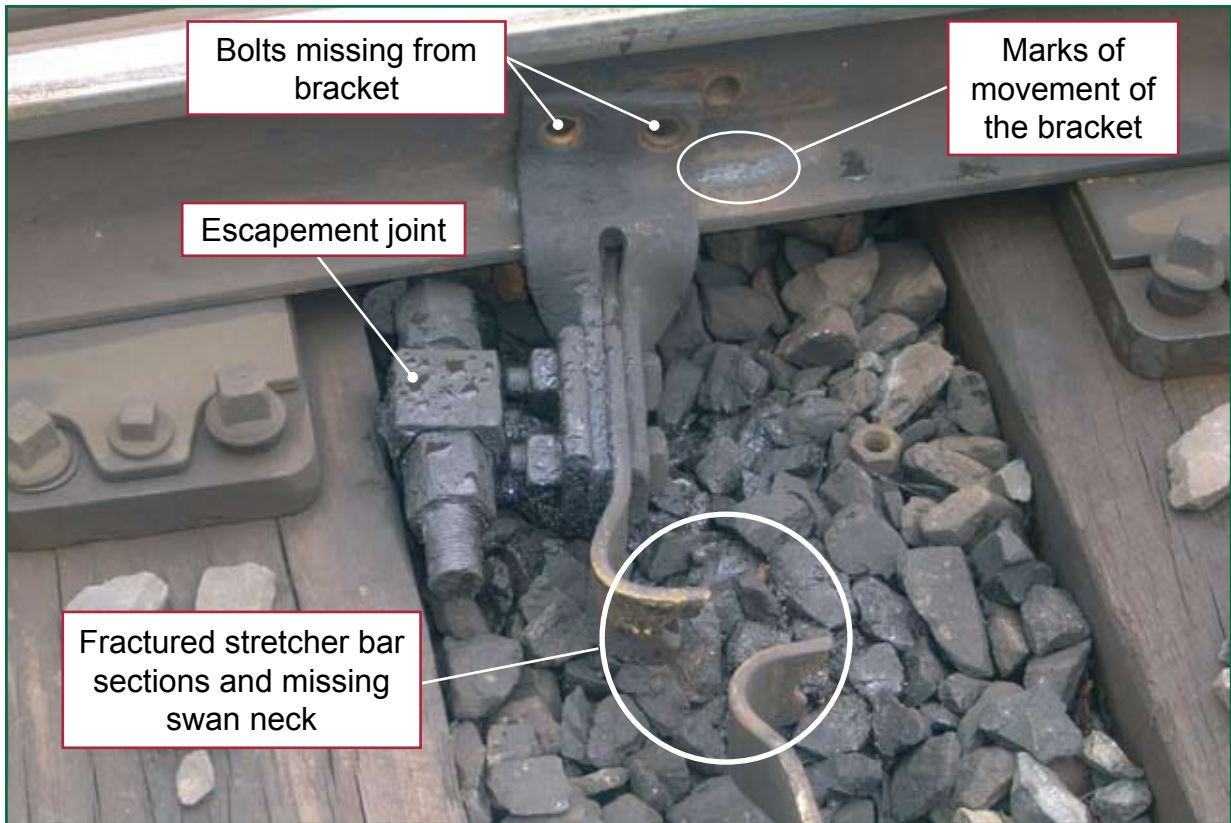
124 The third permanent way stretcher bar was found in place but broken in two places (Figure 20). The *swan neck insulation* assembly was found on the third *bearer* from the point toes in the direction of travel close to the left-hand slide chair (Figures 7 and 21).

Figure 20: The third permanent way stretcher bar

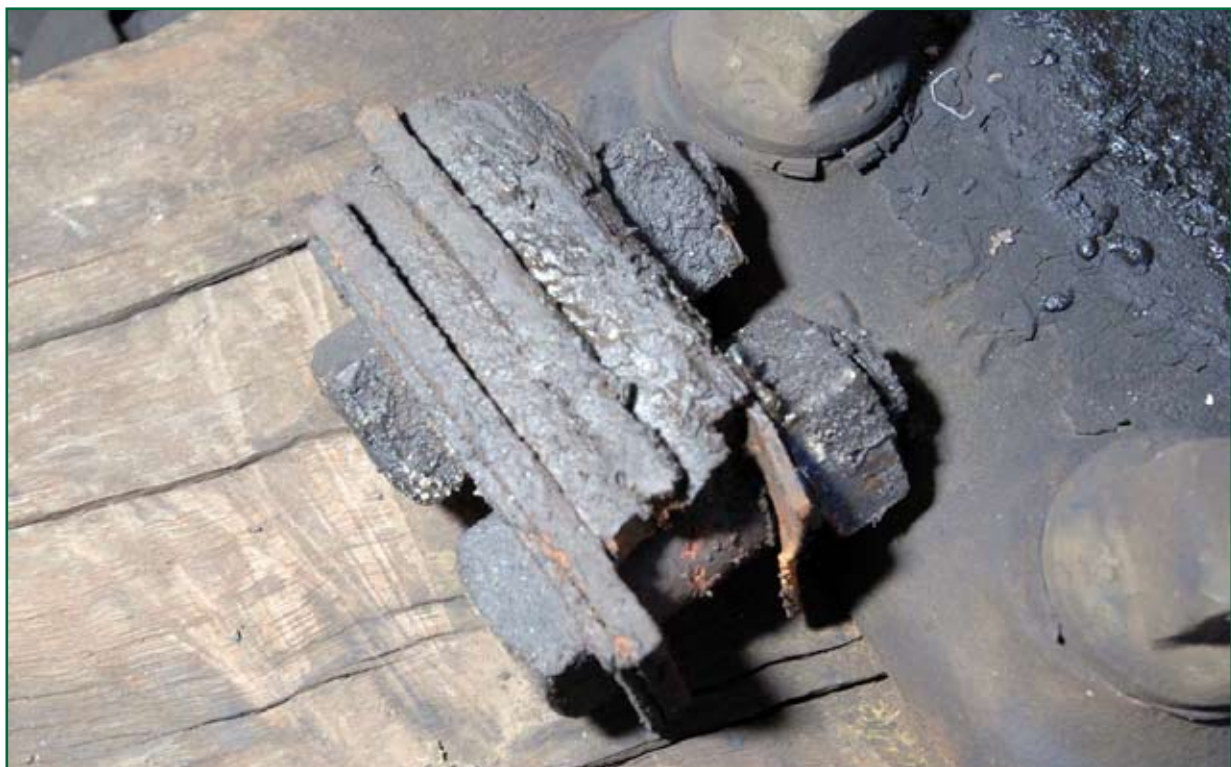
Figure 21: The third permanent way stretcher bar swan neck insulation assembly

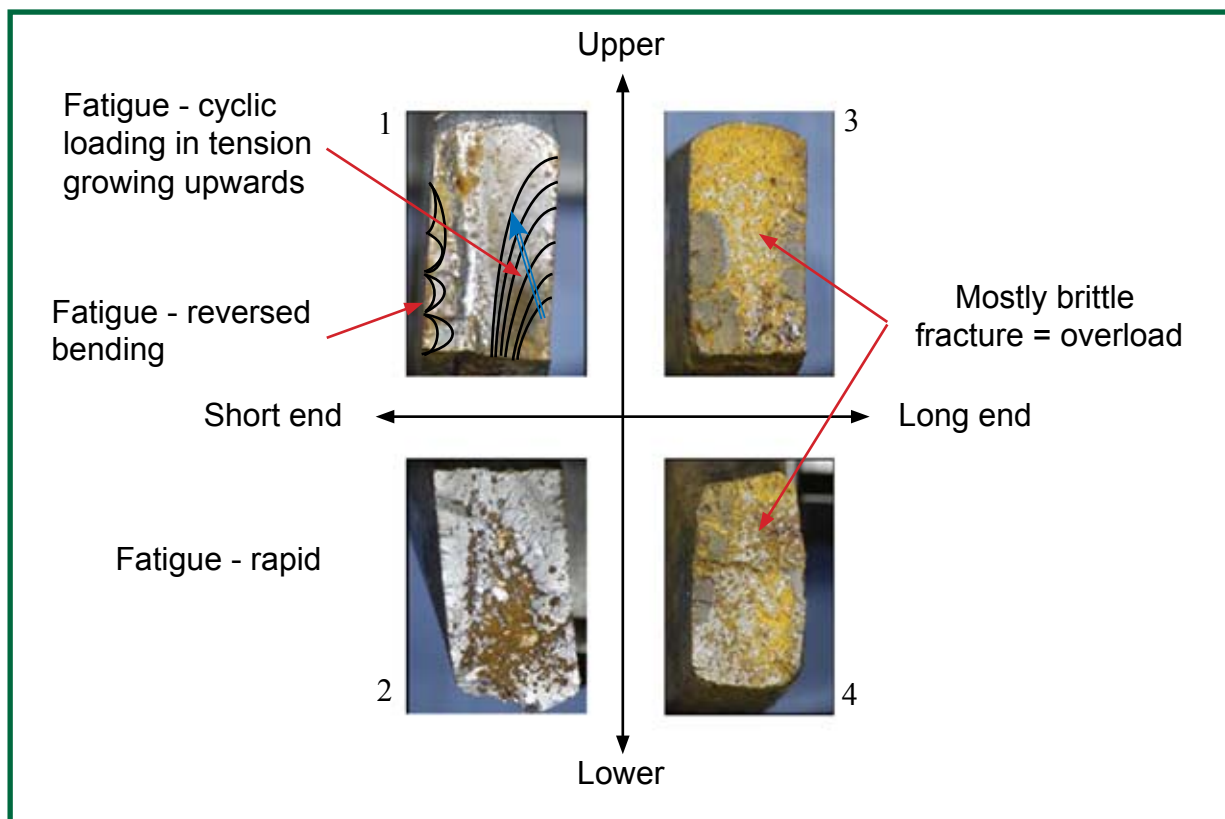
125 The broken components in the third permanent way stretcher bar swan neck insulation assembly had new, corrosion-free fracture surfaces. Additionally there was evidence of older fatigue. The four fracture surfaces in the swan neck insulation assembly are shown in Figure 22.

Figure 22: Fatigue surfaces within the swan neck assembly of the third permanent way stretcher bar

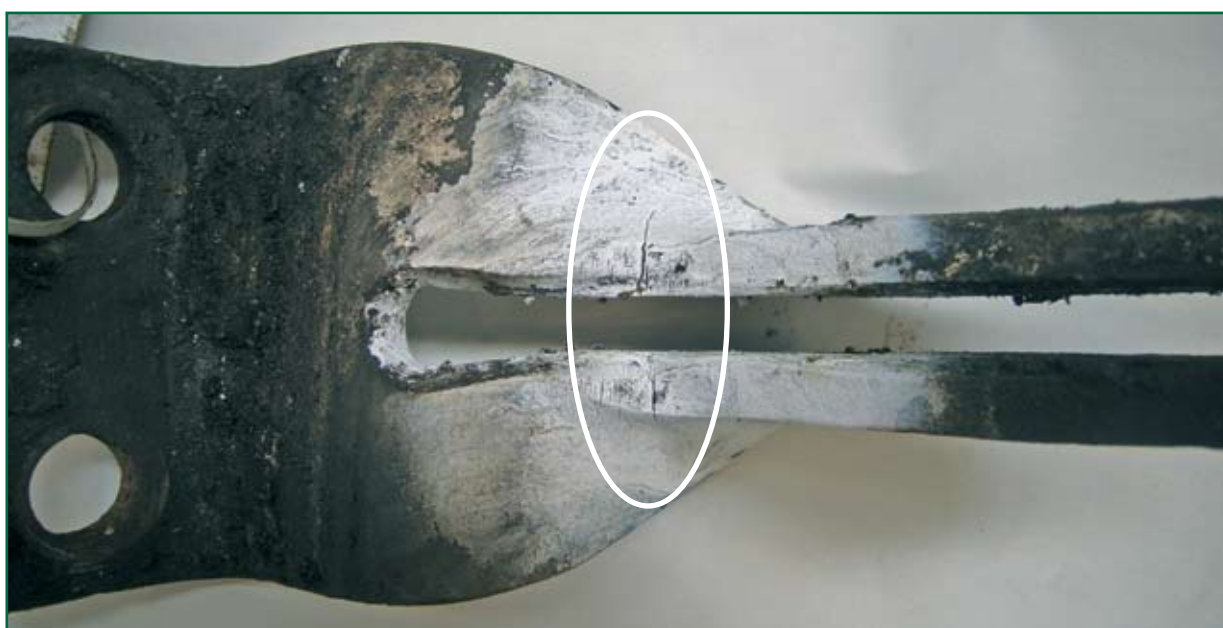
126 There were also cracks in the ligaments of both the left and right-hand switch rail brackets (Figure 23).

Figure 23: Cracks in the left-hand rail bracket of the third permanent way stretcher bar

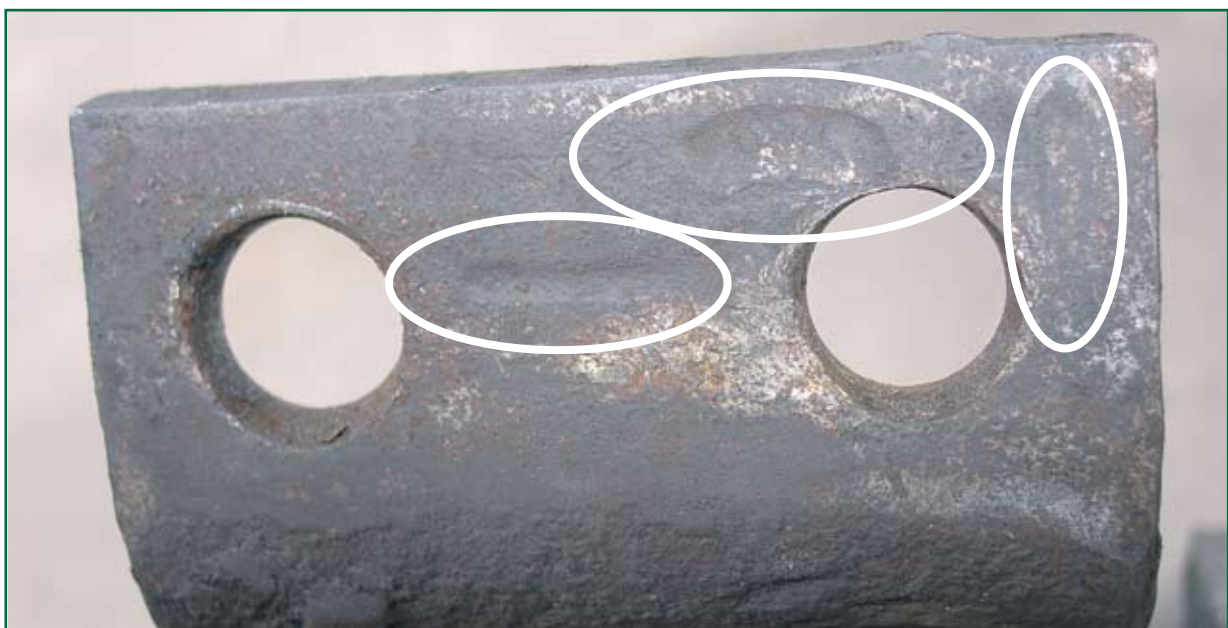
- 129 There were indentations matching the rail branding (paragraph 114) imprinted into the mating face of the right-hand stretcher bar bracket (Figure 25).

Figure 25: Indentations imprinted into the mating face

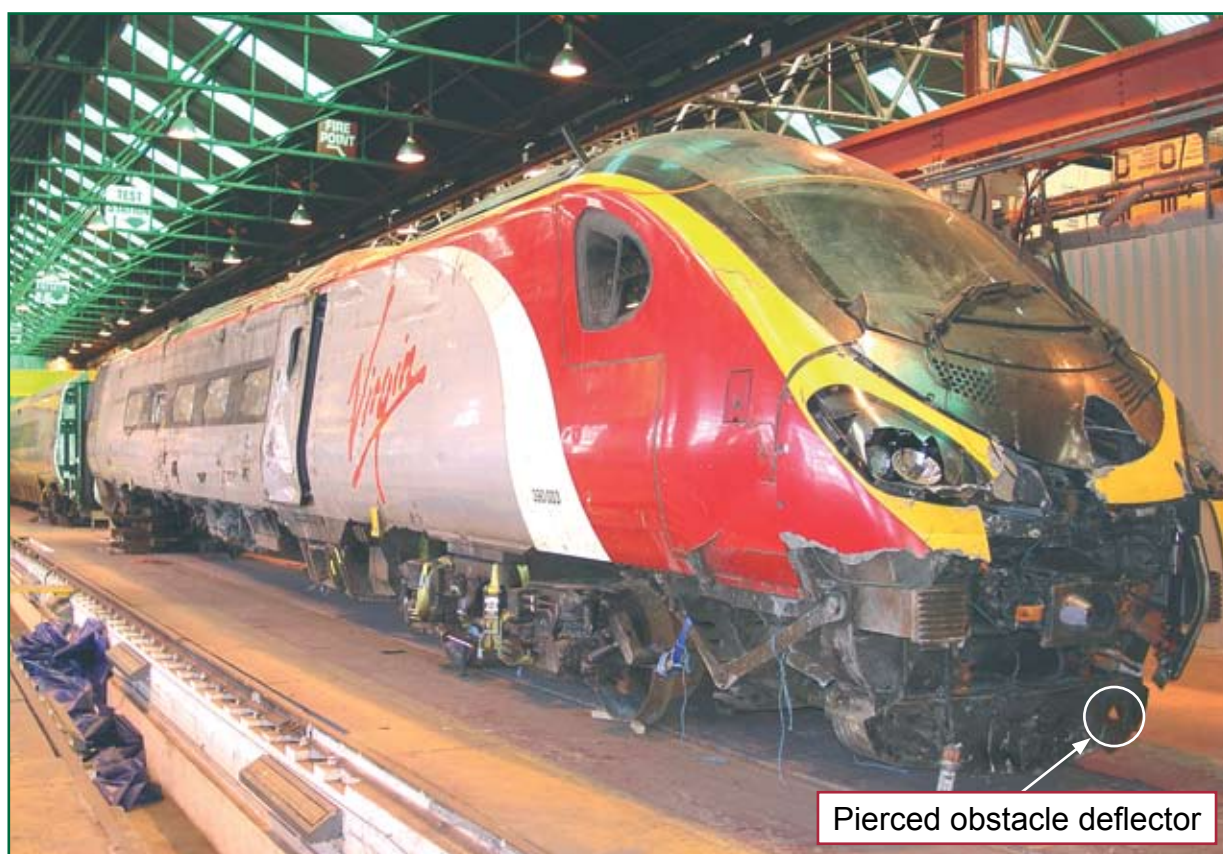
548 As a consequence of the derailment, vehicle one suffered damage to the leading and trailing ends and the right-hand body side, which was buckled and severely scored (Figure 37). The floor was distorted and underframe-mounted equipment was severely damaged. There were concentrated impact damage marks at the two positions along the right-hand cantrail where it had struck overhead line equipment masts (paragraphs 543 and 544) but there was no loss of survival space or penetration through the body structure. Damage to the left-hand side was confined to the leading door and underframe equipment.

Figure 37: Damage to the right-hand bodyside of vehicle one and obstacle deflector

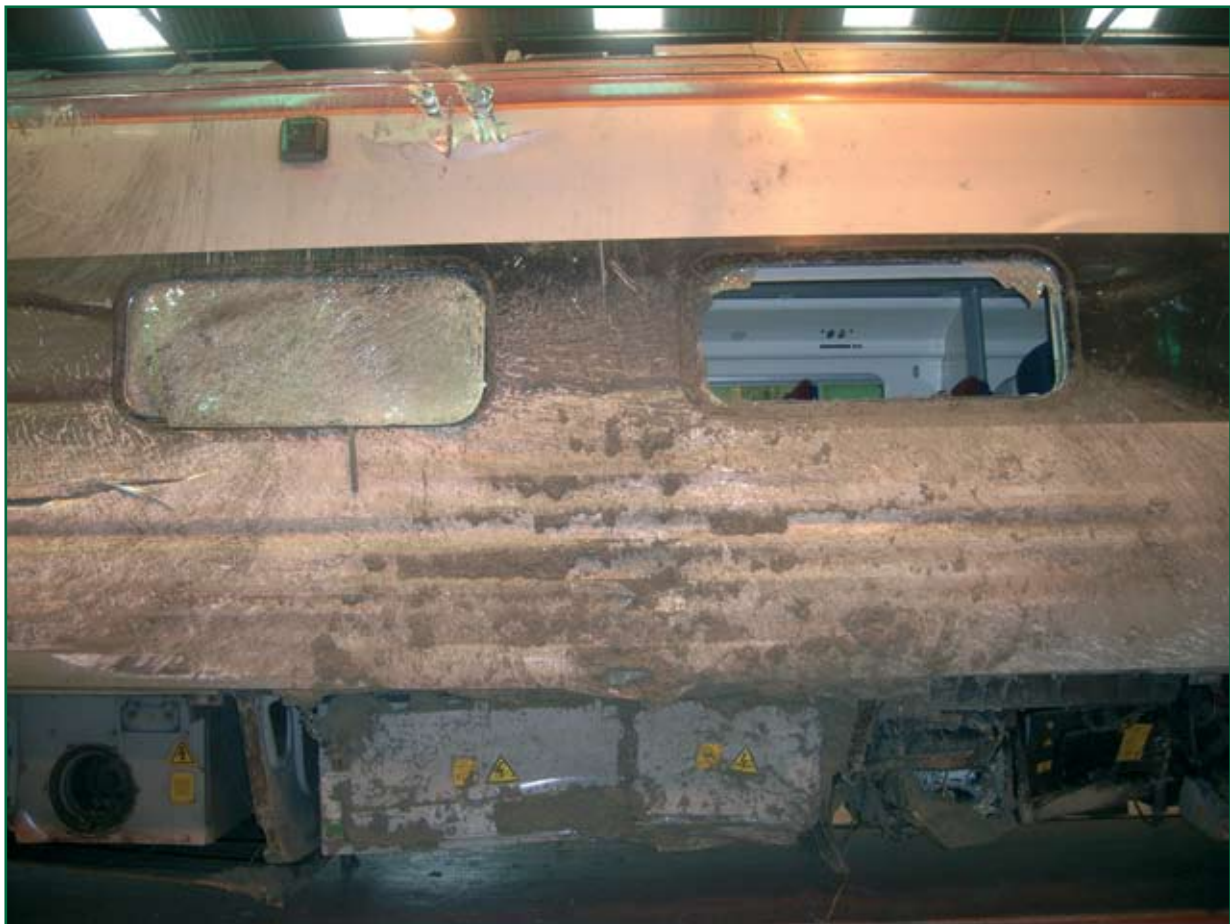
550 Vehicle two sustained damage to both leading and trailing ends, particularly at the left-hand corner of the trailing end which had been pushed in by approximately 320 mm. This localised damage probably occurred when it slid down the embankment on its side, at the end of its travel, and hit the ground before it came to rest. The left-hand side was severely scored by sliding on ballast and had been pushed in by approximately 160 mm at the central section (Figure 38). The right-hand body side was scarcely damaged. Three of the four external doors were jammed in the closed position but this did not hamper evacuation as explained at paragraph 565. Both bogies were damaged but remained attached to the body. The coupler attaching vehicle two to vehicle three had parted at its central connection.

Figure 38: Damaged central section of the left-hand bodyside of vehicle two

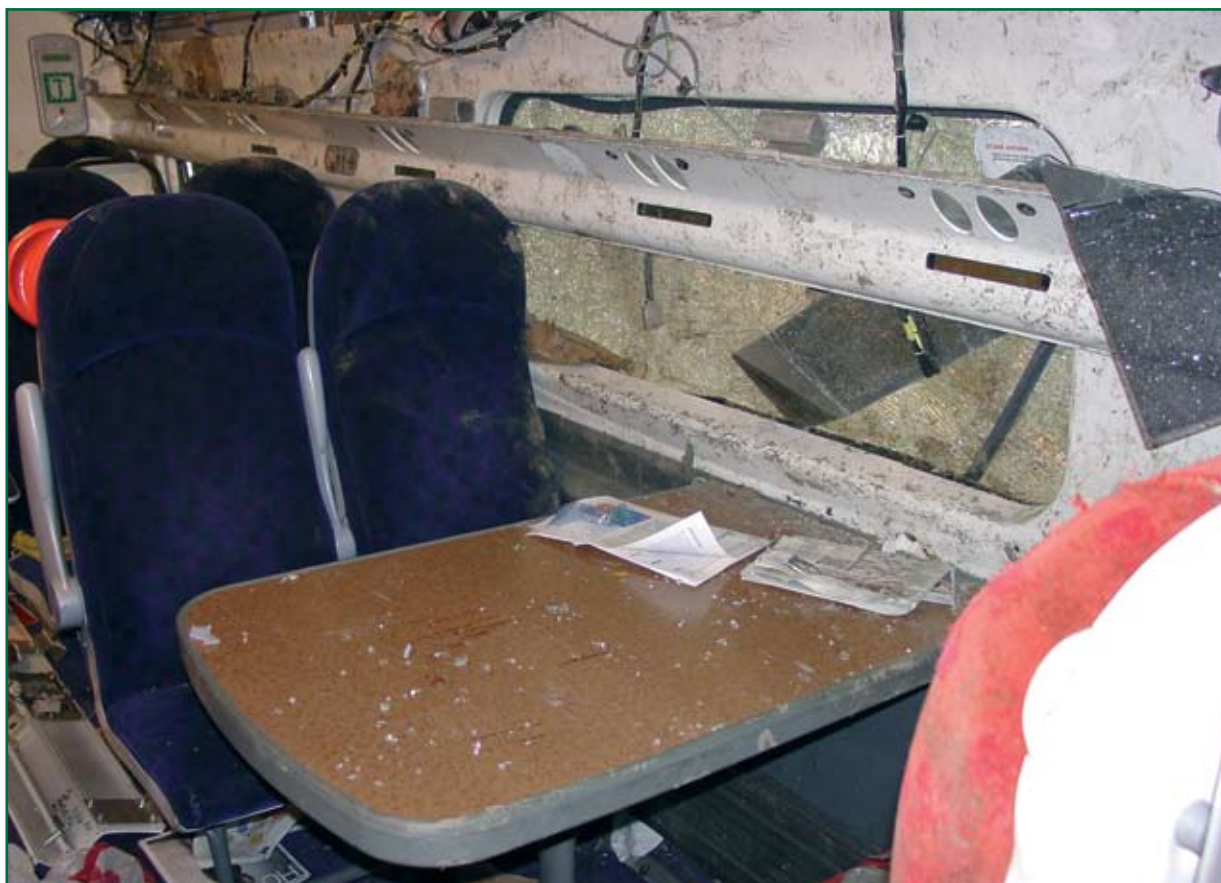
553 The interior of the passenger compartment in vehicle one remained largely intact except for the detachment of all six reading light panels from their mountings. The retaining locks, which secure the outboard edges of the panels to the interior of the bodyside, had distorted and allowed the panels to swing down on hinges mounted on the luggage racks. Five panels detached completely (Figure 39); the sixth remained attached by its hinges.

Figure 39: Detached reading light panels in the leading right-hand side of vehicle one

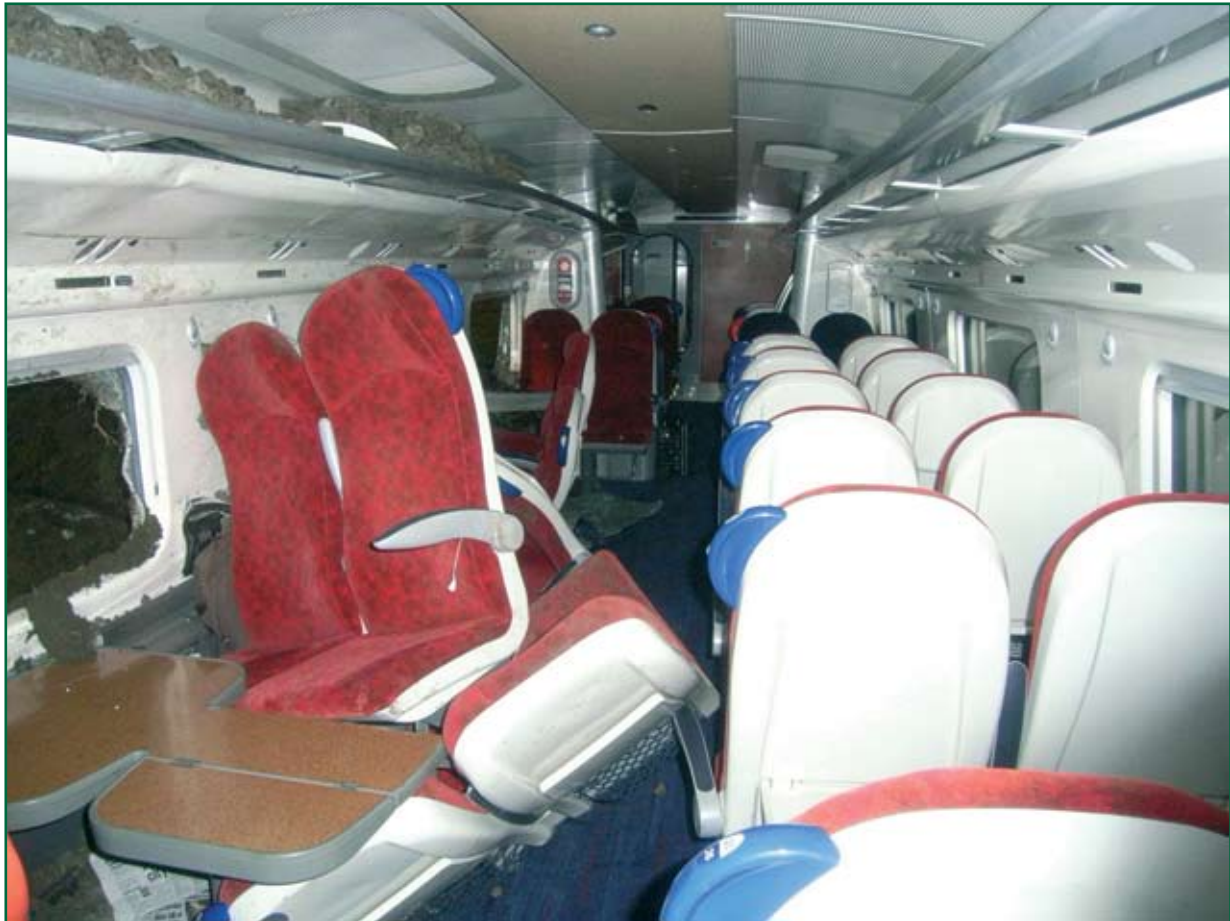
Figure 40: Detached seating on the left-hand side of vehicle two
