Rail Accident Investigation Branch

# Rail Accident Report

## **Derailed at Grayrigg 23 February 2007**

# Derailment at Grayrigg, 23 February 2007

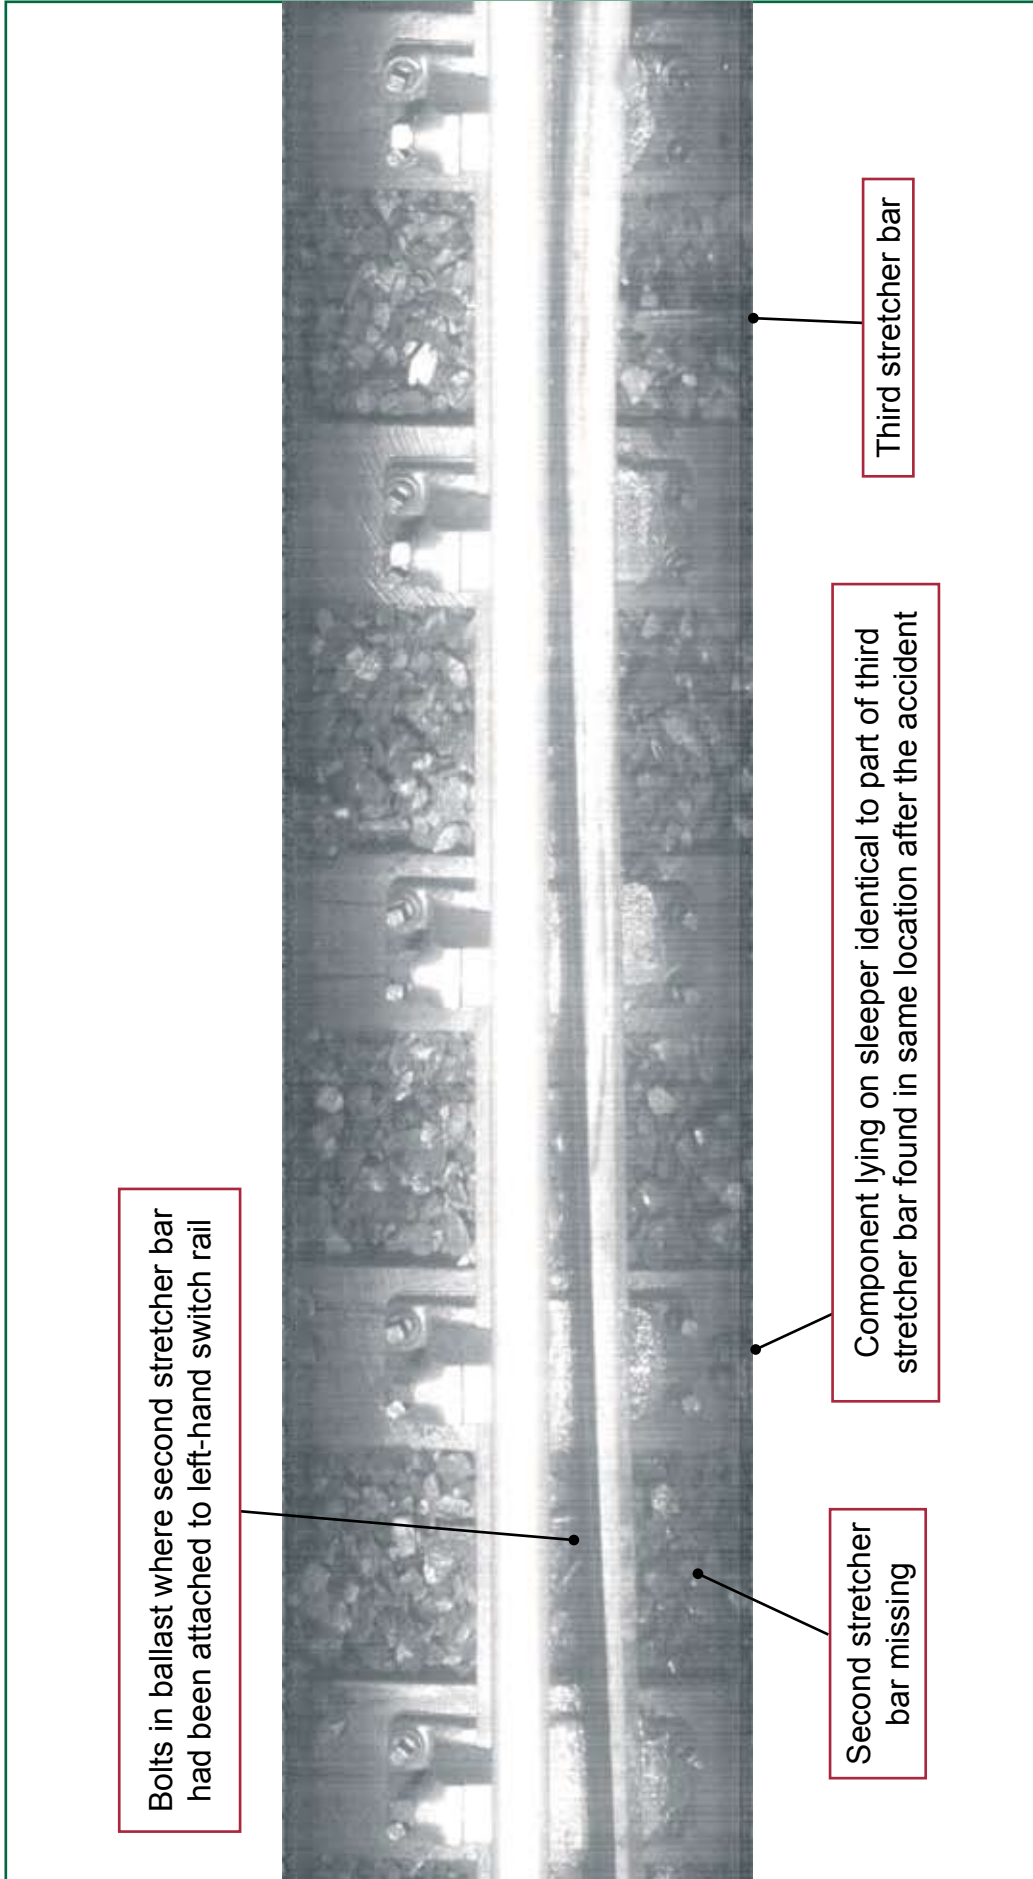
Figure 49: Cybermétéx IVOIRE III image from NMT run on 21 February, showing part of left-hand switch rail
