SS Richard Montgomery

Surveys 2008 & 2009

Summary Report

September 2011

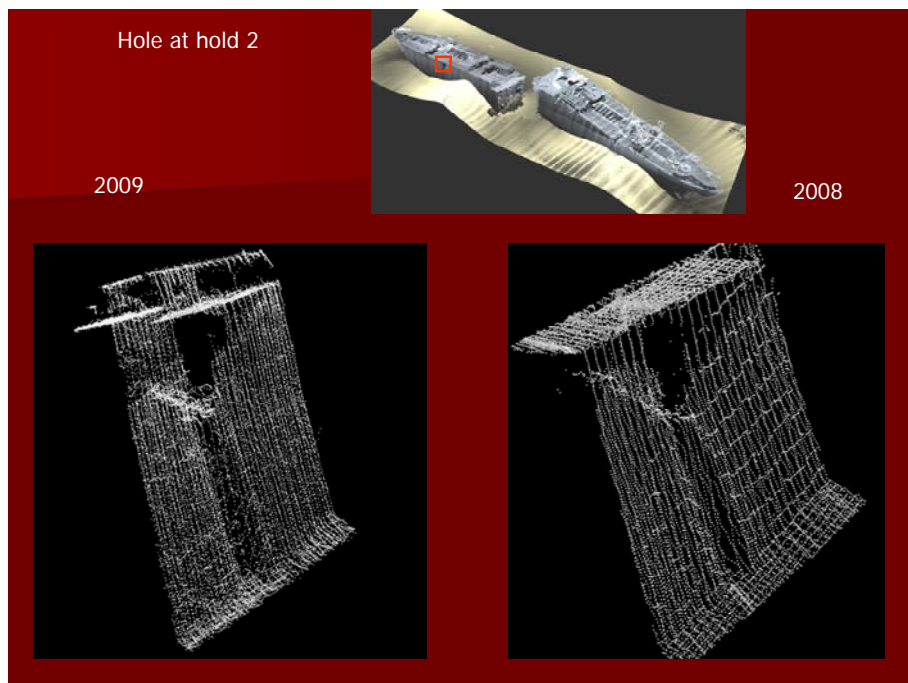
Figure 3 The crack at hold 2, 2009 & 2008

- The orientation, list and pitch of the two sections of the wreck remain unchanged since 2006.
- The wreck appeared to be fully supported by seabed sediment at both bow and stern in both surveys.
- The 2009 survey showed that the main crack in the hull at hold 2 has increased in length and width (width increase of approx 1/2m) since the 2008 survey.

4.2 The crack at hold 2 is not a new development. It has been noted in surveys for many years. However, the 2009 survey suggests that there has been a greater increase in its size than has been noted between any previous sonar surveys.

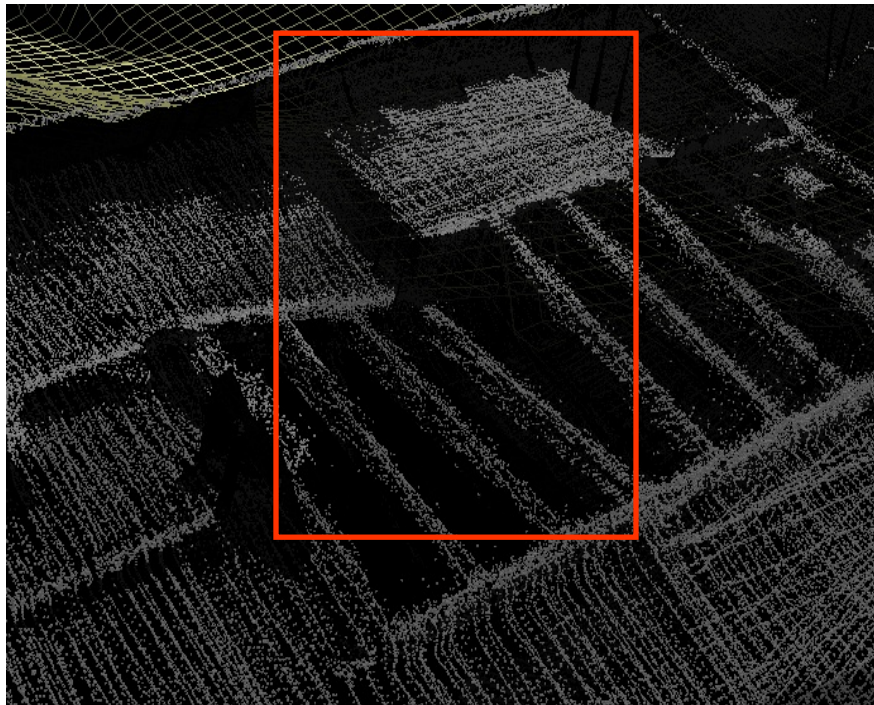
Figure 4 Collapsed deck plating at hold 2

- The 2008 survey showed a new aperture in the bulkhead aft of hold 3 measuring approximately 4m by 1.5m. This had not increased in size in the 2009 survey. Initial results of the 2010 survey do not indicate any further deterioration.
- 2008 data indicated that collapsed deck plating on the port side of hatch 2 had dropped a further 15cm since 2006. The 2009 survey showed a further drop of over half a metre.
- The 2009 survey also showed that the crack running along the deck from this collapsed deck plating now extends all the way along the deck and down the starboard side of the hull.

4.3 The 2009 survey also shows that the area of damage at hold 2 and hatch 2 appears to extend all the way across the deck and down both the port and starboard sides of the hull. This may suggest that, at some point in the future, there could be a complete loss of structural integrity in this area of the wreck, possibly leading to this section breaking into two.

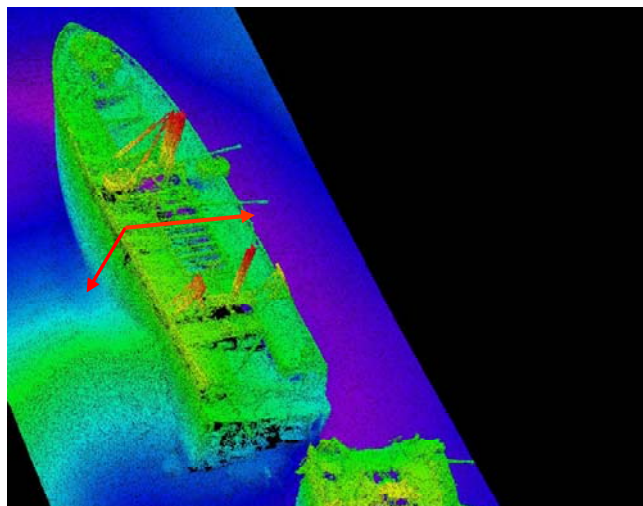
4.4 The image below indicates the area of weakness at hold 2/hatch 2 in the bow section of the wreck where structural failure may occur.

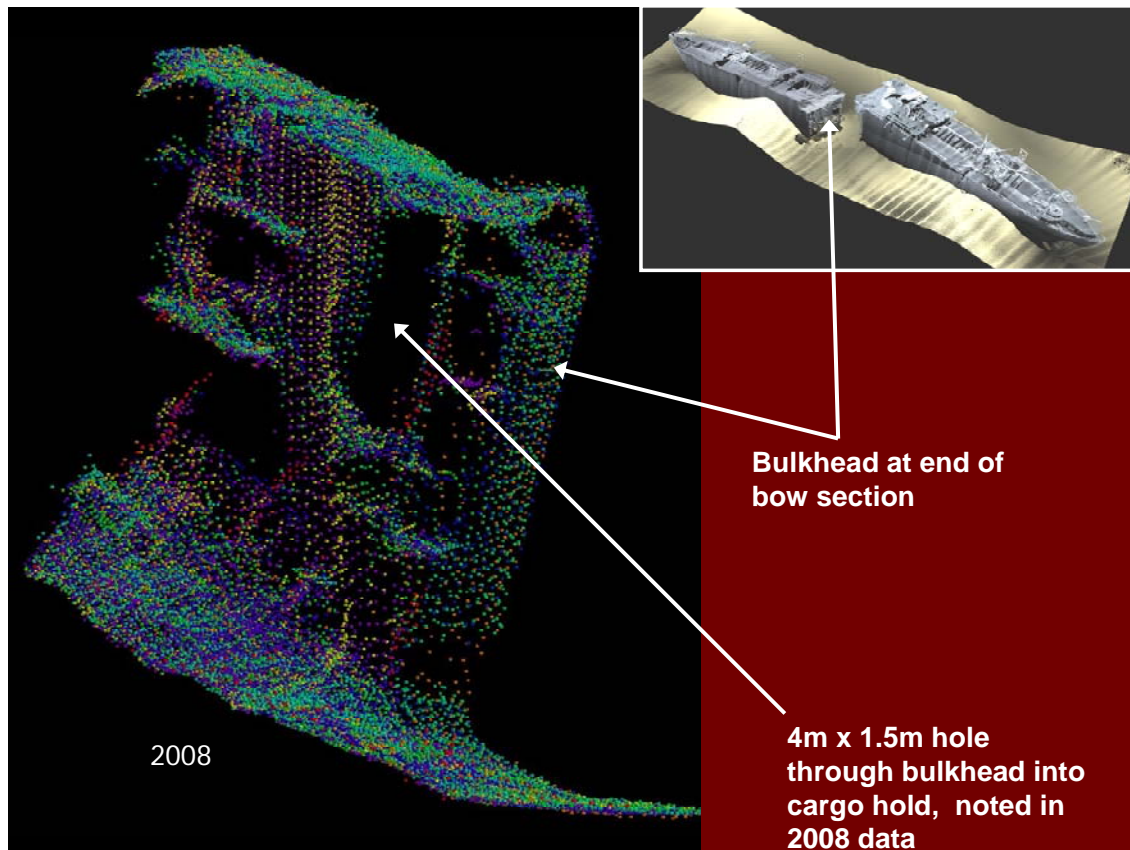
Figure 5 Aperture aft of the forward section

4.5 The area of greatest change noted in the 2008 survey was the aperture at the aft of the forward section. This aperture had not been noted in previous surveys, however, it does not appear to have grown in size between the 2008 and 2009 surveys nor do the initial results of the 2010 survey show any obvious deterioration.
