SALMO
Salvage & Marine Operations

Defence Equipment & Support

Stage 2 Wreck Assessment Report for HMS PRINCE OF WALES and HMS REPULSE

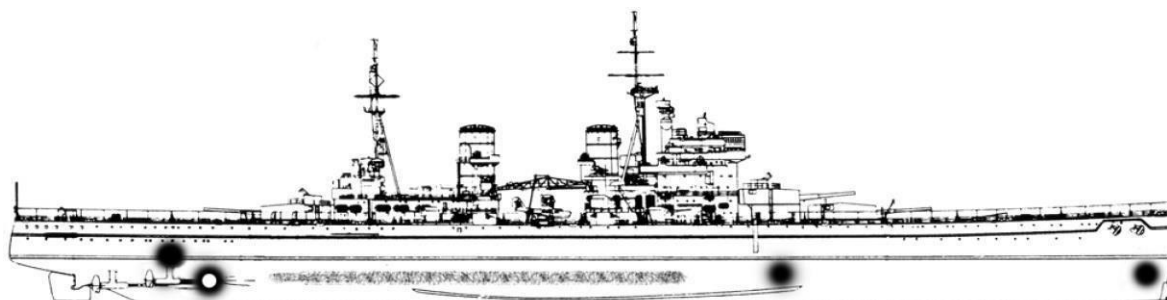
Fig 4. Location of the four torpedo hits on PRINCE OF WALES. Black solid circles = starboard side torpedo hits / Black outline circle = port side torpedo hit. After Denlay 2007.

In 2007 a private research survey Expedition 'Job 74' examined the hulls of both PRINCE OF WALES and REPULSE (Denlay 2007). The survey detailed the nature of the damage to the hull of PRINCE OF WALES resulting from the air attack and the exact location and number of the torpedo hits (Fig 4).

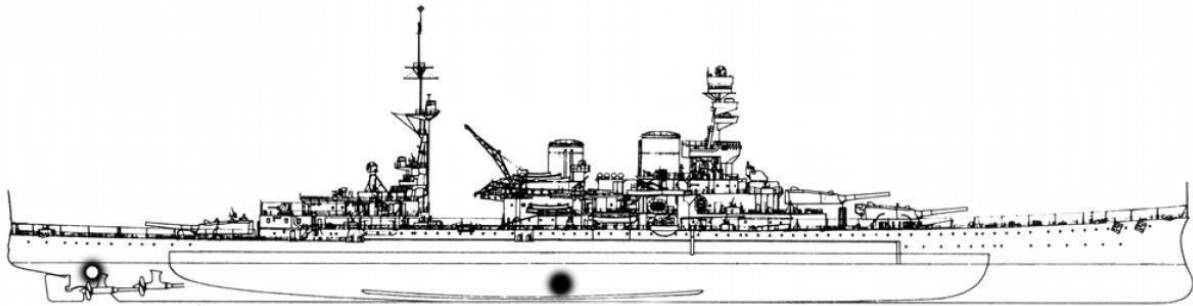
Fig 5. Location of the two torpedo hits on REPULSE. Black solid circles = starboard side torpedo hits / Black outline circle = port side torpedo hit. After Denlay 2007.

The survey also highlighted the damage caused to REPULSE during the air attack although, owing to poor visibility and the build up of sediments along the port hull amidships it was not possible to determine if torpedoes had hit this area (Fig 5).

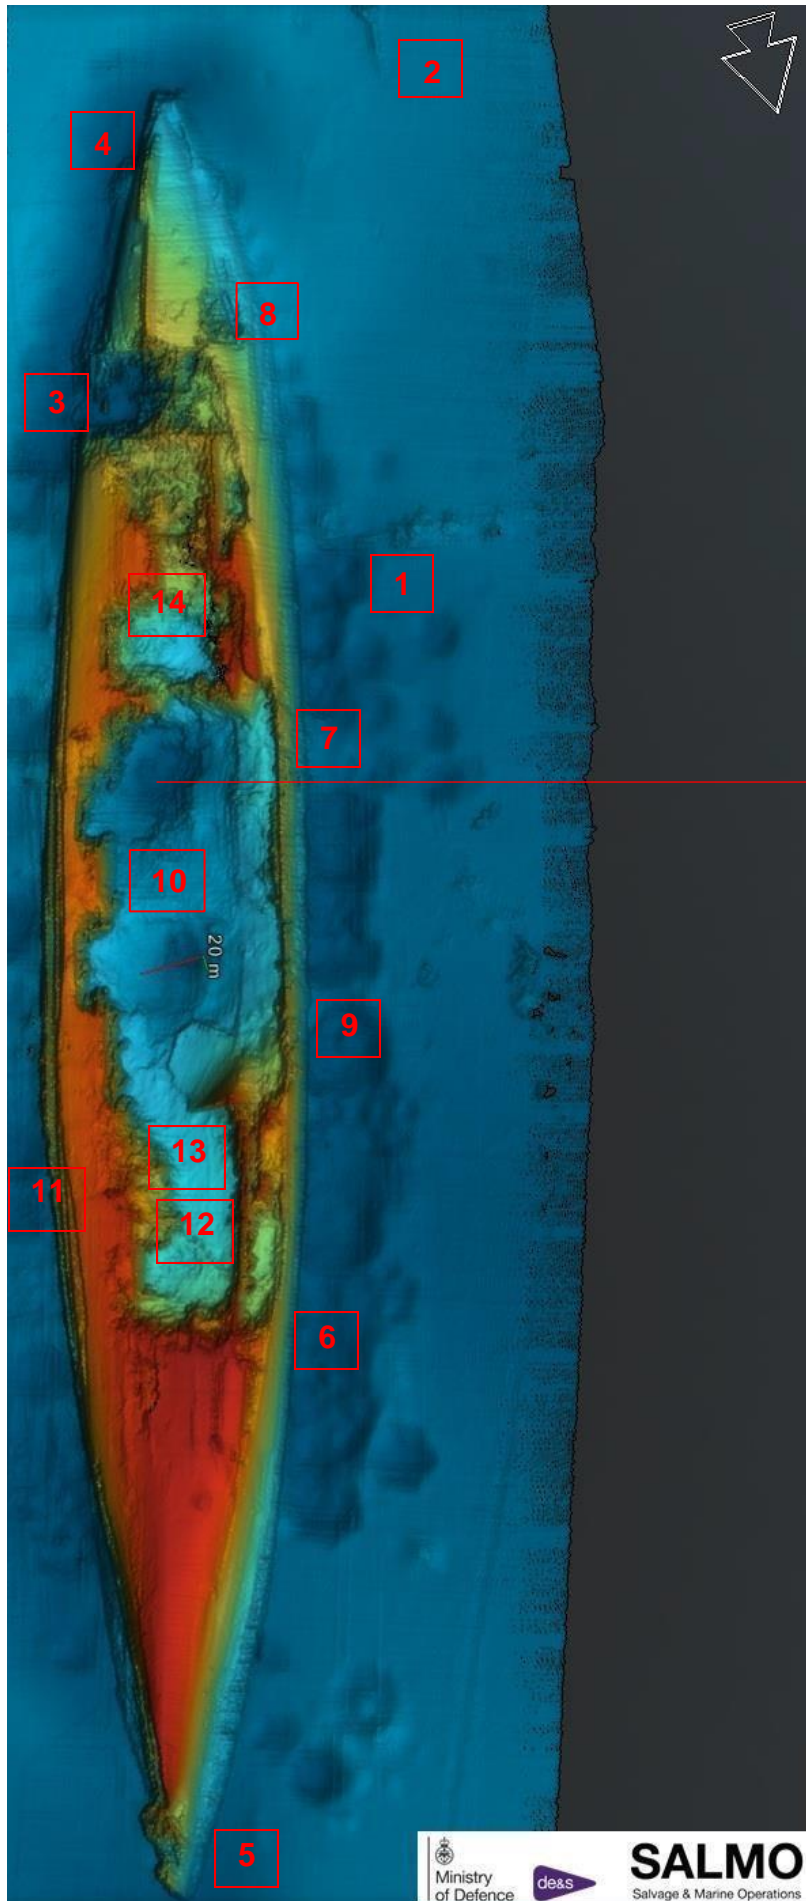
Fig7.HMSPRINCE OF WALES
Multibeamshowingpointsof interest.

The multibeam and video/stills survey of the hull revealed the following. The port side of the vessel is substantially intact from the bow as far back as the torpedo damage at the stern (3). It appears that this has been used as a convenient point of entry by the salvors who have considerably enlarged the hole from its original extent. It now extends for the full height of the side at this point and over onto the bottom of the hull compromising the fuel tanks in this area. Further aft the propellers have been removed (4).

The starboard side of the ship bore the brunt of the torpedo damage (3 hits) and has also suffered greater salvage damage than the port side. The bow stem exhibits damage from the torpedo hit that punched through and out of the port side of the vessel (5). From this point, moving aft the starboard side is relatively intact until, in the vicinity of 'B' turret, a zone of significant damage appears (6). The start of the damage is in the approximate position of the torpedo strike that occurred at this point. Again, the suspicion arises that the torpedo hole has offered a convenient weak point for the salvors. The damaged section extends up and over the bottom of the wreck and runs as far aft as the approximate position of the after funnel (7). For much of this section the side of the ship is degraded to perhaps half its original height. Owing to the extent of the damage it is unlikely that any of the side fuel tanks in this area survive. Aft of this point the starboard side is relatively intact until the torpedo damage at the stern (8). Along both sides of the ship the seabed has been 'scooped' out but this is particularly marked on the starboard side (9). It is likely that the scooping is the result of the actions of the grab/s used by the salvors, perhaps gathering up material that had fallen to the seabed when working the hull.

The bottom of the ship has suffered extensive damage extending from 'B' turret to the after funnel. The salvors have effectively hollowed out the entire midships section to the level of the seabed and have possibly mined into this as well (10). The focus of the activity appears to have been the engine rooms and the items of high salvage value contained within.

larger guns were stored. Smaller guns made use of brass cartridges and it is possible that these have been gathered by the salvors and their contents emptied over the wreck. Consequently, quantifying the remaining ammunition on the wreck is difficult. It is likely that 'A' turret magazine survives relatively intact. However, that for 'B' turret is likely to have been entirely removed leaving what appears to be the barbette of this turret visible in the multibeam (12). There is heavy damage to the hull beneath 'Y' turret although this does not appear to penetrate very deeply into the wreck. It is therefore likely that the magazines in this area have been disturbed but not totally destroyed. The magazines for the secondary, 5.25-inch guns were concentrated in the ship's hold in sections of the wreck (13-14) which have been heavily compromised.

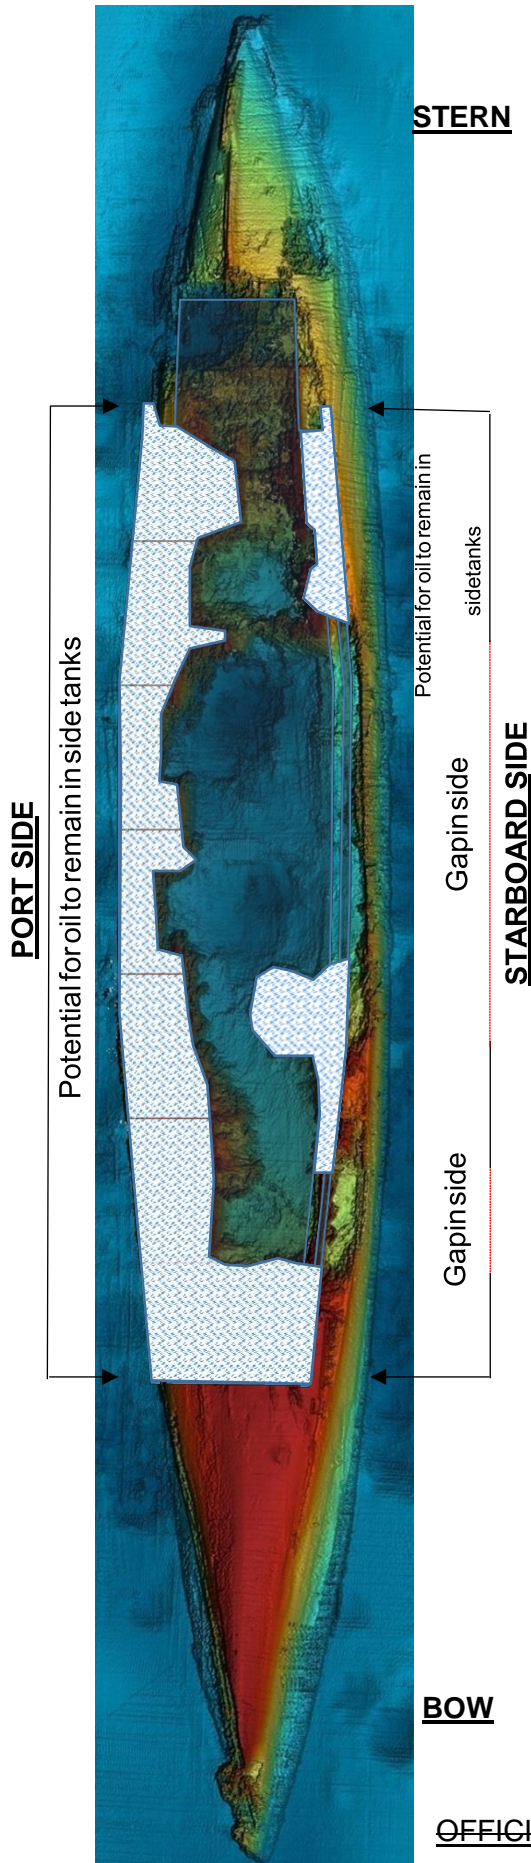
Fig8.HMSPRINCEOFWALES_Destroyed and potentially intact fuel tanks.

The damage to the bottom of the wreck and its penetration to the interior has undoubtedly compromised the majority of the tanks in this area. Potentially some may survive towards the bow (11) but even here, where the hull survives in a more intact state it is doubtful whether they could have survived the combined shock of explosives and grabs in use nearby. Determining the exact quantity of oil remaining onboard the wreck is probably a futile task given the effect of such concussive force.

The survey revealed that although the wreck is in better condition than REPULSE the majority of the fuel tanks have either been completely destroyed or seriously compromised by the salvage. Estimating the likely remaining amount is difficult. For the purposes of the environmental assessment commissioned from Arcadis it was assumed that, prior to salvage the wreck contained 1,200 m³ of oil. It now appears that at least two thirds of the oil tanks on the wreck have either been destroyed or have suffered damage (Fig 8). Therefore, it is possible that perhaps 400 m³ now remains. Any intervention to remove this oil would require contracted-in commercial support to achieve and the cost effectiveness, and viability, of this approach is doubtful. The wrecks, as evidenced by the lines detected on REPULSE are likely being actively salvaged and it is doubtful that an oil removal operation could be arranged before further significant damage occurs.

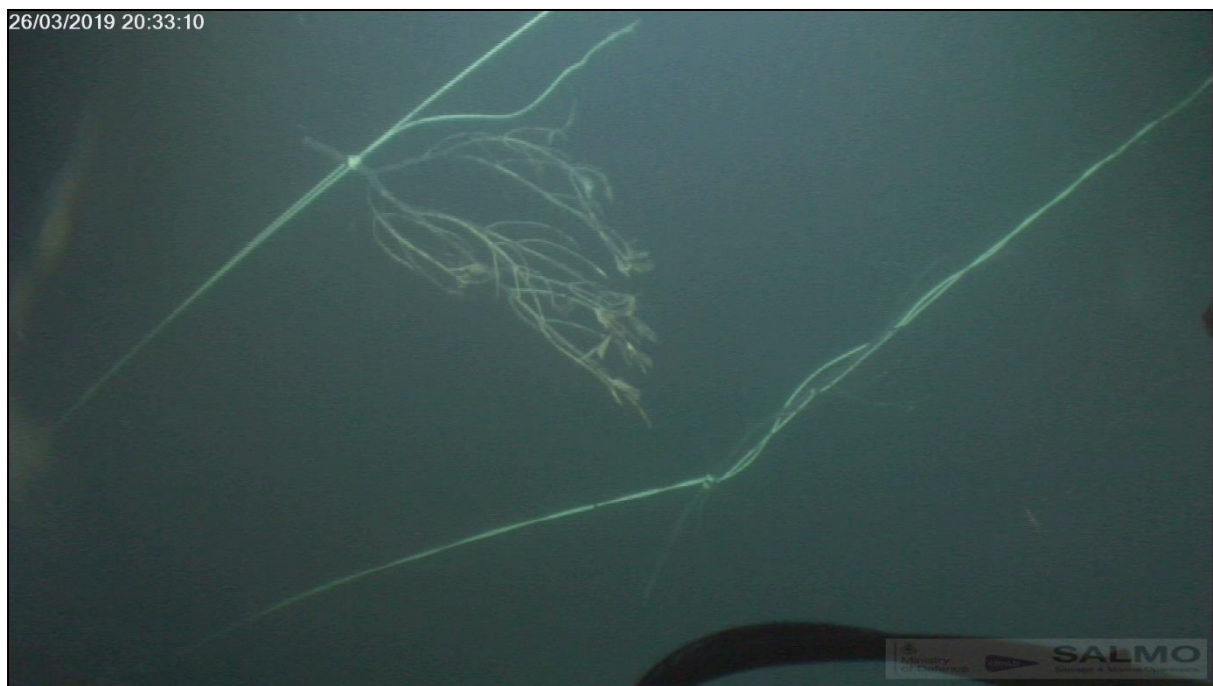
Fig 9. Two lines with branches on REPULSE. Possibly used by salvage divers to indicate depth.

Note, any reference to port and starboard in the discussion below refers to the ship as afloat. A key finding from the survey was that this wreck is likely being actively salvaged and that the perpetrators may have been on site immediately prior to SALMO's arrival. During the video survey two lines were detected running up from the wreck with branches, with fresh leaves on, tied at regular intervals along it (Fig. 9). The purpose of the branches is uncertain. It is possible they have been placed to attract small fish which, in turn lure larger fish. These are then targeted by fishing boats. Less innocently, the branches may be being used by the divers involved in the salvage to determine the depth at which they are operating.

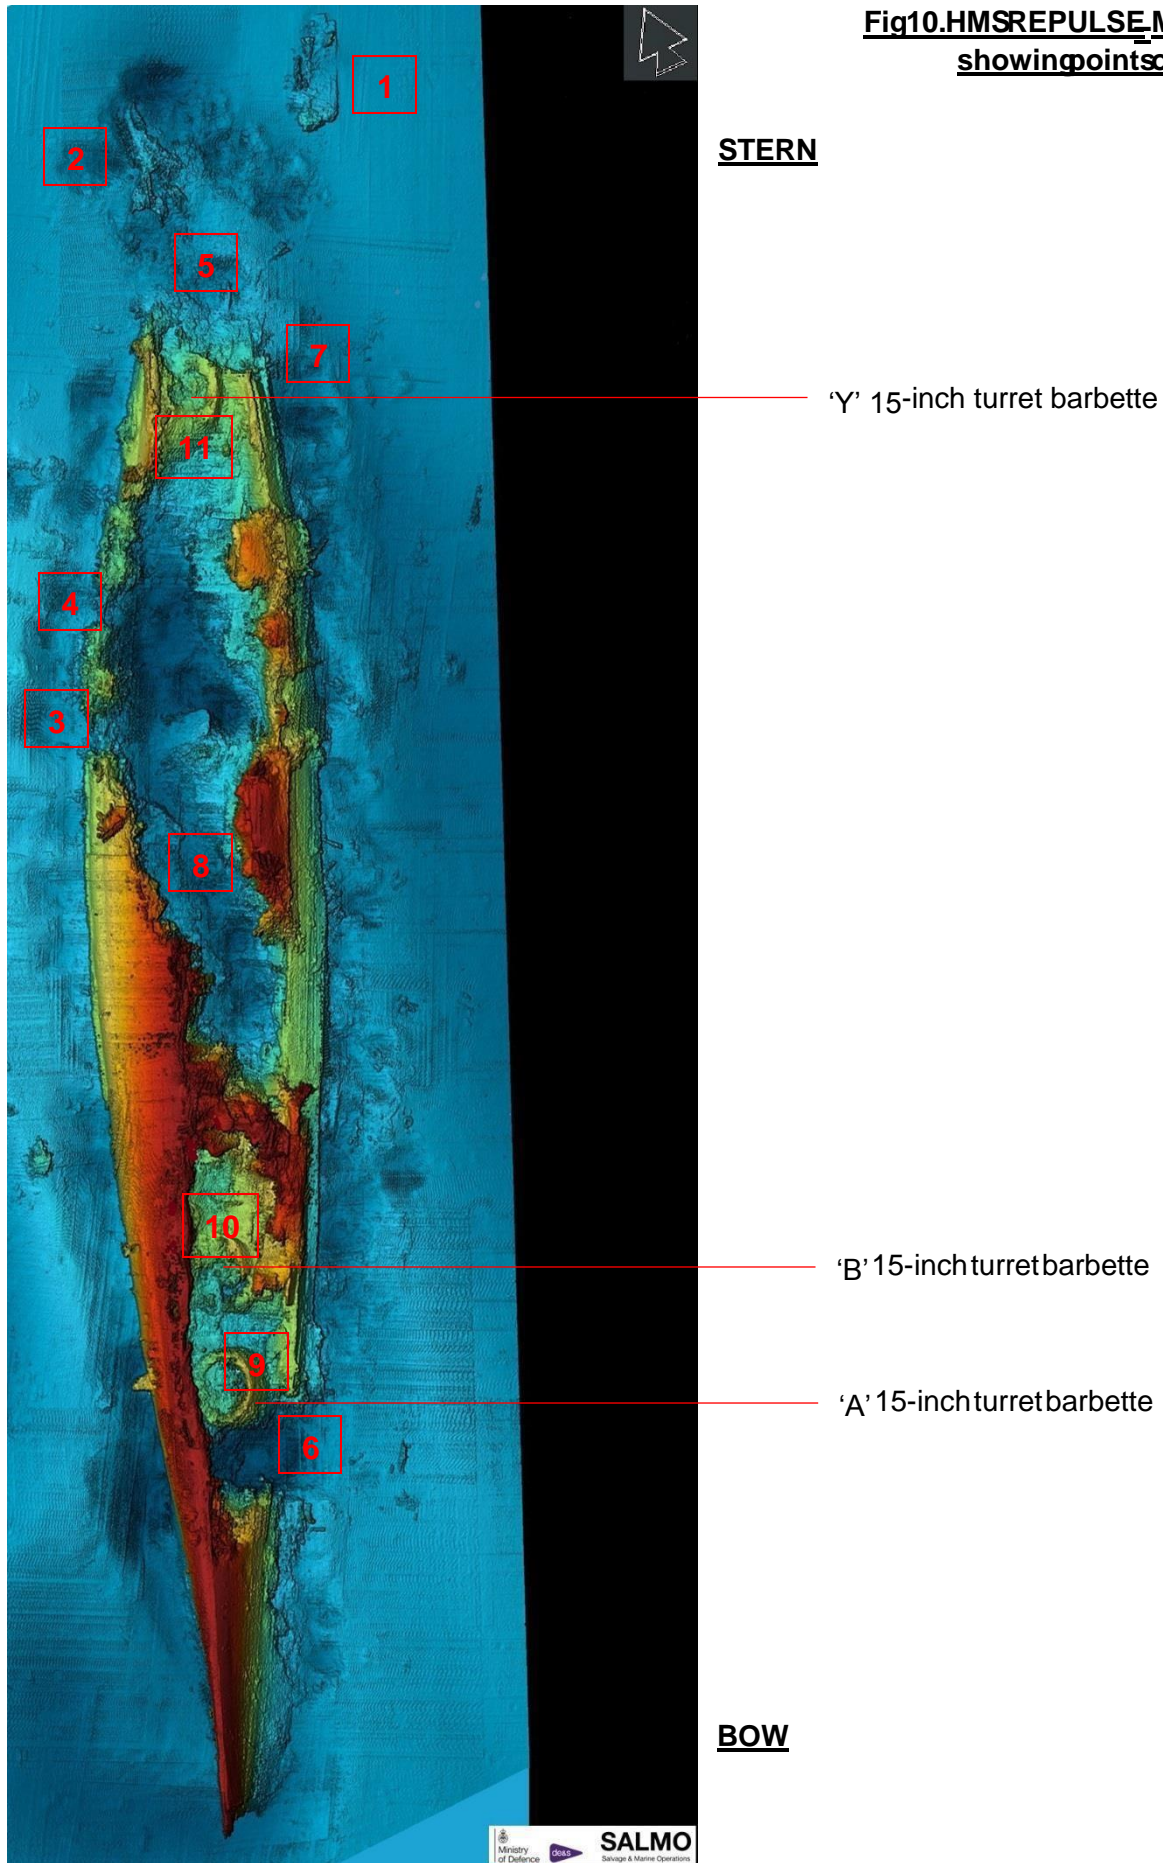
Fig10.HMSREPULSE_Multibeam
showingpointsofinterest.

In the 2007 survey the port side of the hull was noted as partially pushed down into the seabed (Denlay 2007: 9). However, as with PRINCE OF WALES the salvage has resulted in significant scooping and removal of the sediments along the wreck leaving the port side exposed. The wreck has clearly suffered far greater damage than PRINCE OF WALES, possibly because its shallower depth made it more accessible. The damage to the wreck is so extensive that it is no longer possible to discern the torpedo damage which caused the ship to sink.

Moving aft from the bow along the port side the wreck initially appears to be in reasonable condition until approximately midships (3). Up until this point there is potential for the side fuel tanks that began from approximately the position of 'A' turret to survive. However, from this point the line of the side cuts rapidly down and, while the outline of the ship is preserved until a point just aft of 'Y' turret in some places little of the structure survives above the level of the seabed (4). None of the side fuel tanks can have survived in this zone. Immediately aft of 'Y' turret the stern has been removed in its entirety leaving only the scattered items of debris noted above (5).

Immediately aft from the bow along the starboard side the wreck again appears reasonably intact. However, from just forward of 'A' turret a large gap appears cutting down and into the seabed (6). Thereafter the side reappears but is very degraded for its entire length until it stops at 'Y' turret (7). While some remnants of the starboard tanks may survive it is extremely doubtful that they contain any fuel due to the extreme damage apparent in this area.

The bottom of the ship has been torn apart and the interior mined down to the seabed for high value metals and machinery. Again, the engine spaces appear to have been preferentially targeted (8) but it is also notable that all three of the upside-down barbettes for the main battery turrets are clearly visible in the multibeam (9-11). Some of the bottom fuel tanks may potentially survive but it is doubtful that they retain much oil given the brutal nature of the salvage combining explosives and grabs. The missing stern suggests that, now that the majority of the high value items have been removed from the interior, the salvors are attempting to systematically remove what remains.

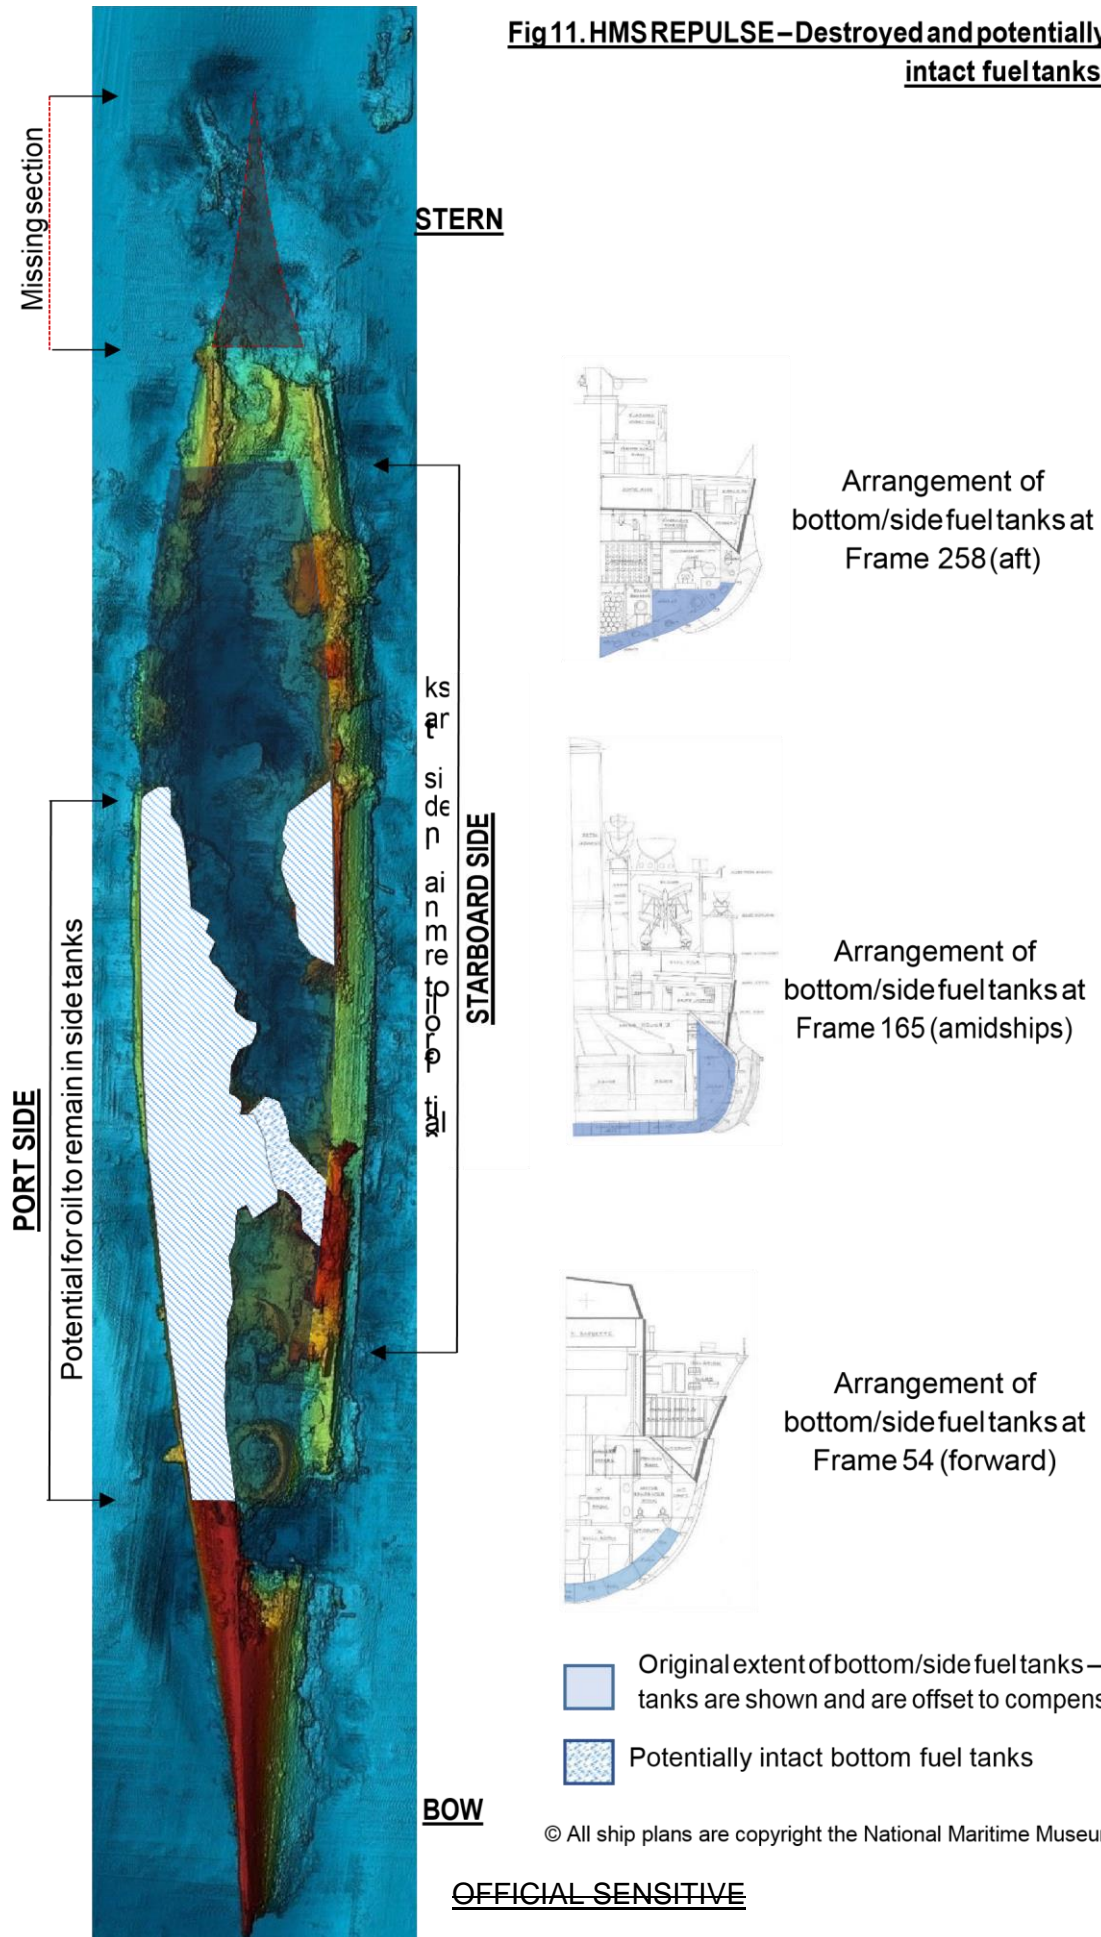
Fig 11. HMS REPULSE – Destroyed and potentially intact fuel tanks.

The wreck has suffered far greater damage than PRINCE OF WALES and little oil is now likely to remain. It appears that the salvors are actively working the wreck and that their intent is to remove it in its entirety, as evidenced by the missing stern. For the purposes of the environmental assessment commissioned from Arcadis it was assumed that, prior to salvage, the wreck contained 1,000 m³ of oil. It now appears that around three quarters of the oil tanks on the wreck have either been destroyed or have suffered damage (Fig 11). Consequently, it is possible that only around 250 m³ still remains on the wreck. For the reasons noted above with respect to PRINCE OF WALES it is unlikely that, even if an intervention to remove the oil was pursued, it would be possible to make the necessary commercial arrangements before the wreck suffers further damage.

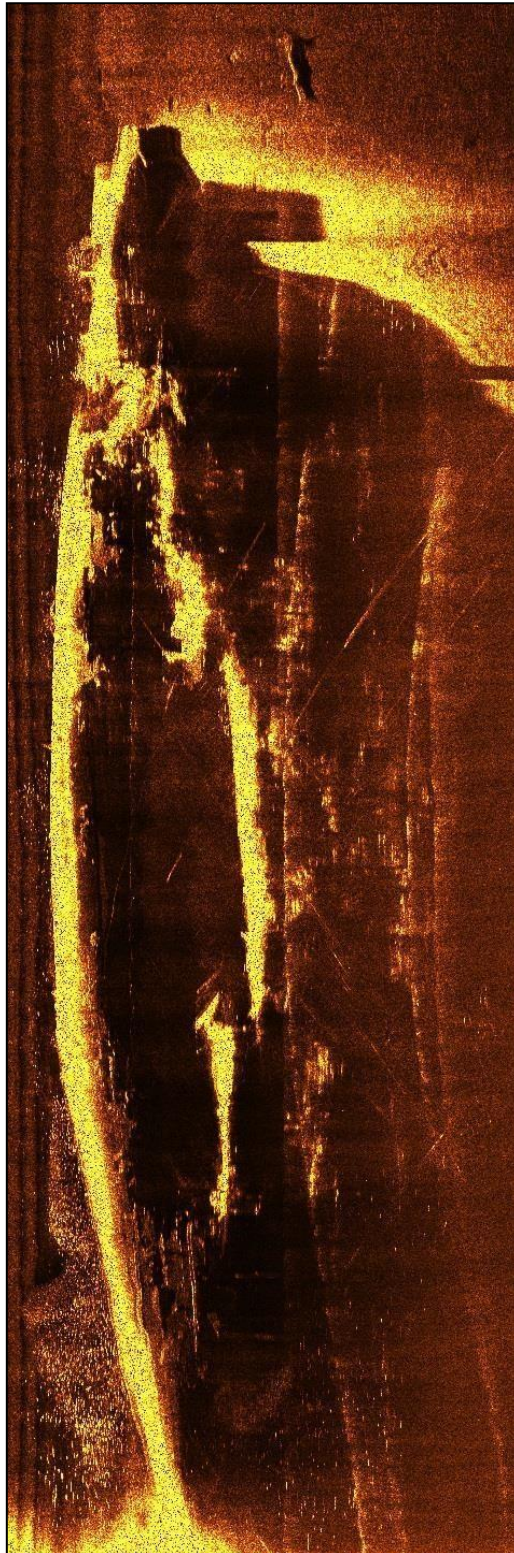
PRINCE OF WALES - sidescan survey showing the wreck and the salvage damage to the midships section.

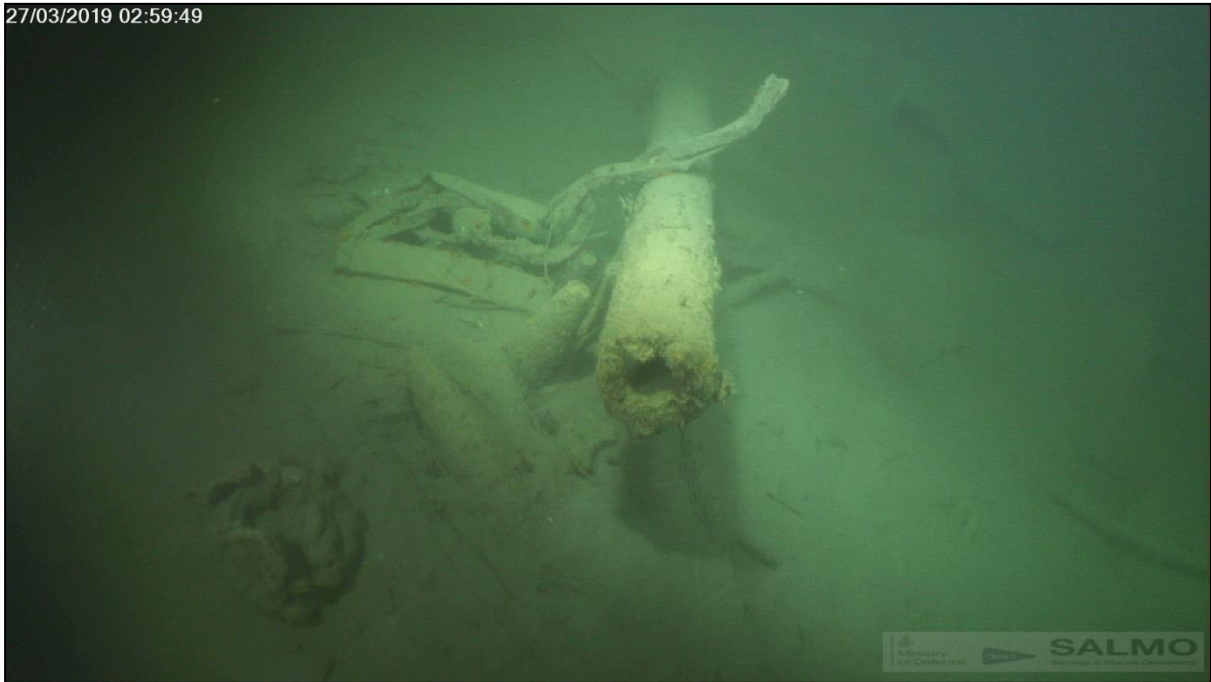
PRINCE OF WALES – 5.25-inch barrel with ammunition.

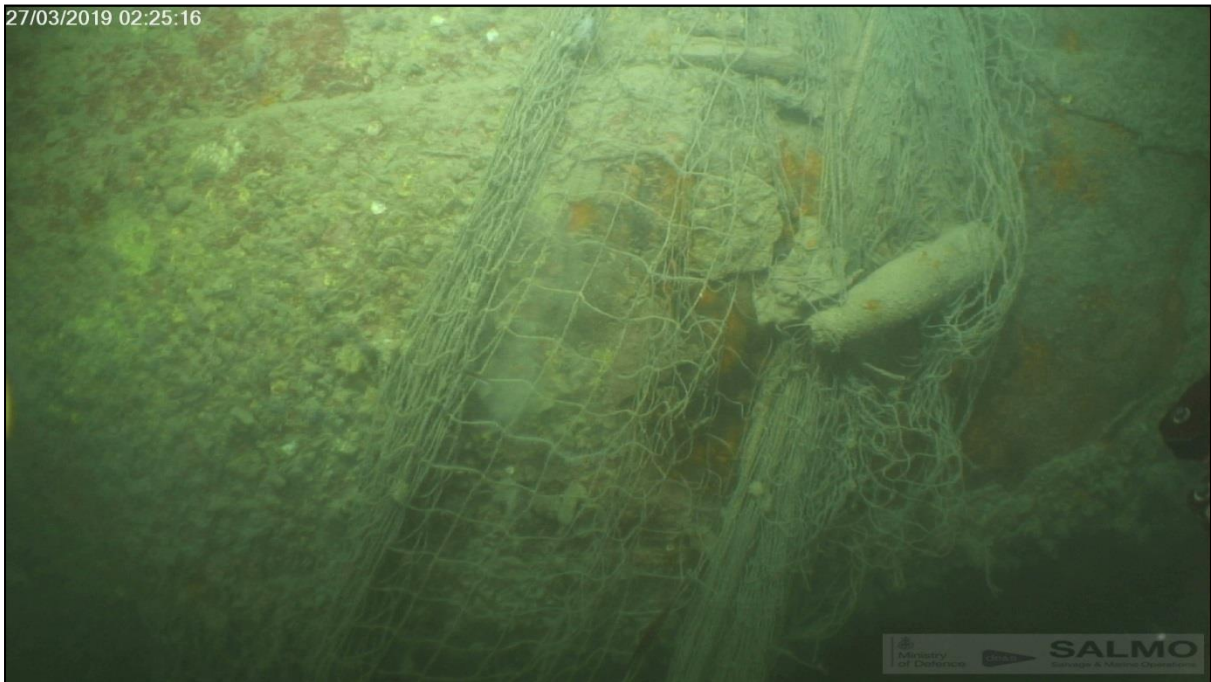
PRINCE OF WALES – Fishing net with ammunition caught in it.

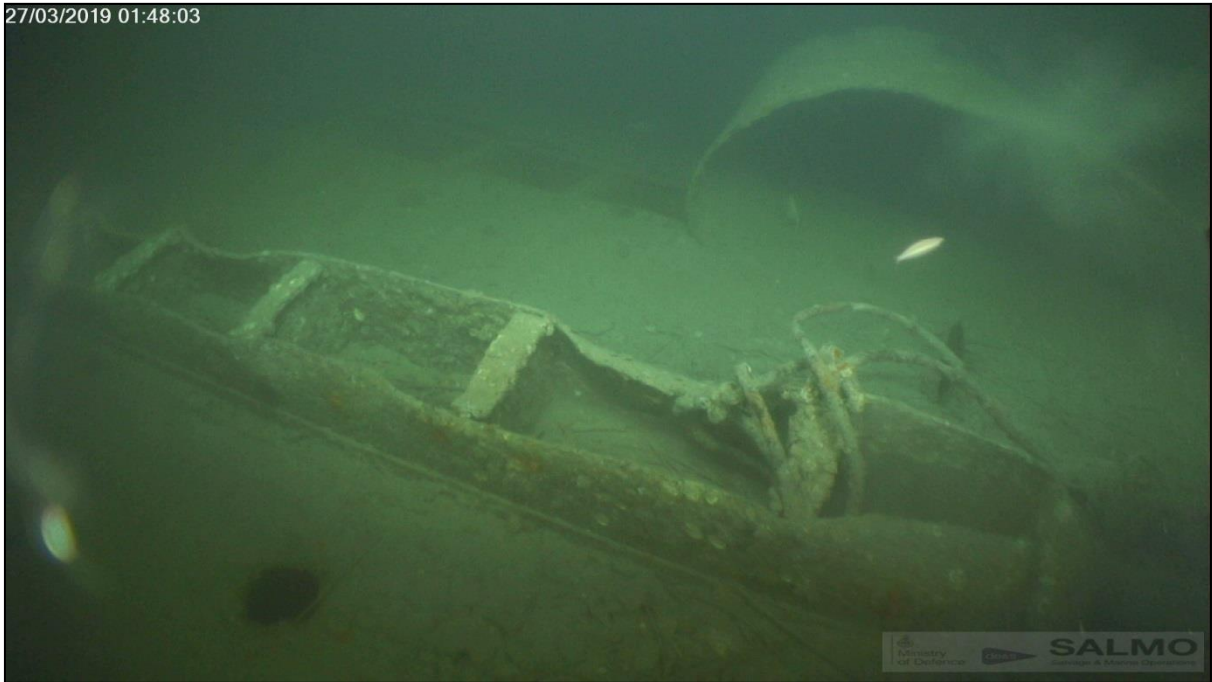
PRINCE OF WALES – Bottom of the hull showing section of plate peeled back by salvors.

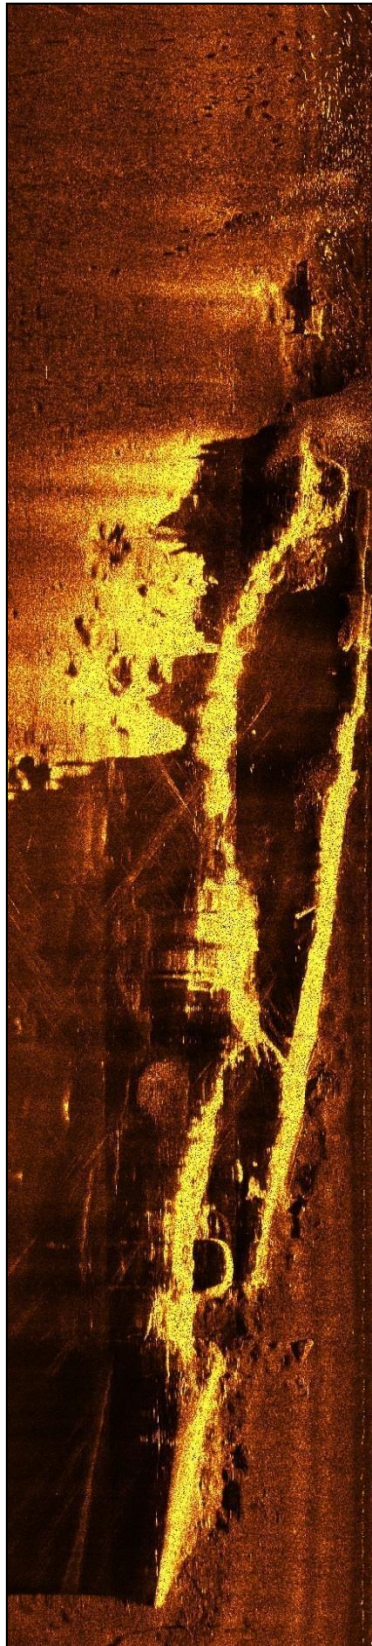
REPULSE - sidescan survey showing the wreck and the salvage damage to the midships section.

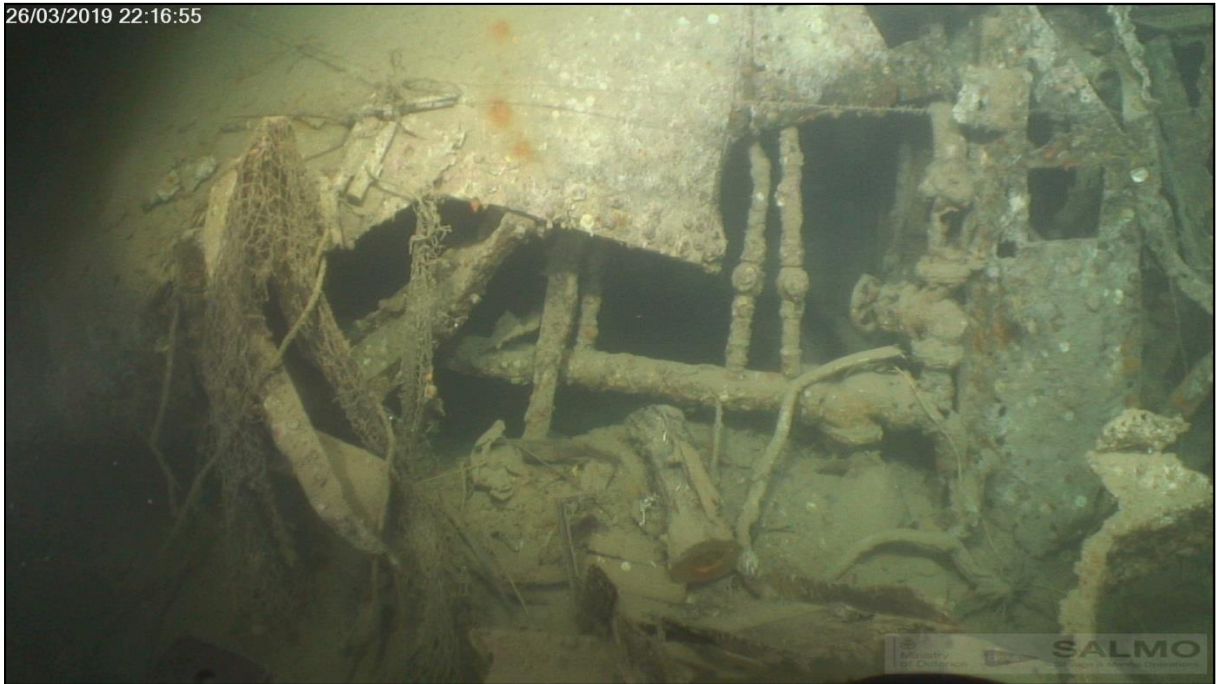
REPULSE – Salvage damage at the bow.

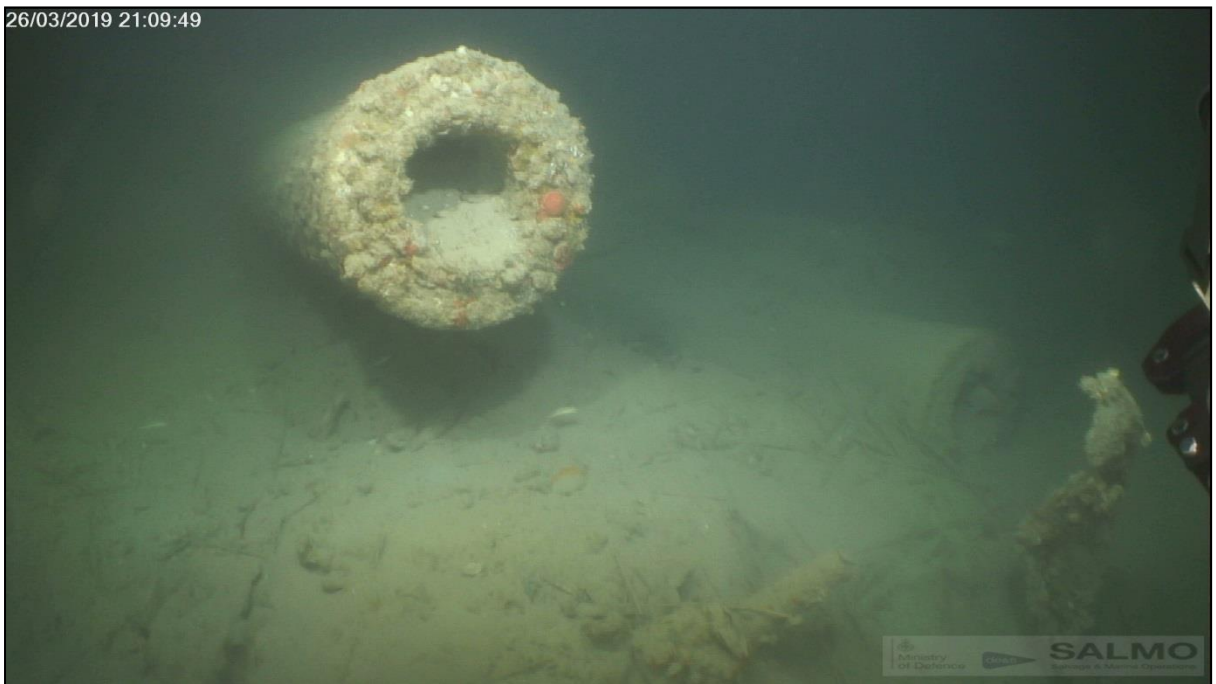
REPULSE – Gun barrels of 'Y' turret. The inverted turret is buried in the seabed beneath the hull.

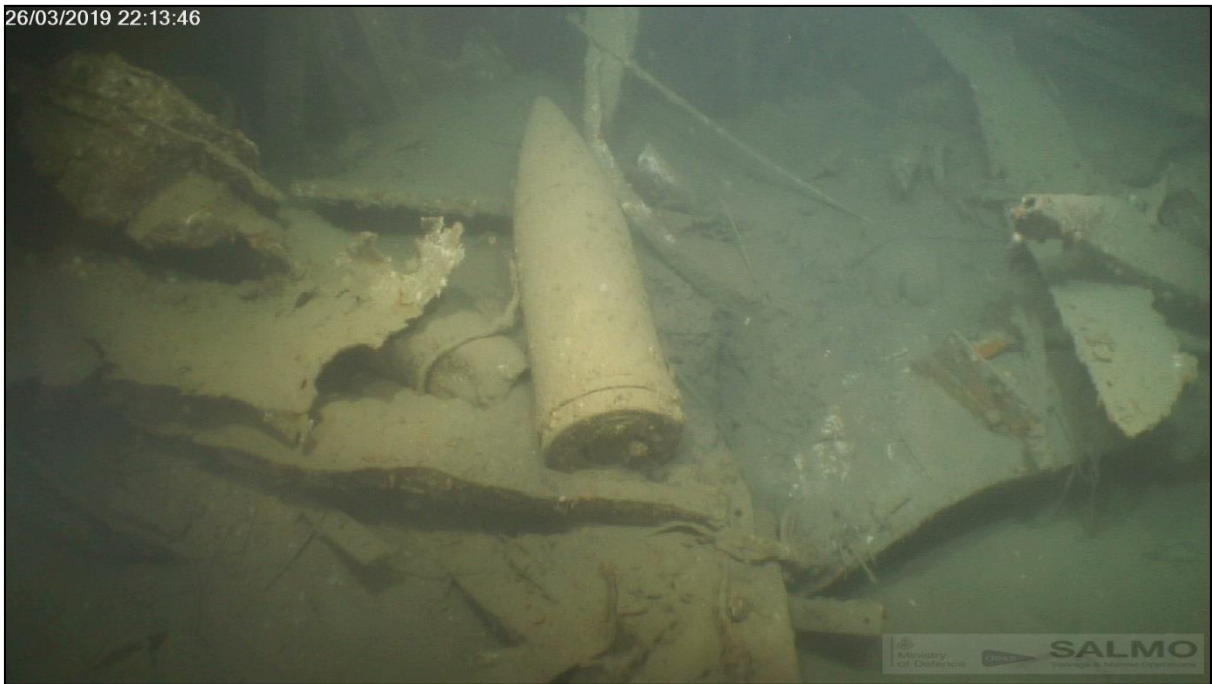
REPULSE – 15-inch shell lying in the wreckage.

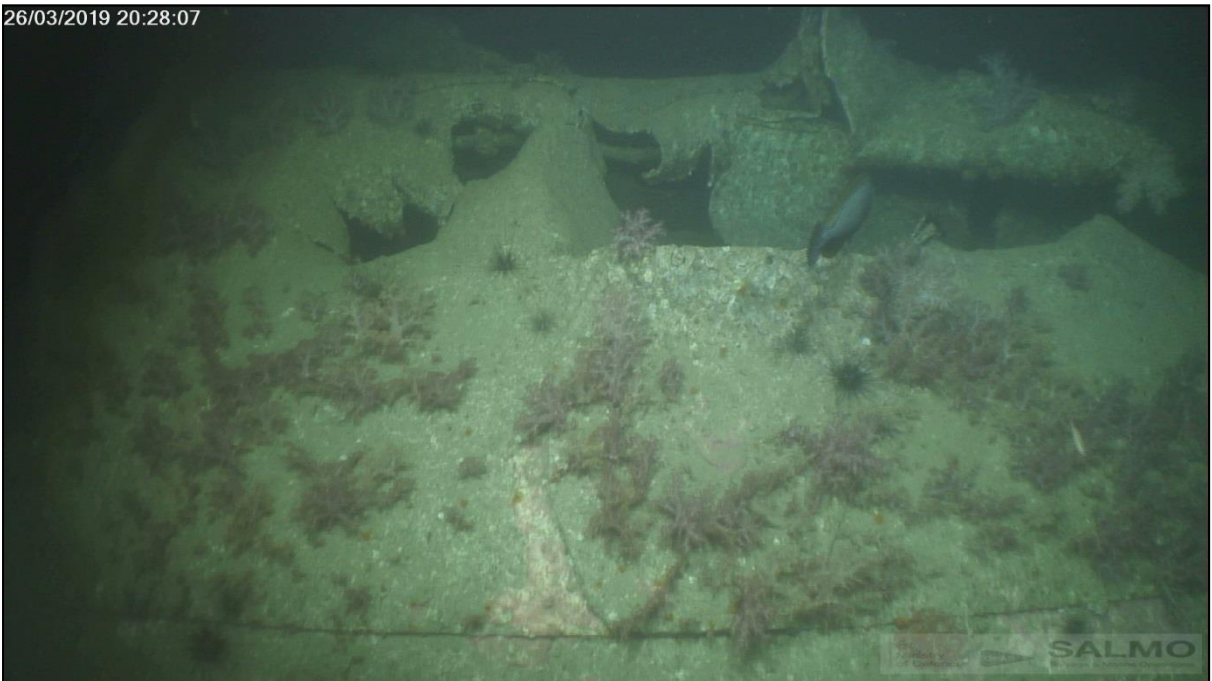
REPULSE – Sparse marine growth remaining on the wreck.

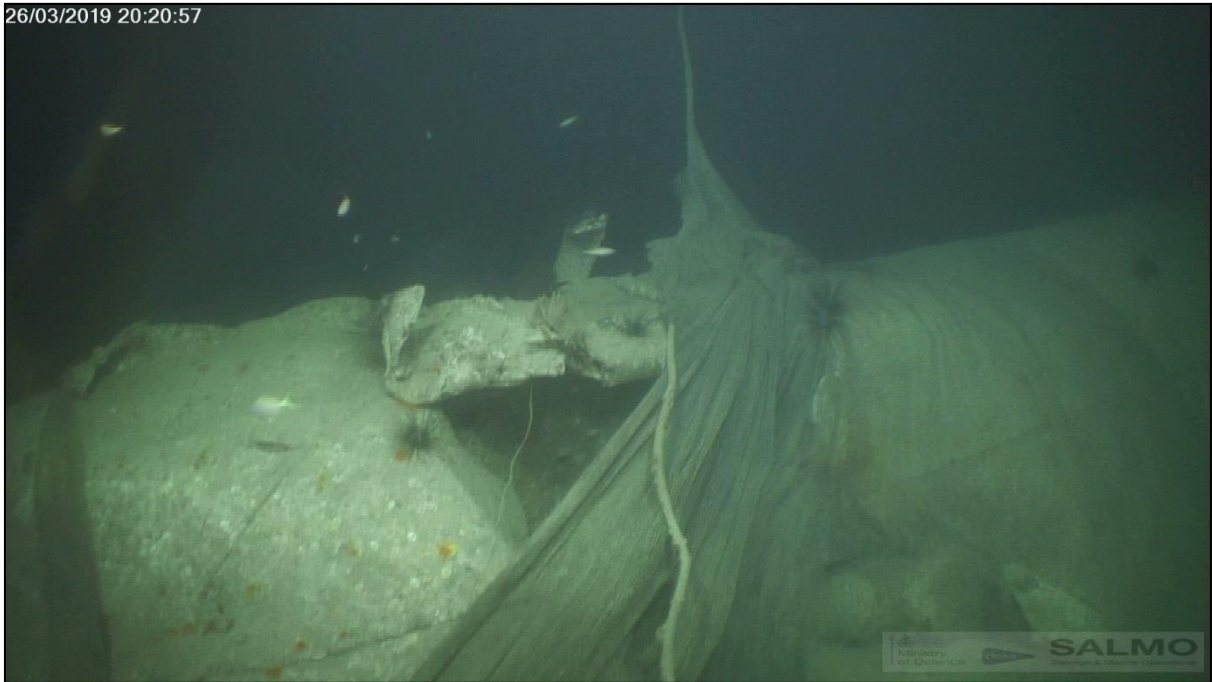
REPULSE – Fishing net on the wreck.
