Ministry of Housing, Communities and Local Government Final Research Report

Fire Performance of Cladding Materials Research – Appendix G Supplementary experimental work

MHCLG Contract: CCZZ17A36

Report Number: P111324-1024 (M19D21V3)

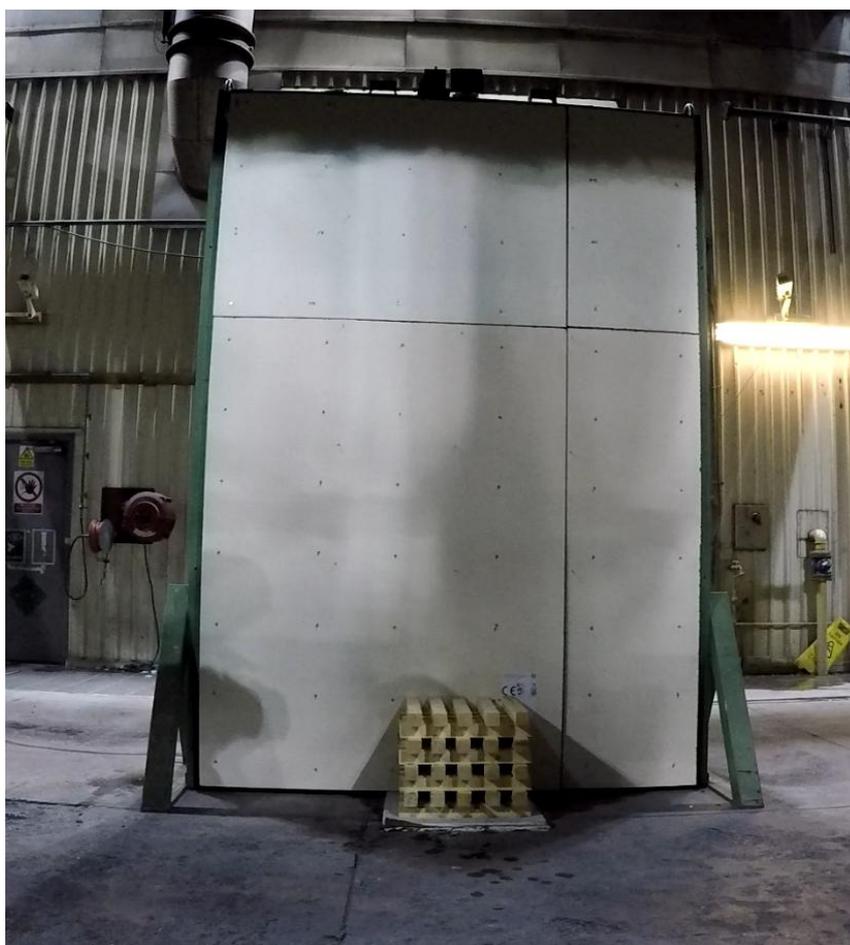
The sample for the first additional experiment (twenty third sample) consisted of high pressure laminate (HPL) panels of natural fibres impregnated with phenolic resin and coated on the outside with acrylic resin. The 6 mm thick HPL panels were cut to size and installed onto 100 mm wide aluminium T-shaped rails positioned 400 mm apart. The panels were installed onto the rails using 25 mm long self-drill self-tap screws at 300 mm vertical centres. Figure G1 shows the material installed on the rig. A cavity of 50 mm was provided between the HPL panels and the non-combustible support of the experimental rig (calcium silicate board). One vertical joint and one horizontal joint were provided within the installation shown in Figure G1.

Figure G1 – Sample S23 HPL panels installed on the rig

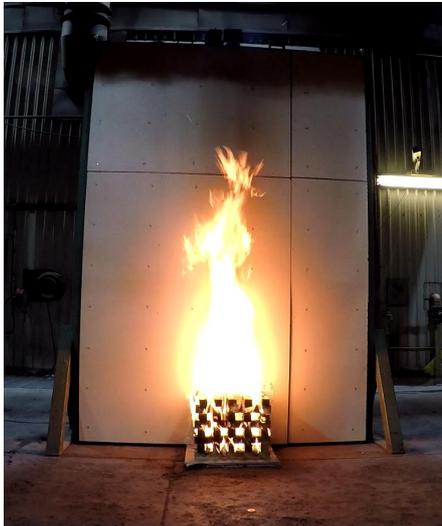
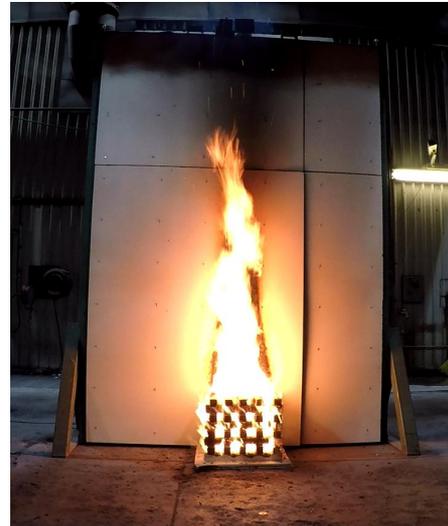
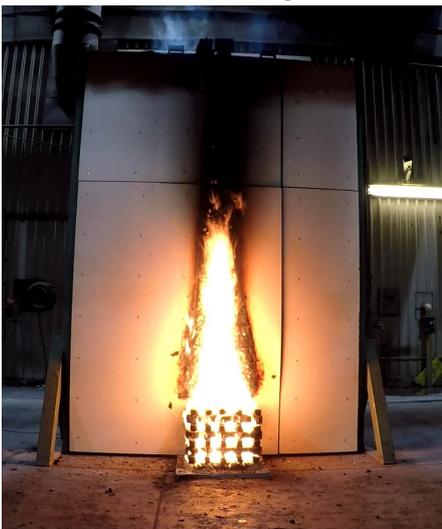
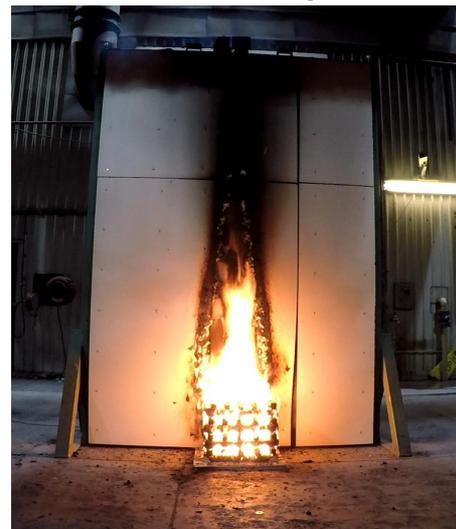
Figure G2 – Photographs during the fire at 5, 10, 20, and 25 minutes from ignition

During the fire exposure no burning droplets were observed. Discoloration of the panels was observed in the area of direct flame impingement.

The fire breached the cavity after approximately 11 minutes of thermal exposure based on both measured values and visual observation. Localised cracks were observed on the surface of the panels. Detachment of small parts of the panels in the area of direct flame impingement along the central axis was observed during the experiment.

Localised sustained flaming was observed on the surface of the panels in the fire exposed area. Limited horizontal flame spread was observed on the external surface of the panels in the area of direct flame impingement. The surface flaming self-extinguished without direct flame exposure.

No significant vertical or horizontal fire spread on the surface of the HPL panels was observed.

Figure G2 shows photographs during the fire experiment at specified times.

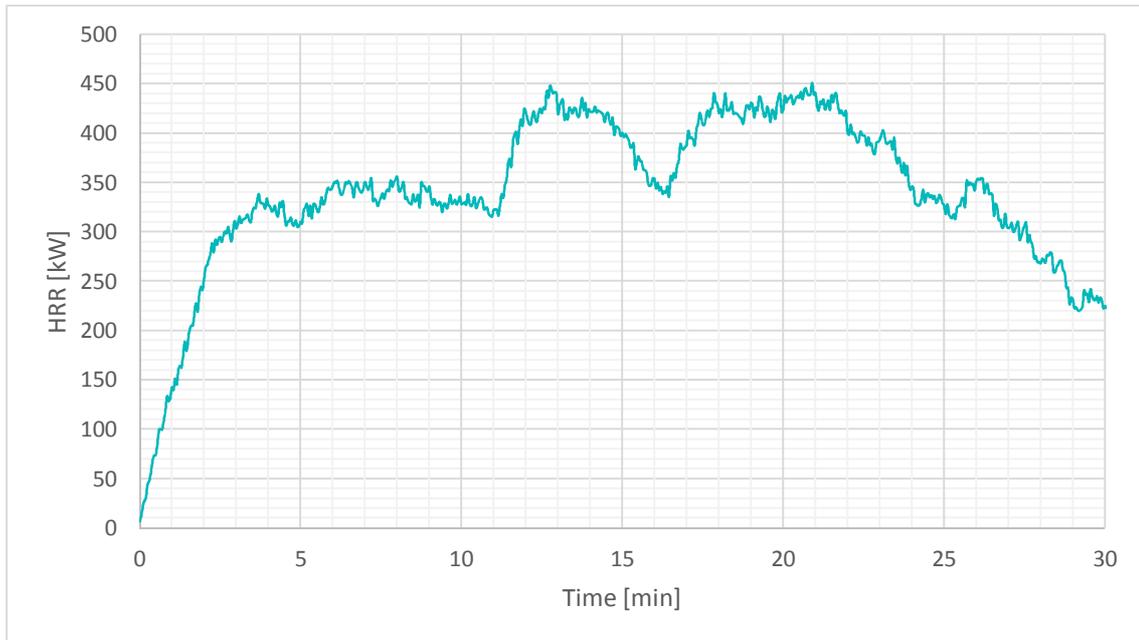
Figure G3 shows the heat release rate as a function of time during the fire exposure, including the fire source. Based on the original crib calibrations and measured values from the calorimeter, it is assumed that the peak heat release rate for the crib is approximately 300 kW. Figure G4 shows the measured value of heat flux on the centre line of the rig 3 m from the ground.

Figure G3 – Heat release rate measured during the fire, including the fire source

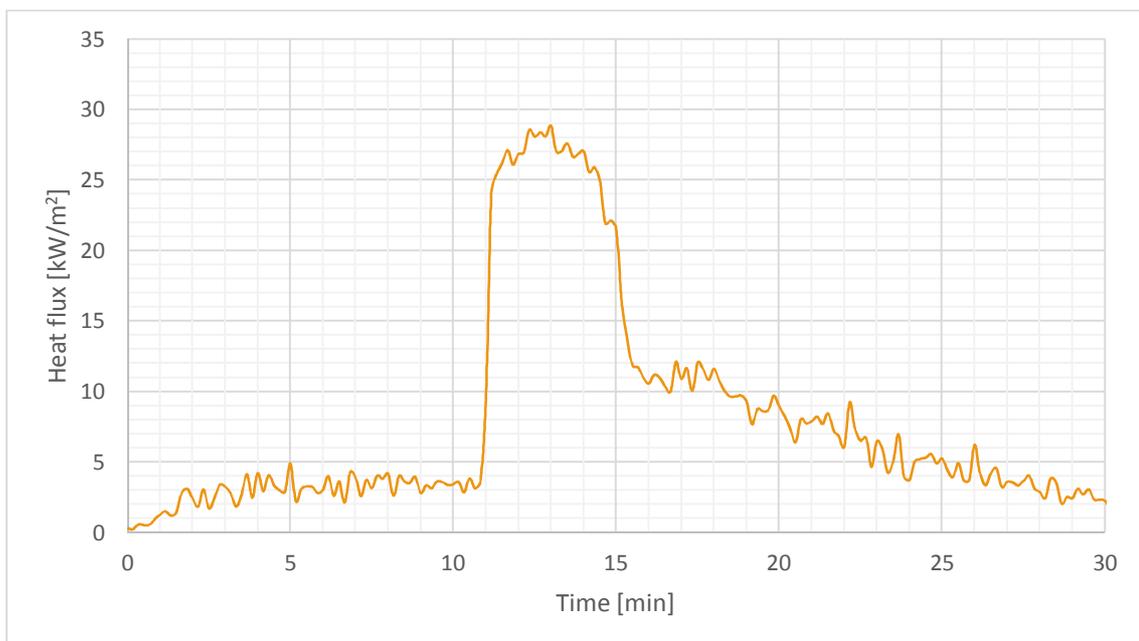
Figure G4 – Heat flux recorded during the fire at 3.0 m height

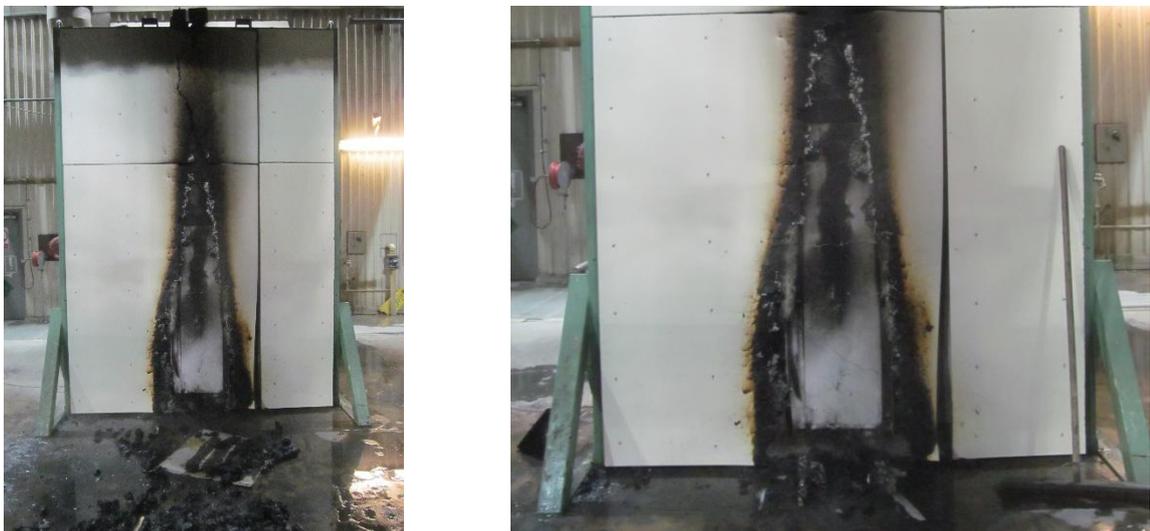
Figure G5 shows the sample after the fire. The HPL panels were consumed locally in the zone of direct flame impingement. Discoloration and distortion could be observed on the surface of the panels. Detachment of charred parts of the panels was observed after the fire. The panels became brittle after exposure to fire. Localised cracks could be observed in the area of direct heating on the panels.

Figure G5 – Post fire observations

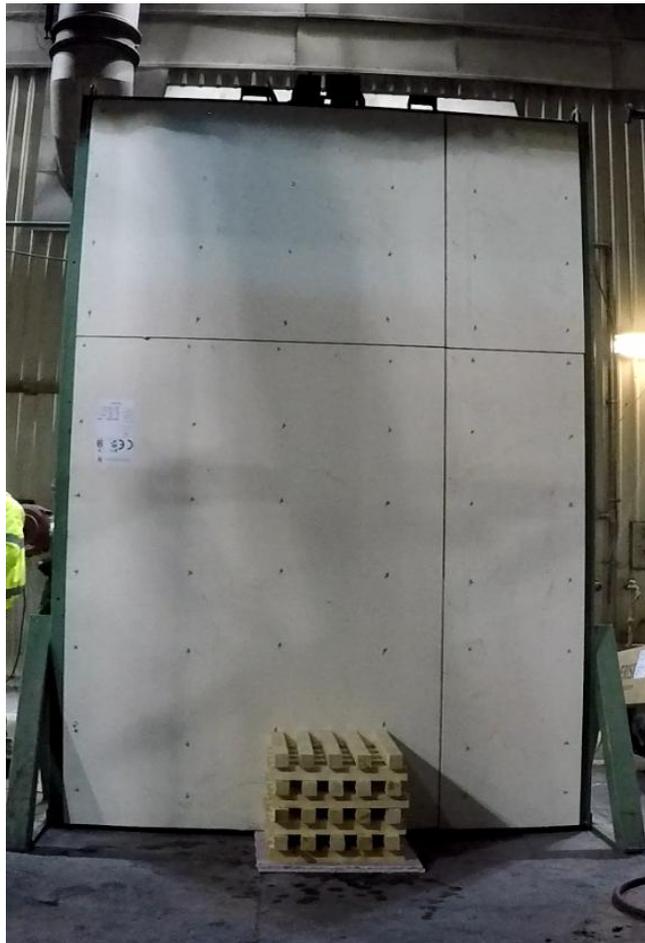
The sample for the second additional experiment (twenty fourth sample) consisted of high pressure laminate (HPL) panels of natural fibres impregnated with phenolic resin and coated on the outside with acrylic resin. The 10 mm thick HPL panels were cut to size and installed onto 100 mm wide aluminium T-shaped rails positioned 400 mm apart. The panels were installed onto the rails using 25 mm long self-drill self-tap screws at 300 mm vertical centres. Figure G6 shows the material installed on the rig. A cavity of 50 mm was provided between the HPL panels and the incombustible support of the experimental rig. One vertical joint and one horizontal joint were provided within the installation shown in Figure G6.

Figure G6 – Sample S24 HPL panels installed on the rig

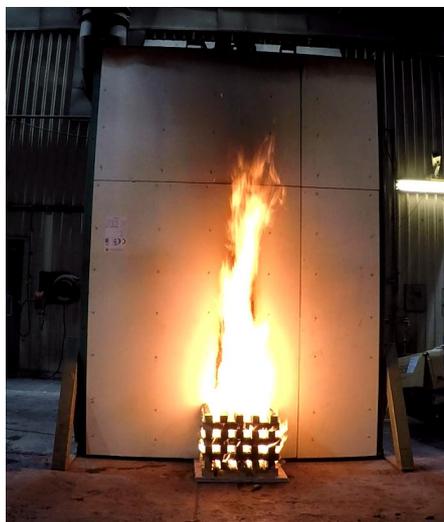
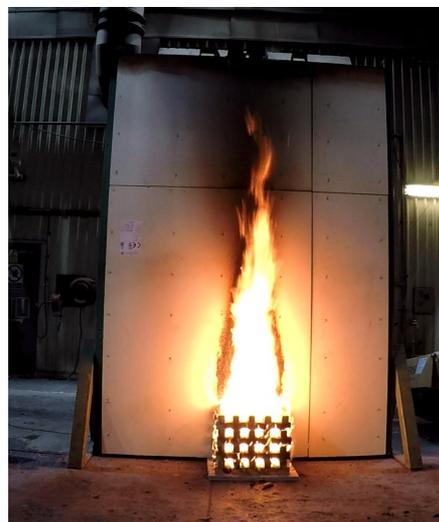
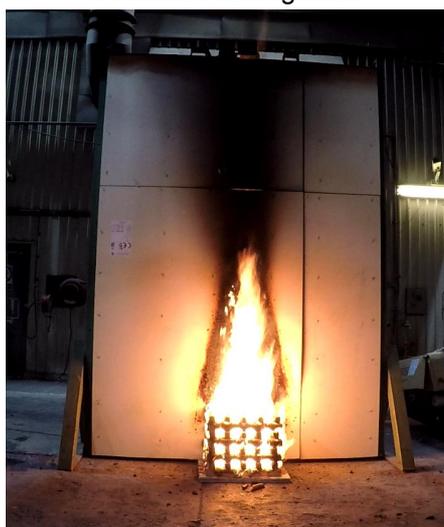
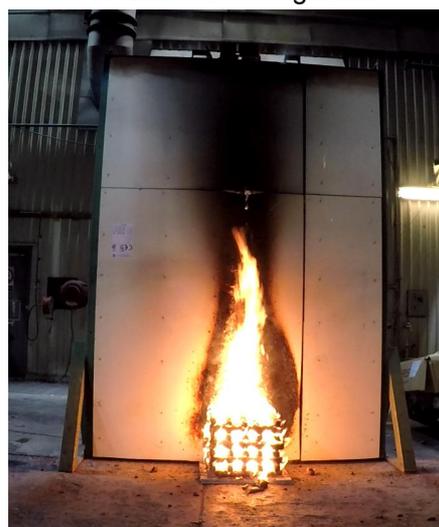
Figure G7 – Photographs during the fire at 5, 10, 20, and 25 minutes from ignition

During the fire exposure no burning droplets were observed. Discoloration of the panels was observed in the area of direct flame exposure. Due to the restraint and thermal expansion the central panel tended to bend towards the fire source.

The fire breached the cavity after approximately 17 minutes of thermal exposure based on both measured values and visual observation. Localised cracks were observed on the surface of the panels. Detachment of small parts of the panels in the area of direct flame impingement and on the central axis was observed during the experiment.

Localised sustained flaming was observed on the surface of the panels in the fire exposed area. Limited horizontal flame spread was observed on the external surface of the panels in the area of direct heat exposure. The surface burning self-extinguished without direct flame exposure. No significant vertical or horizontal flame spread on the surface of the HPL panels was observed.

Figure G7 shows photographs during the fire exposure at specified times.

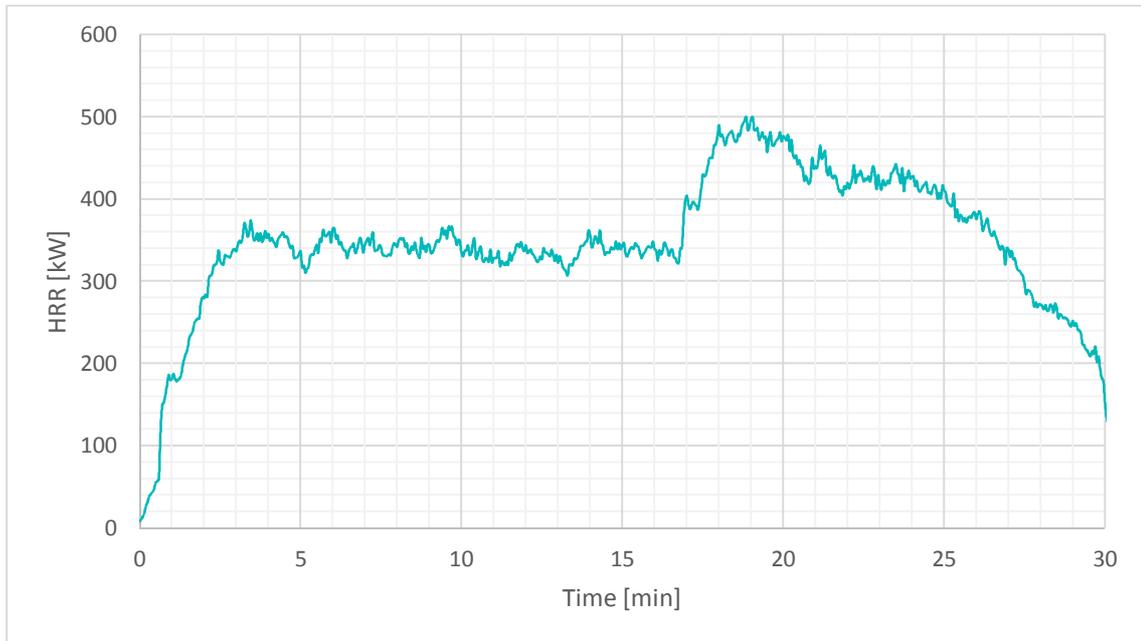
Figure G8 shows the heat release rate as a function of time during the fire exposure, including the fire source. Based on the original crib calibrations and measured values from the calorimeter, it is assumed that the peak heat release rate for the crib is approximately 300 kW.

Figure G8 – Heat release rate measured during the fire, including the source

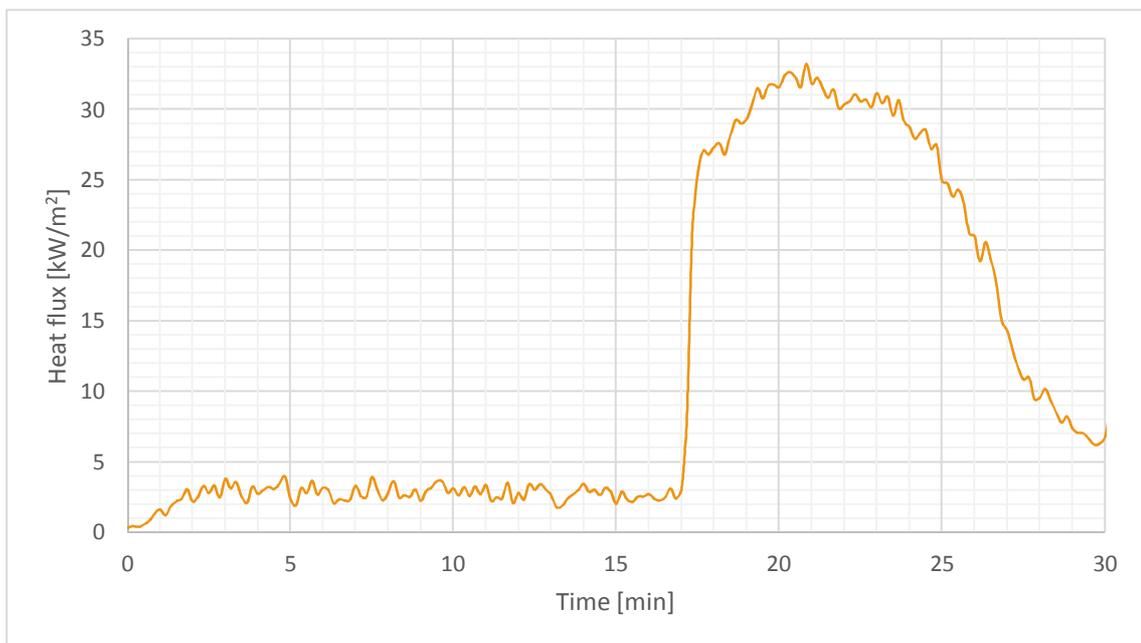
Figure G9 shows the heat flux on the centre line recorded during the fire at a height of 3.0 m from the ground.

Figure G9 – Heat flux recorded during the fire at 3.0 m height

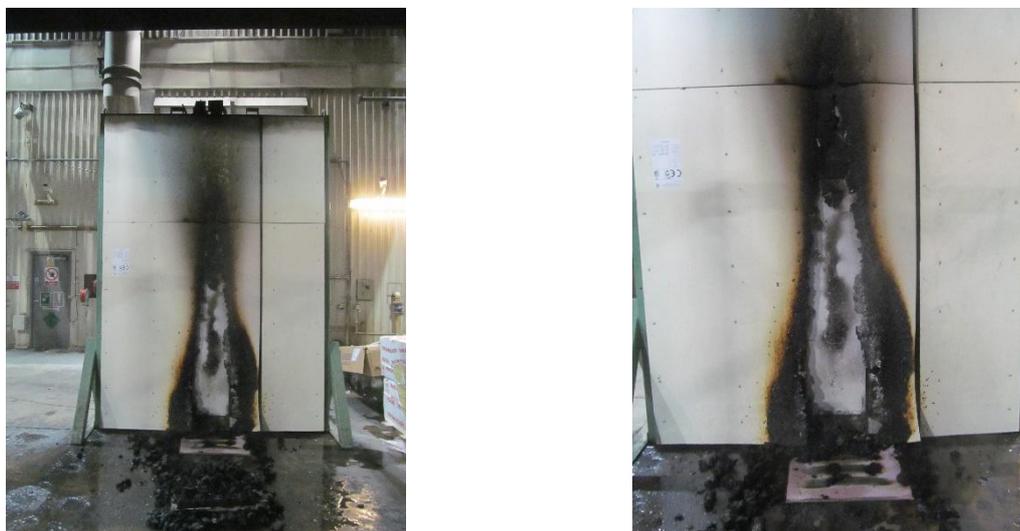
Figure G10 shows the sample after the fire. The HPL panels were consumed locally in the zone of direct flame impingement. Discoloration and distortion could be observed on the surface of the panels. Detachment of charred parts of the panels was observed after the fire. The panels became brittle after exposure to fire. Localised cracks could be observed in the area of direct heating on the panels.

Figure G10 – Post fire observations

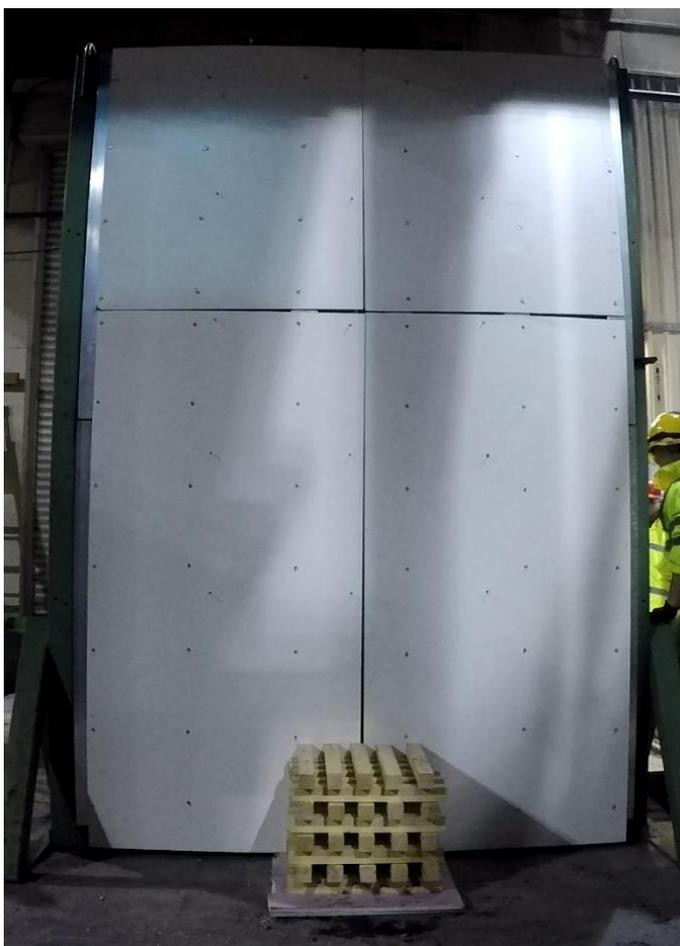
The sample for the third additional experiment (twenty fifth sample) consisted of high pressure laminate (HPL) with a wood fibre core, bonded with thermosetting resins at high pressures and temperature. The classification report provided by the supplier states that the product is intended for internal wall and ceiling finishes. The 6 mm thick HPL panels were cut to size and installed onto 100 mm wide aluminium T-shaped rails positioned 400 mm apart. The panels were installed onto the rails using 25 mm long self-drill self-tap screws at 300 mm vertical centres. Figure G11 shows the material installed on the rig. A cavity of 50 mm was provided between the HPL panels and the incombustible support of the experimental rig. One vertical joint and one horizontal joint were provided within the installation as shown in Figure G11.

Figure G11 – Sample S25 HPL panels installed on the rig

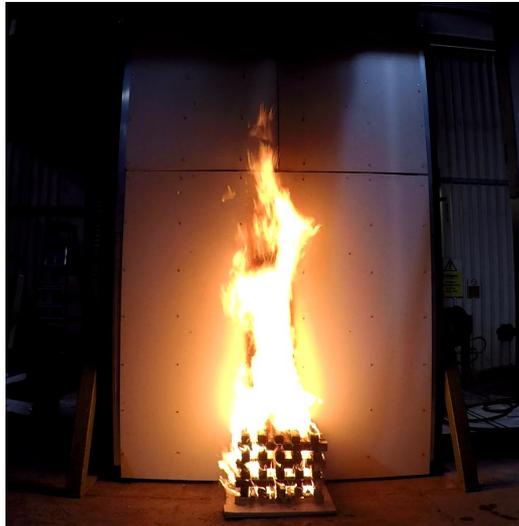
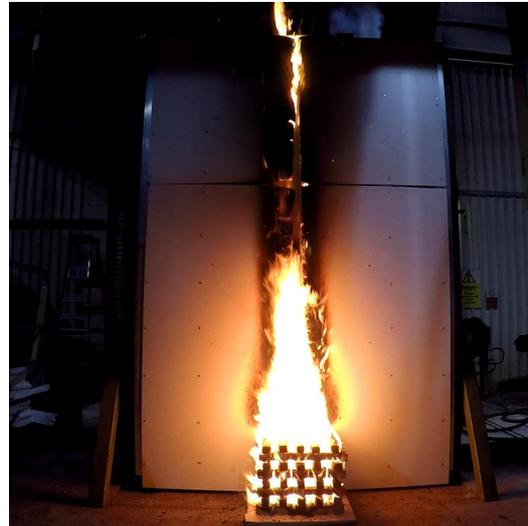
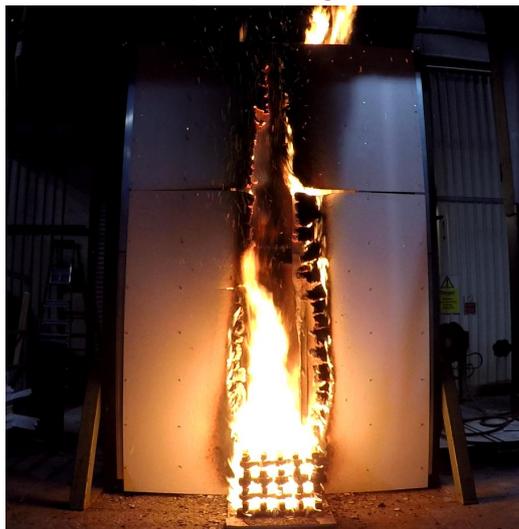
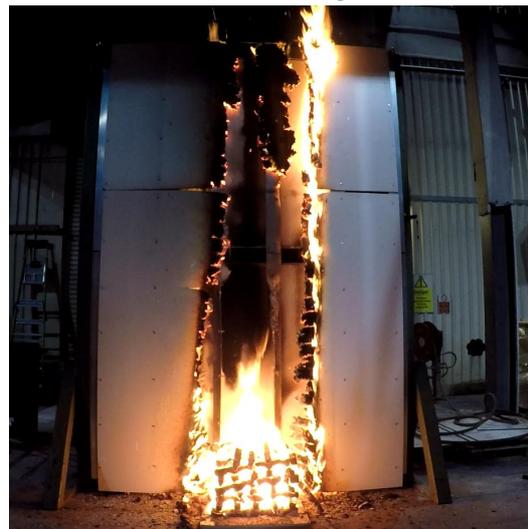
Figure G12 – Photographs during the fire at 5, 10, 20, and 25 minutes from ignition

During the fire exposure no burning droplets were observed. Discoloration of the panels was observed in the area of direct flame exposure.

Based on both measured values and visual observation, after approximately 4 minutes of thermal exposure the fire breached the cavity through the vertical joint present. Localised cracks were observed on the surface of the panels. Detachment of small parts of the panels in the area of direct flame impingement and on the central axis was observed during the experiment.

Sustained flaming was observed on the surface of the panels in the fire exposed area. Horizontal flame spread was observed on the external surface of the panels. After 15 minutes of exposure the fire spread inside the cavity beyond the aluminium rails positioned next to the centreline. At the end of the experiment the horizontal fire spread observed was relatively symmetrical, approximately 600 mm from the centreline. The surface burning self-extinguished without direct flame exposure. Vertical and horizontal flame spread on the surface of the HPL panels was observed as shown in the figure above.

Figure G12 shows photographs during the fire exposure at specified times.

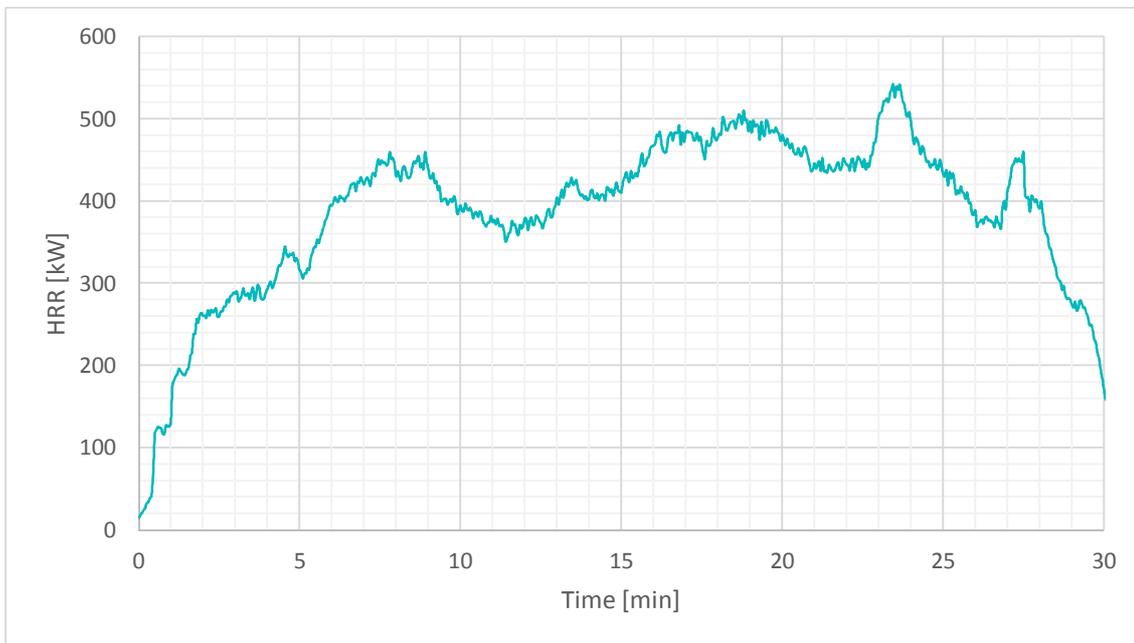
Figure G13 shows the heat release rate as a function of time during the fire exposure, including the fire source. Based on the original crib calibrations and measured values from the calorimeter, it is assumed that the peak heat release rate for the crib is approximately 300 kW.

Figure G13 – Heat release rate measured during the fire, including the source

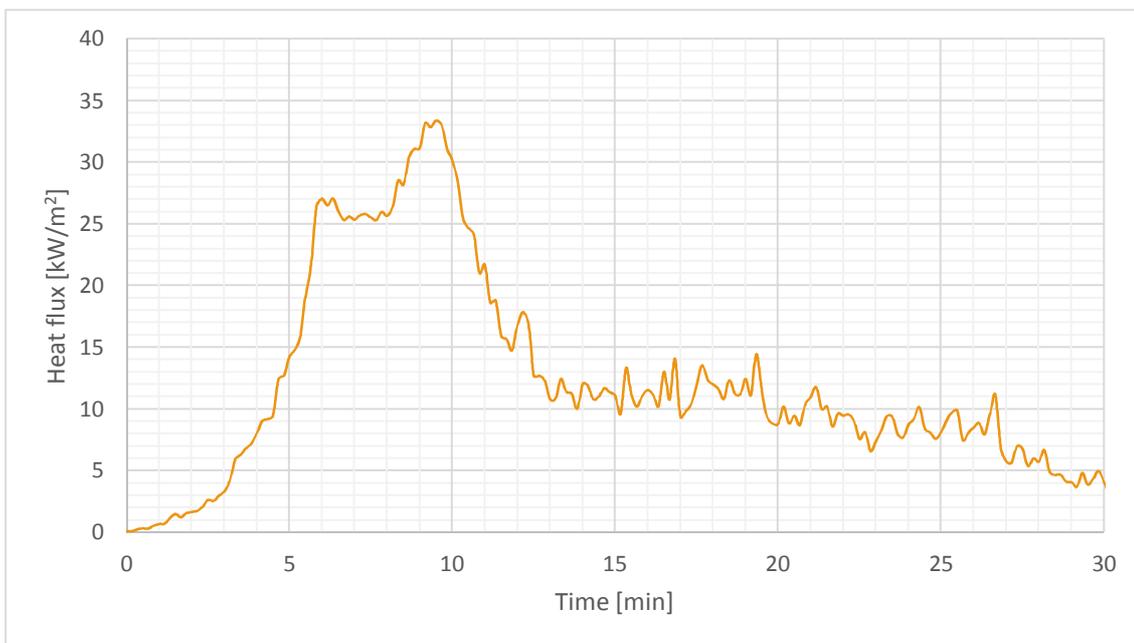
Figure G14 shows the heat flux on the centre line recorded during the fire at a height of 3.0 m from the ground.

Figure G14 – Heat flux recorded during the fire at 3.0 m height

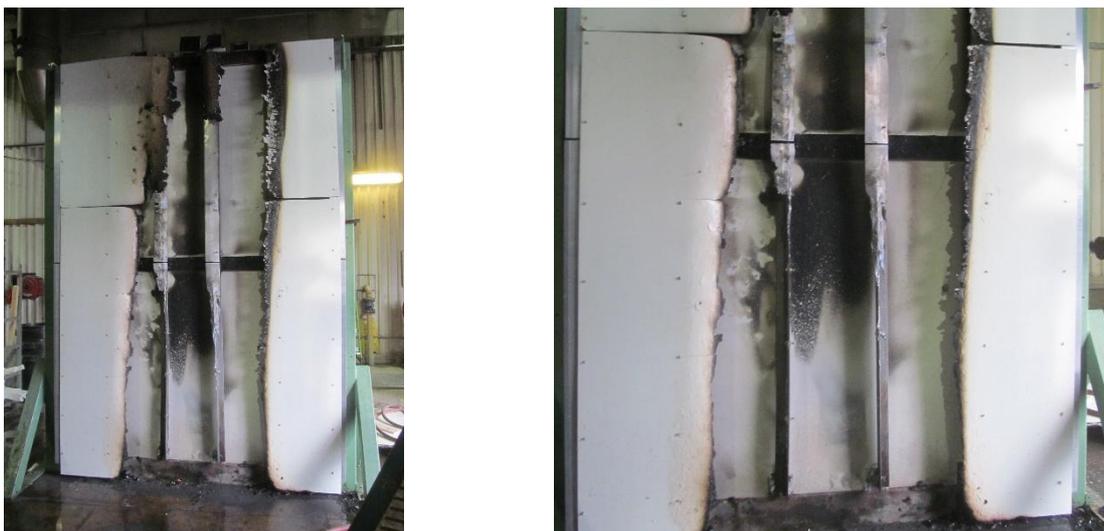
Figure G15 shows the sample after the fire. The HPL panels were consumed over an area of approximately 3.1 m². Discoloration and distortion could be observed on the remaining surface of the panels. Detachment of charred parts of the panels could be observed after the fire. The panels became brittle after exposure to fire. Localised cracks could be observed in the area of direct heating on the panels. At the end of the 30 minutes period the crib was extinguished, and some localized flaming continued on the surface of the panel for a short duration.

Figure G15 – Post fire observations

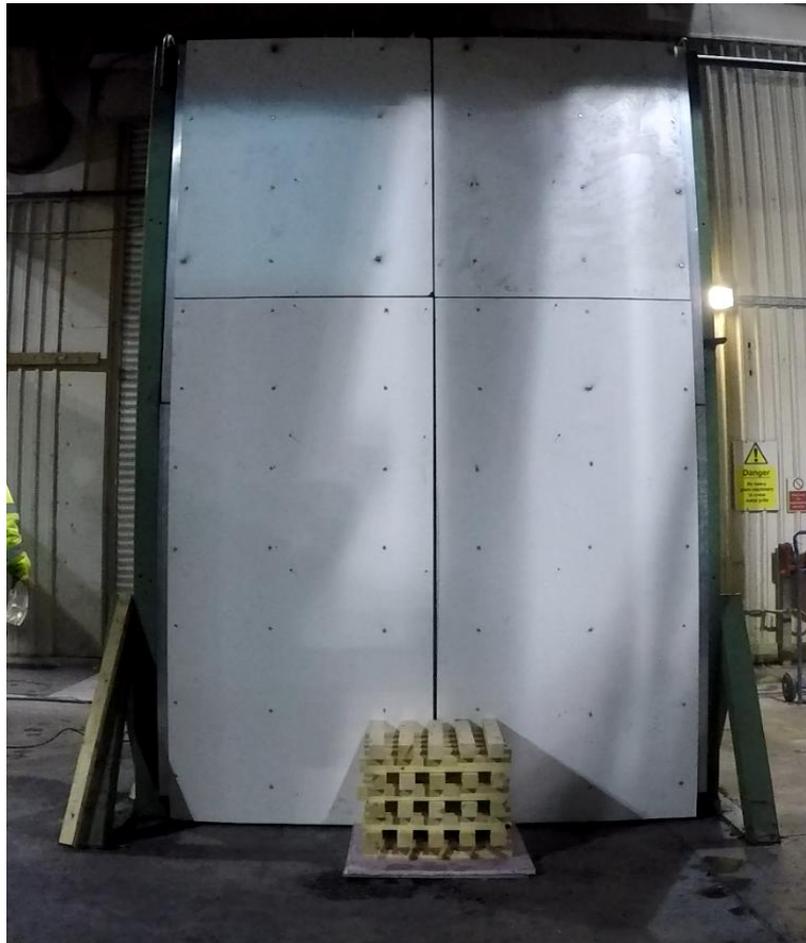
The sample for the fourth additional experiment (twenty sixth sample) consisted of high pressure laminate (HPL) with a wood fibre core, bonded with thermosetting resins at high pressures and temperature. The classification report provided by the manufacturer states that the product is intended for internal wall and ceiling finishes. The 10 mm thick HPL panels were cut to size and installed onto 100 mm wide aluminium T-shaped rails positioned 400 mm apart. The panels were installed onto the rails using 25 mm long self-drill self-tap screws at 300 mm vertical centres. Figure G16 shows the material installed on the rig. A cavity of 50 mm was provided between the HPL panels and the incombustible support of the experimental rig. One vertical joint and one horizontal joint were provided within the installation shown in Figure G16.

Figure G16 – Sample S26 HPL panels installed on the rig

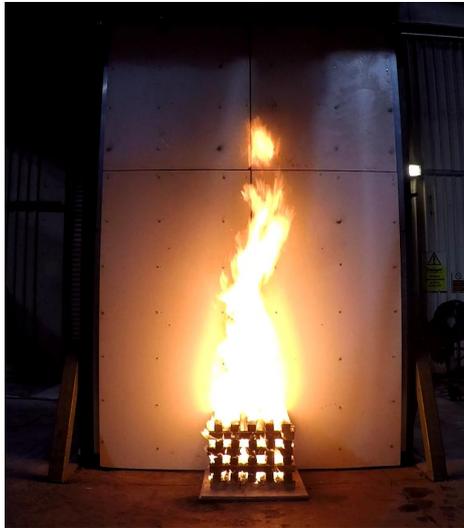
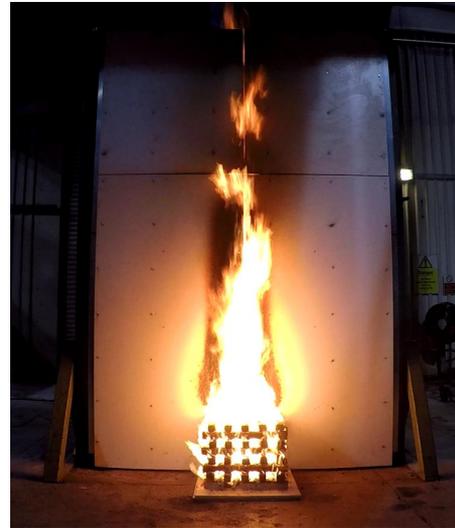
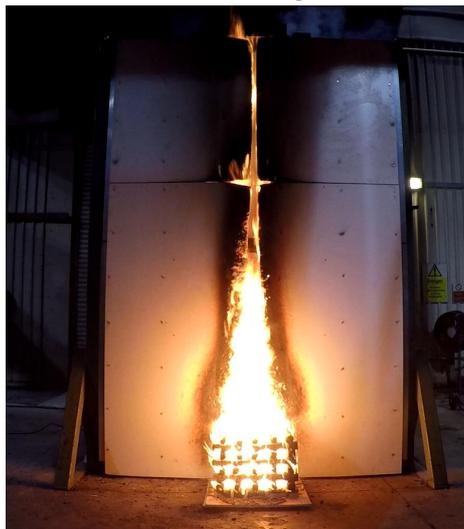
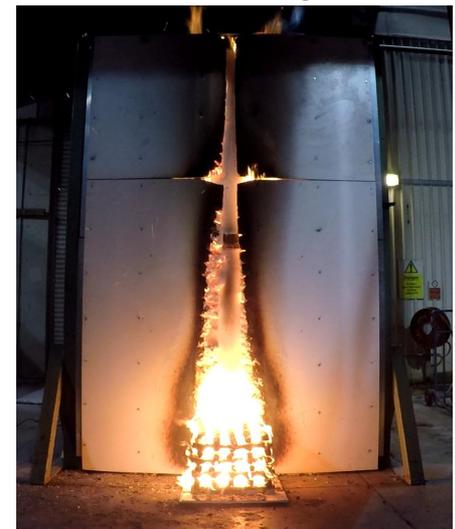
Figure G17 – Photographs during the fire at 5, 10, 20, and 25 minutes from ignition

During the fire exposure no burning droplets were observed. Discoloration of the panels was observed in the area of direct flame exposure.

Based on both measured values and visual observation, after approximately 5 minutes of thermal exposure the fire breached the cavity through the vertical joint present. Localised cracks were observed on the surface of the panels. Detachment of small parts of the panels in the area of direct flame impingement and central axis was observed during the experiment.

Sustained flaming was observed on the surface of the panels in the fire exposed area. Limited horizontal flame spread was observed on the external surface of the panels. After 23 minutes of exposure, the fire spread inside the cavity beyond the aluminium rails positioned next to the centreline. The surface burning self-extinguished. Vertical and horizontal flame spread on the surface of the HPL panels was observed as shown in the figure above.

Figure G17 shows photographs during the fire exposure at specified times.

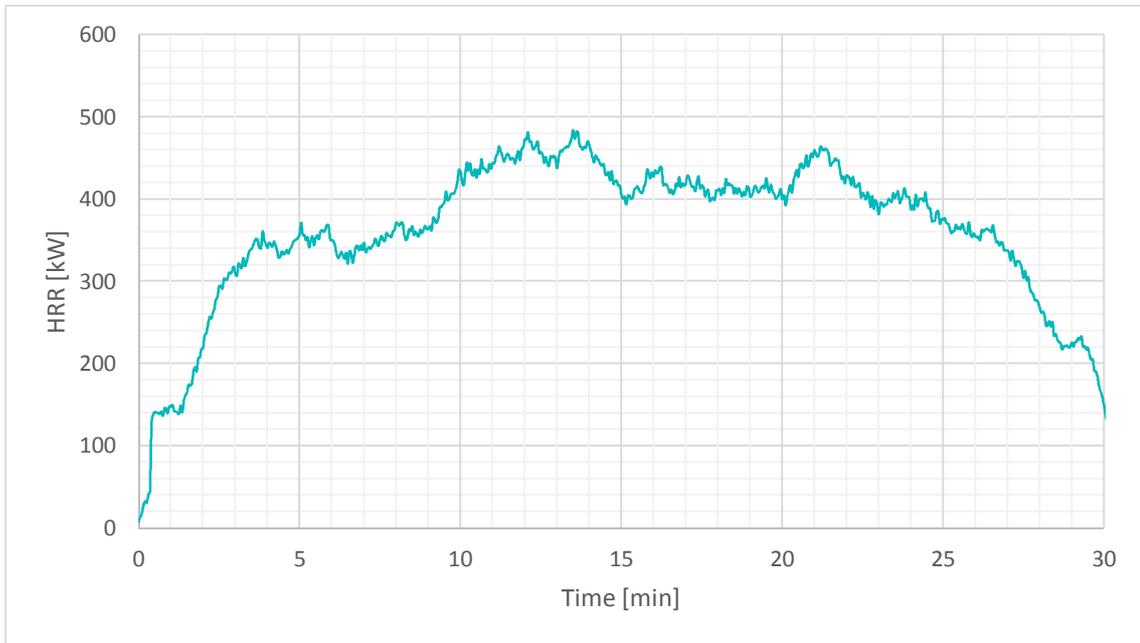
Figure G18 shows the heat release rate as a function of time during the fire exposure, including the fire source. Based on the original crib calibrations and measured values from the calorimeter, it is assumed that the peak heat release rate for the crib is approximately 300 kW.

Figure G18 – Heat release rate measured during the fire, including the source

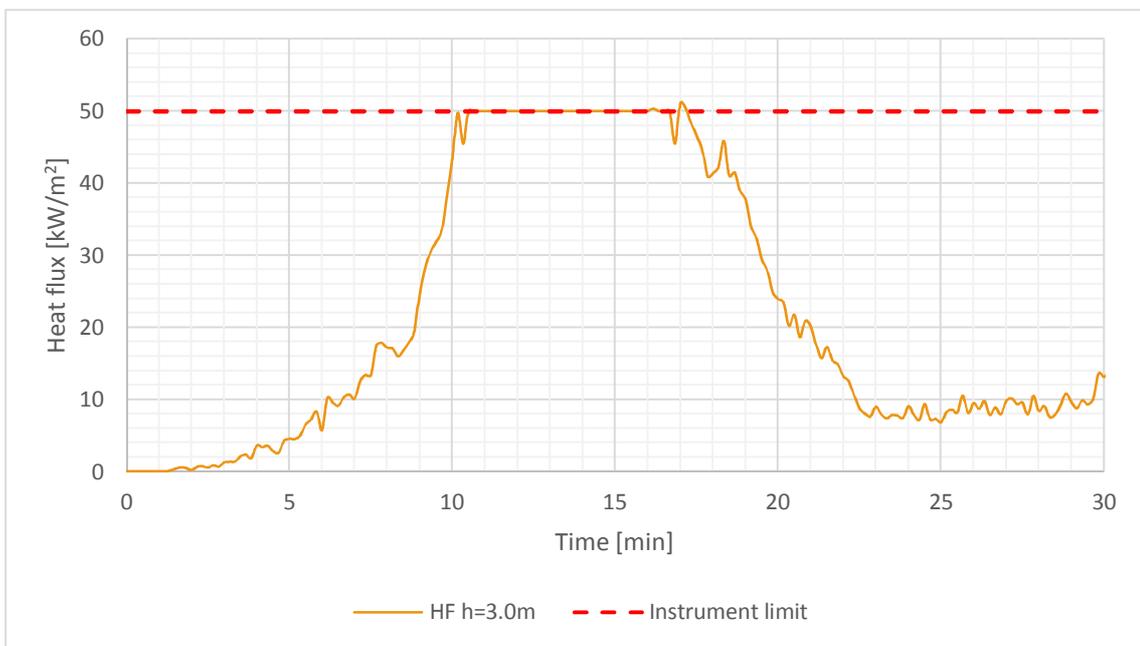
Figure G19 shows the heat flux on the centre line recorded during the fire at a height of 3.0 m from the ground and the maximum recording capacity of the instrument.

Figure G19 – Heat flux recorded during the fire at 3.0 m height

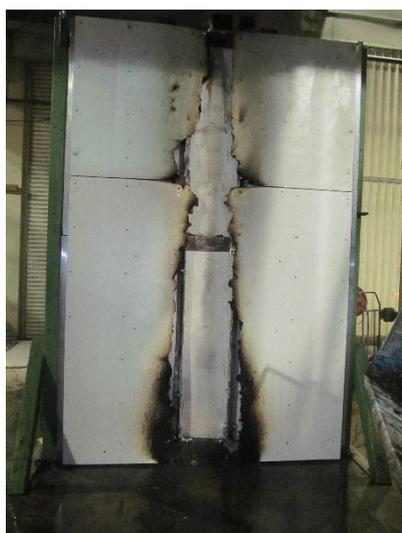
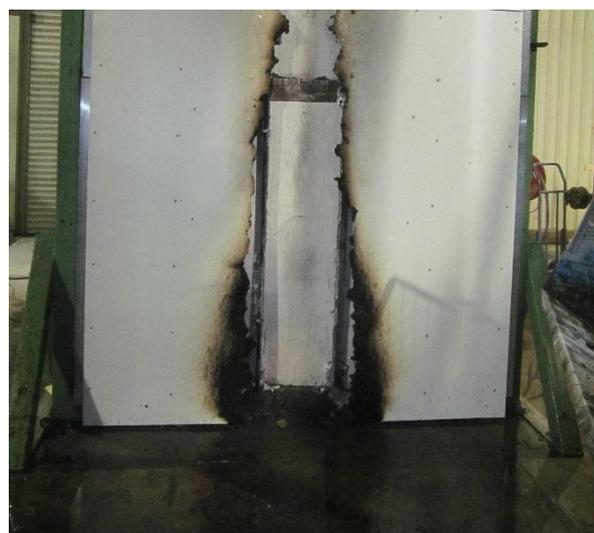
Figure G20 shows the sample after the fire. The HPL panels were consumed over an area of approximately 1.4 m². Discoloration and distortion could be observed on the remaining surface of the panels. Detachment of charred parts of the panels could be observed after the fire. The panels had a brittle behaviour when exposed to fire. Localised cracks of the panels could be observed in the area of direct heating. At the end of the 30 minutes period the crib was extinguished, and flaming in the cavity continued for a short duration.

Figure G20 – Post fire observations

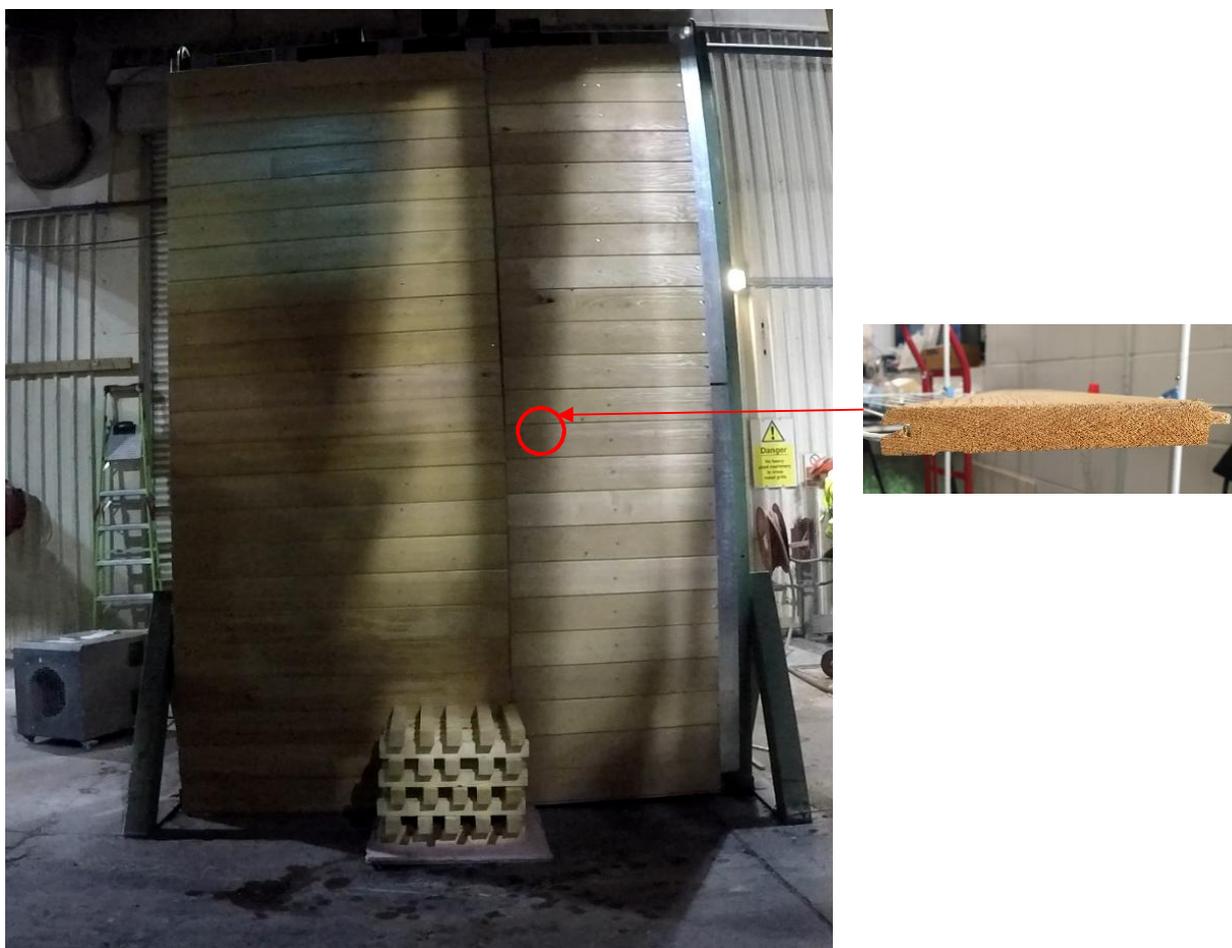
The sample for the fifth additional experiment (twenty seventh sample) consisted of untreated cedar wood. The timber slats were of a tongue and groove type with a thickness of 19 mm, a width of 140 mm and a cross sectional profile as shown in Figure G21. The density of the timber was 355 kg/m³ as measured. The timber slats were cut to size (0.8 m and 1.3 m lengths) and installed onto 100 mm wide aluminium T-shaped rails positioned 400 mm apart. The panels were installed onto the rails using 25 mm long self-drill self-tap screws at 140 mm vertical centres. Figure G21 shows the material installed on the rig and the profile of the tongue and groove joint. A cavity of 50 mm was provided between the timber cladding and the incombustible support of the experimental rig. One vertical joint was provided within the installation shown in Figure G21. The measured moisture content of the timber cladding prior to the fire was between 13% and 15%.

Figure G21 – Sample S27 timber cladding a) installed on the rig (left) and b) cross sectional profile of tongue and groove (right)

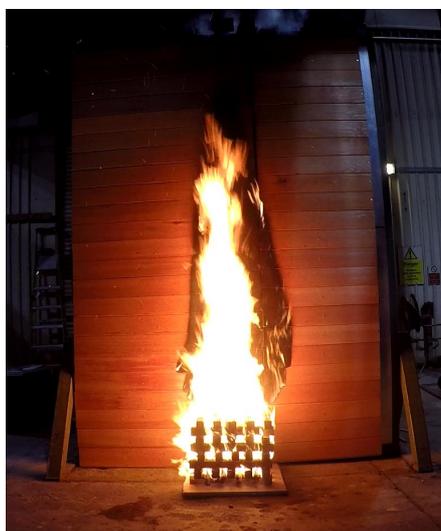
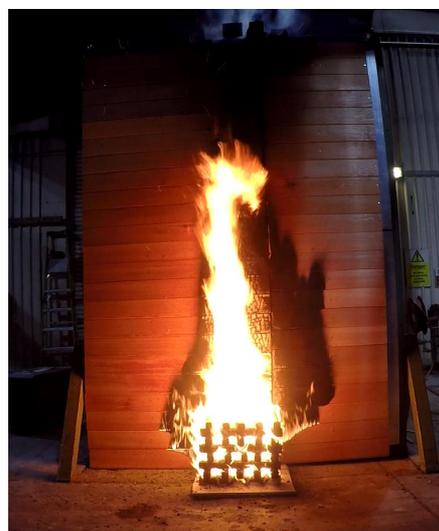
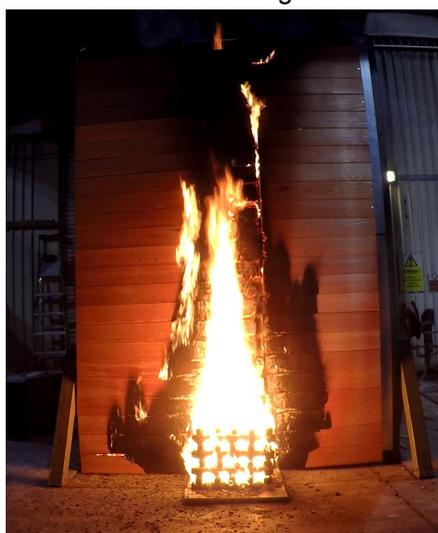
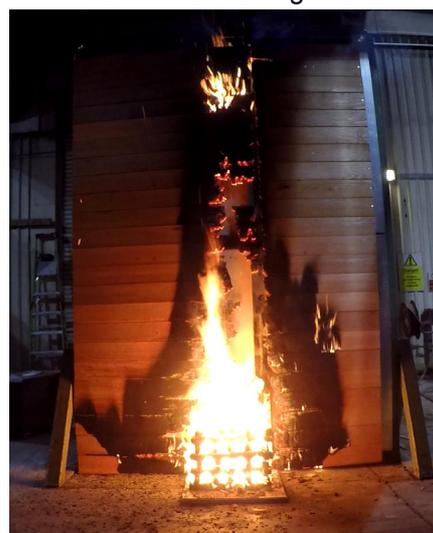
Figure G22 – Photographs during the fire at 5, 10, 20, and 25 minutes from ignition

After approximately 3 minutes of fire exposure, the surface of the timber cladding ignited. The average gas temperature measured in the ignition area prior to the surface burning was approximately 360°C. Once the timber cladding had charred, self-extinguishment of the burning surface occurred.

Based on both measured values and visual observation, after approximately 14 minutes of thermal exposure the fire breached the cavity. The fire spread both vertically and horizontally on the surfaces of both the cavity facing and external faces of the timber cladding. Detachment of small parts of the timber cladding in the area of direct flame impingement was observed during the experiment. After 17 minutes of fire exposure, flames were observed coming out from the vertical joint present. Sustained flaming was observed on the surface of the timber cladding in the fire exposed area. After approximately 23 minutes of exposure, the timber cladding was fully consumed in the area of direct flame impingement. Sustained flaming and smouldering was observed on the surface in the area of direct flame exposure after the fire source had been removed. Some vertical and horizontal flame spread on the surface of the timber cladding was observed. During the fire exposure no burning droplets were observed.

Figure G22 shows photographs during the fire exposure at specified times.

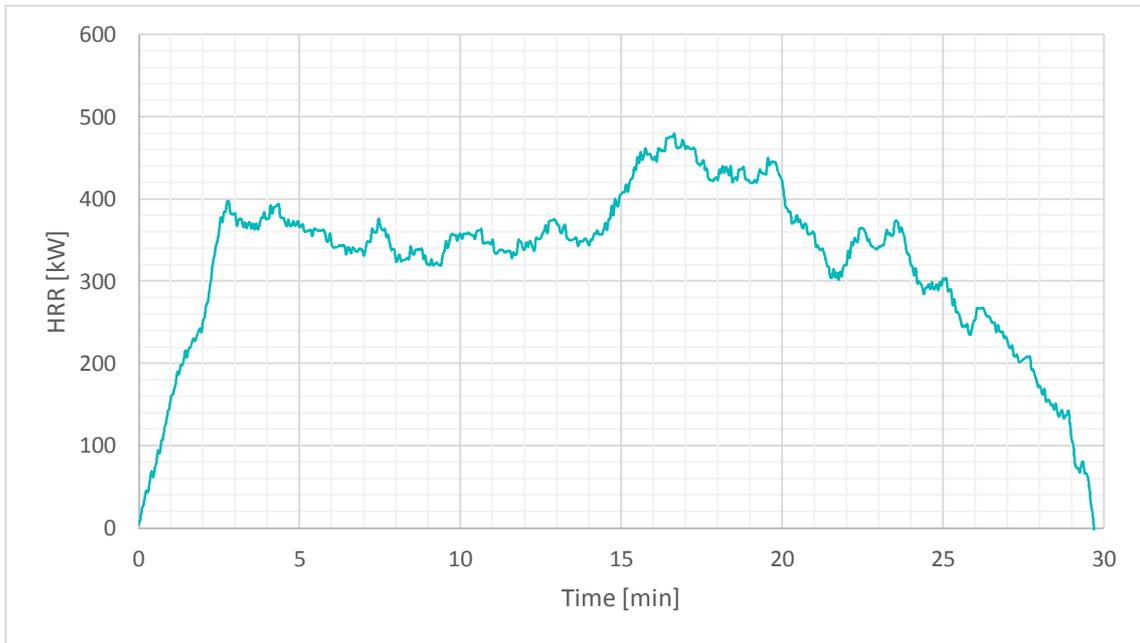
Figure G23 shows the heat release rate as a function of time during the fire exposure, including the fire source. Based on the original crib calibrations and measured values from the calorimeter, it is assumed that the peak heat release rate for the crib is approximately 300 kW.

Figure G23 – Heat release rate measured during the fire, including the source

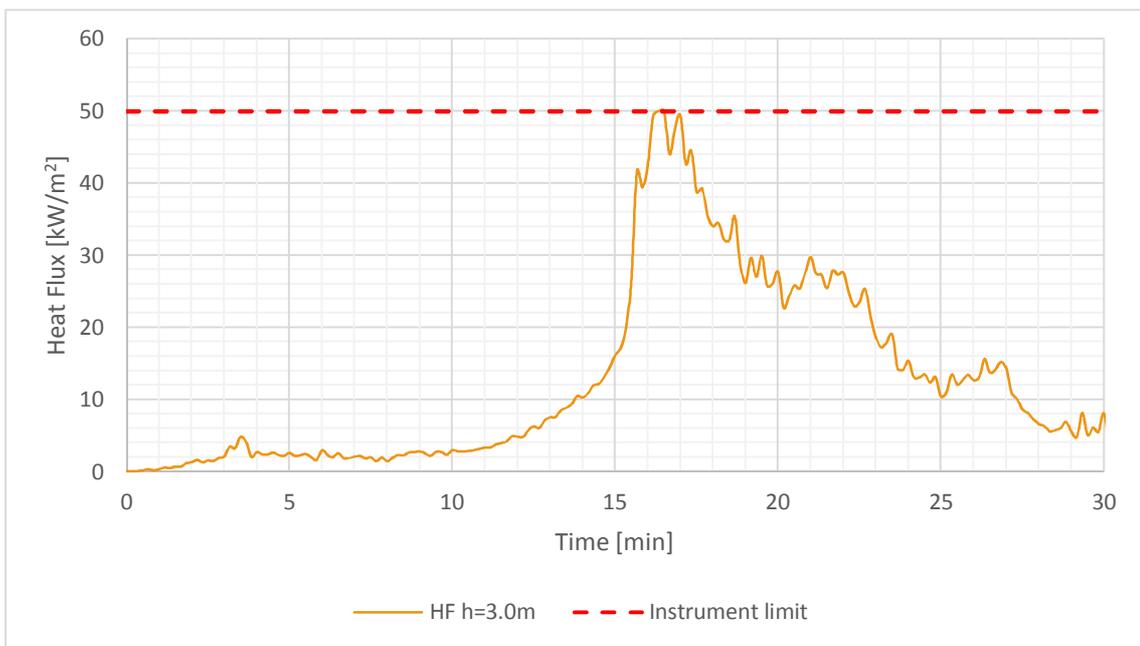
Figure G24 shows the heat flux on the centre line recorded during the fire at a height of 3.0 m from the ground and the maximum recording capacity of the instrument.

Figure G24 – Heat flux recorded during the fire at 3.0 m height
