Ministry of Housing, Communities and Local Government Final Research Report

Fire Performance of Cladding Materials Research – Appendix G Supplementary experimental work

MHCLG Contract: CCZZ17A36

Report Number: P111324-1024 (M19D21V3)

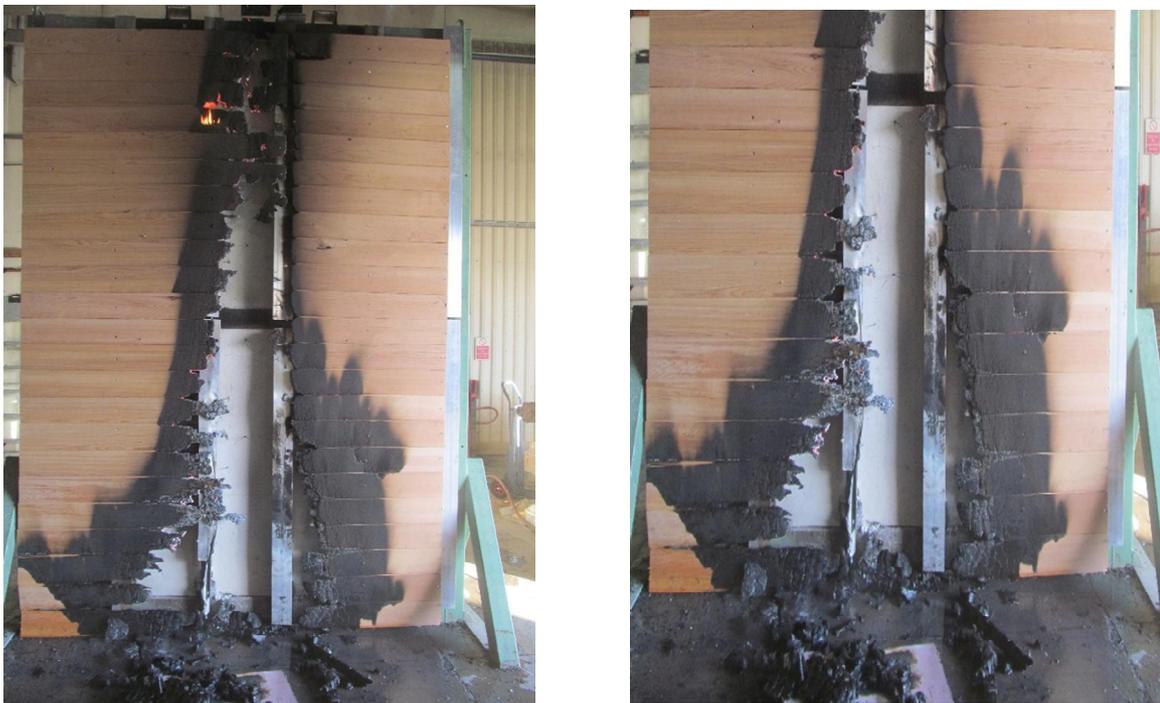
Figure G25 shows the sample after the fire. The timber cladding was consumed over an area of approximately 1.65 m². Discoloration and charring can be observed on the remaining surface of the panels. Detachment of charred parts of the timber cladding was observed after the fire. At the end of the 30 minutes period the crib was extinguished, and some localised flaming and charring continued for a short duration.

Figure G25 – Post fire observations

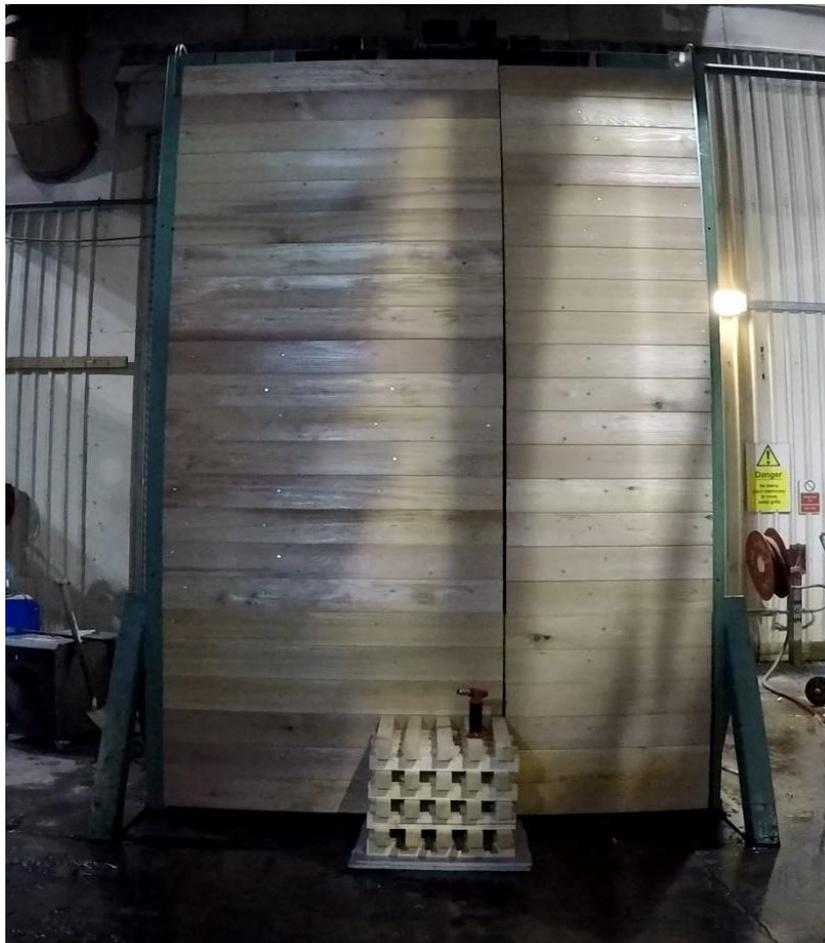
The sample for the final additional experiment (twenty eighth sample) was a repeat of sample twenty seven and consisted of untreated cedar wood. The timber slats were of a tongue and groove type with a thickness of 19 mm, a width of 140 mm and a cross sectional profile as shown in Figure G21. The density of the timber was 355 kg/m^3 as measured. The timber slats were cut to size (0.8 m and 1.3 m lengths) and installed onto 100 mm wide aluminium T-shaped rails positioned 400 mm apart. The panels were installed onto the rails using 25 mm long self-drill self-tap screws at 140 mm vertical centres. Figure G26 shows the material installed on the rig. A cavity of 50 mm was provided between the timber cladding and the incombustible support of the experimental rig. One vertical joint was provided within the installation shown in Figure G26. The measured moisture content of the timber cladding prior to the fire was between 13% and 15%.

Figure G26 – Sample S28 timber cladding installed on the rig

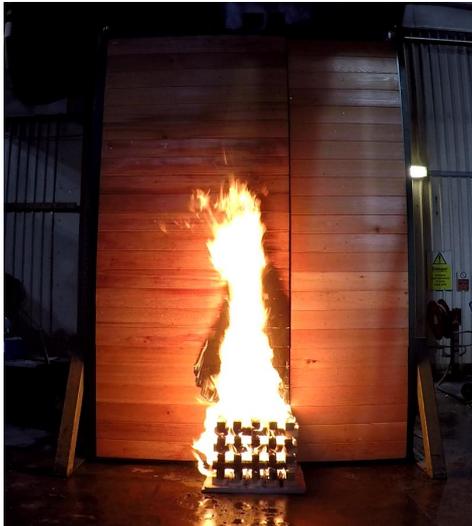
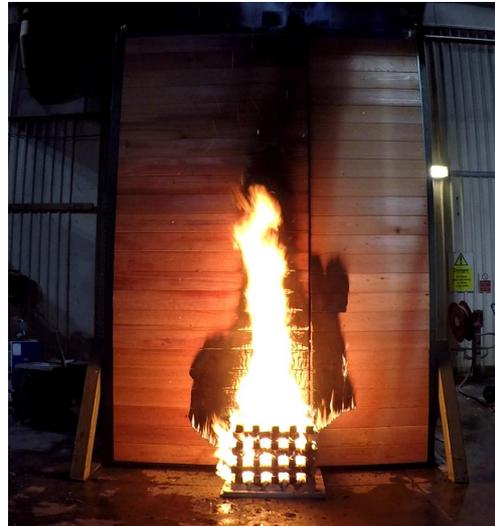
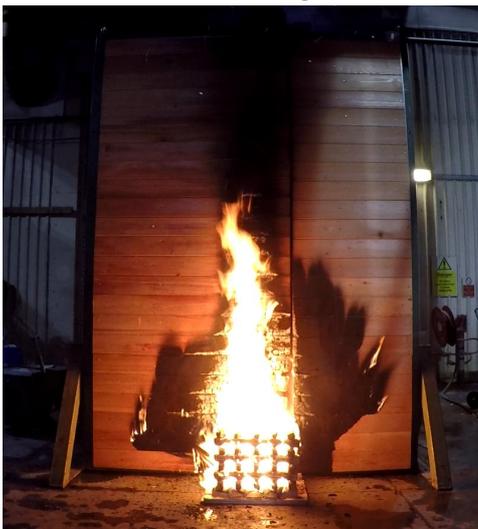
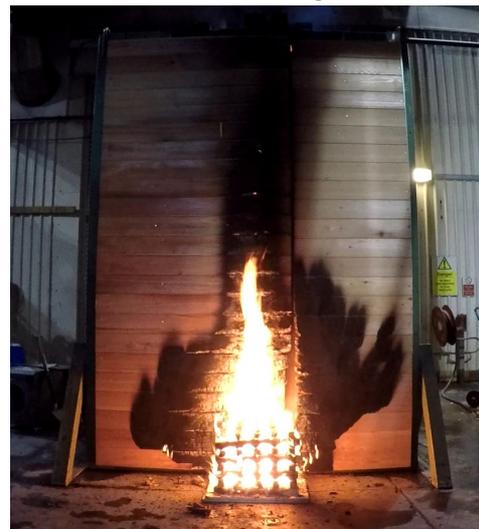
After approximately 2 minutes 50 seconds of fire exposure, the surface of the timber cladding ignited. The average gas temperature measured in the ignition area prior to the surface burning was approximately 360°C. Once the timber cladding has been charred, self-extinguishment of the burning surface occurred.

Based on both measured values and visual observation, after approximately 21 minutes of thermal exposure, the fire breached the cavity. The fire spread both vertically and horizontally on the surfaces of both the cavity facing face and the external faces of the timber cladding. Detachment of small parts of the timber cladding in the area of direct flame impingement was observed during the experiment. Sustained flaming was observed on the surface of the timber cladding in the fire exposed area. After approximately 26 minutes of exposure, the timber cladding was fully consumed in the area of direct flame impingement. Sustained flaming and smouldering were observed on the surface in the area of direct flame exposure after the fire source had been removed. Some vertical and horizontal flame spread on the surface of the timber cladding was observed. During the fire exposure no burning droplets were observed.

Figure G27 shows photographs during the fire exposure at specified times.

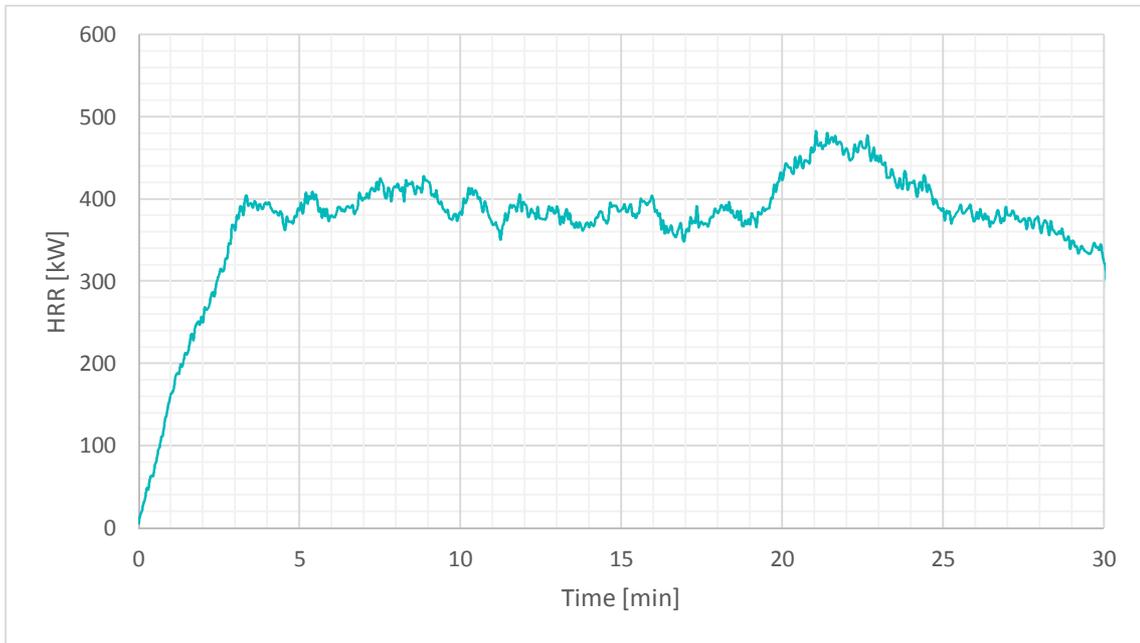
Figure G28 shows the heat release rate as a function of time during the fire exposure, including the fire source. Based on the original crib calibrations and measured values from the calorimeter, it is assumed that the peak heat release rate for the crib is approximately 300 kW.

Figure G28 – Heat release rate measured during the fire, including the source

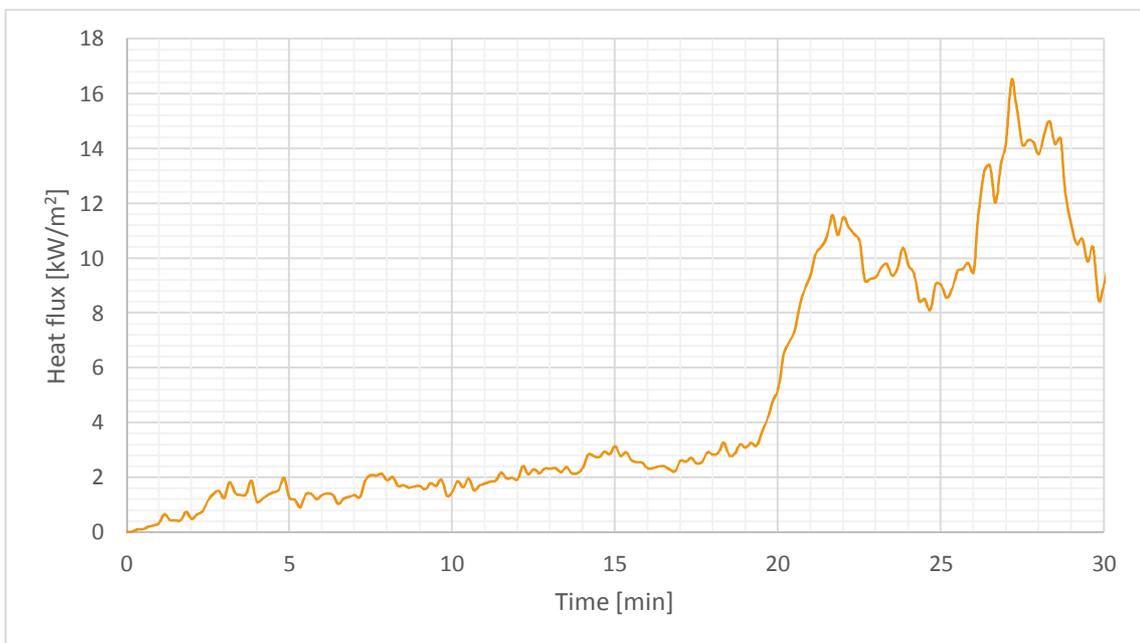
Figure G29 shows the heat flux on the centre line recorded during the fire at a height of 3.0 m from the ground.

Figure G29 – Heat flux recorded during the fire at 3.0 m height

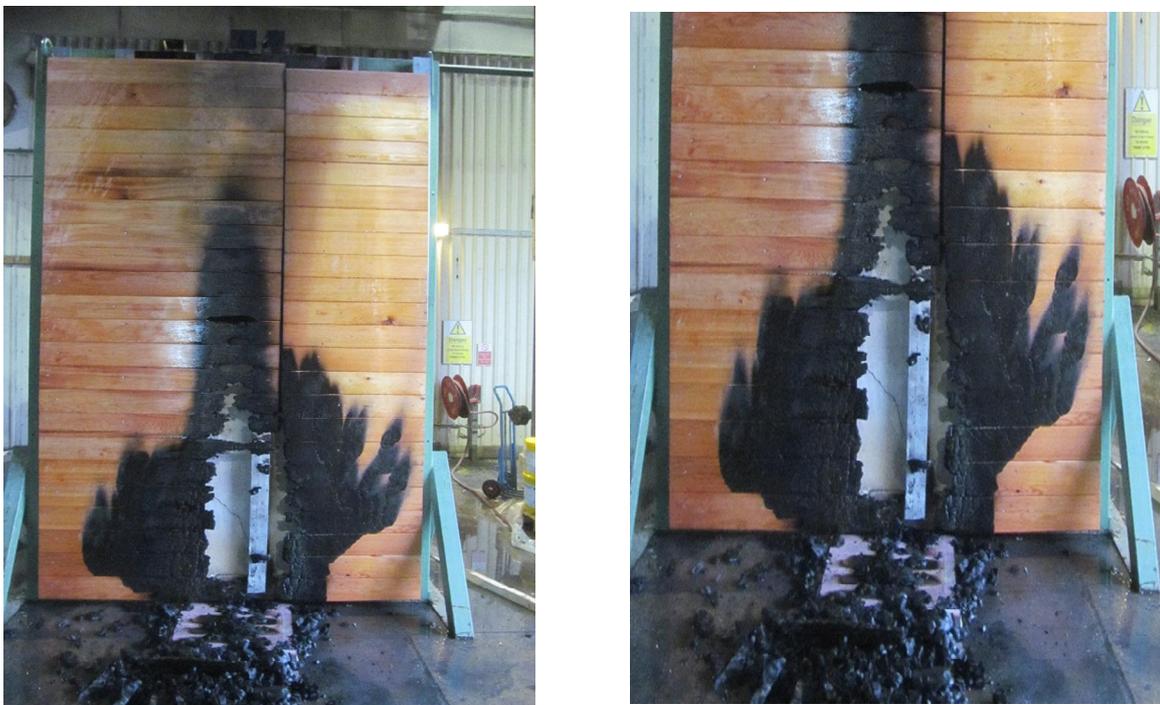
Figure G30 shows the sample after the fire. The timber cladding was consumed over an area of approximately 0.72 m². Discoloration and charring could be observed on the remaining surface of the panels. Detachment of charred parts of the timber cladding could be observed after the fire.

Figure G30 – Post fire observations

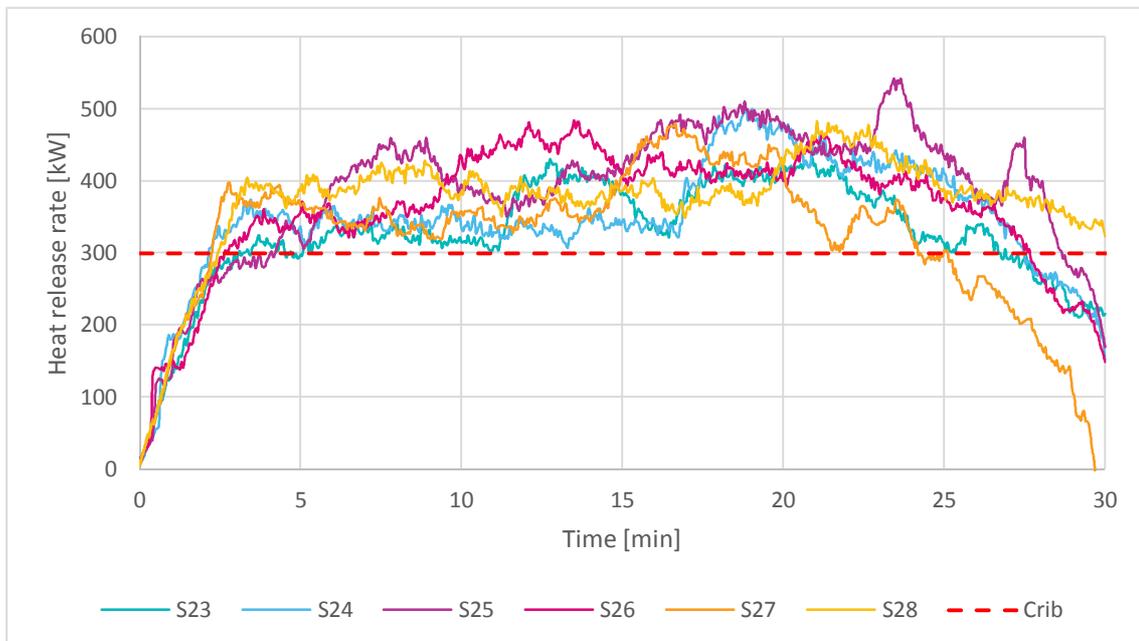
Figure G31 shows the measured HRR for all the individual samples (S23 to S28) compared to the base value for the crib fire source.

Figure G31 – Heat release rate for all samples showing base value of crib

The heat release rate for any given material or product is dependent on the area burning as a function of time. As can be seen from the earlier results, there was a difference between the extent of damage or area burnt between the two nominally identical timber cladding systems, S27 and S28. In these cases, the variations measured are potentially a function of the efficiency of the fixings into the supporting framework, the studs.

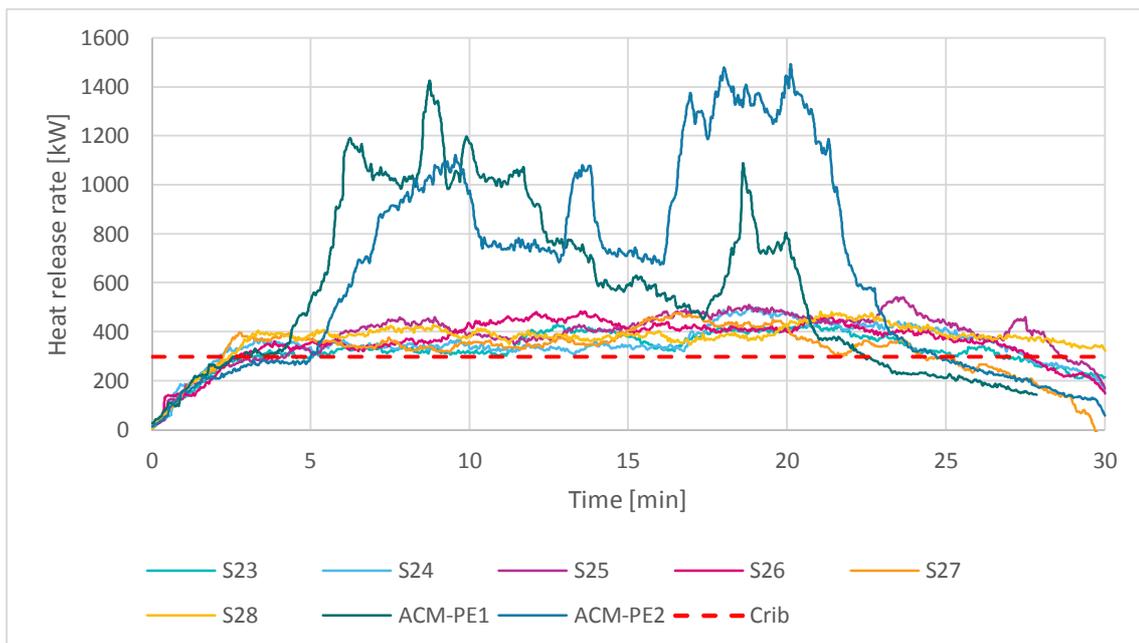
As can be seen from the experimental results, in the case of two of the HPL panels, S25 and S26 (class C – s1, d0; intended for internal use) and one of the timber cladding systems, S27, the fire spread up the full height of the experimental rig consuming the samples. This means that the fire has sustained vertical fire spread beyond the area of direct flame contact produced by the crib ignition source. In each of these cases, the extent of lateral or horizontal fire spread appears to have been constrained by the metal framing system to which the samples were fixed. This suggests that the results in these experiments are particularly sensitive to the mounting and fixing arrangements and in the case of the HPL samples, the location of the vertical joint relative to the crib ignition source. The vertical joint on the centreline of the crib ignition source appears to represent the worst case in terms of penetration of the fire into the cavity.

Figure G32 – Heat release rate for all samples showing base value of ignition source and comparison with PE ACM samples

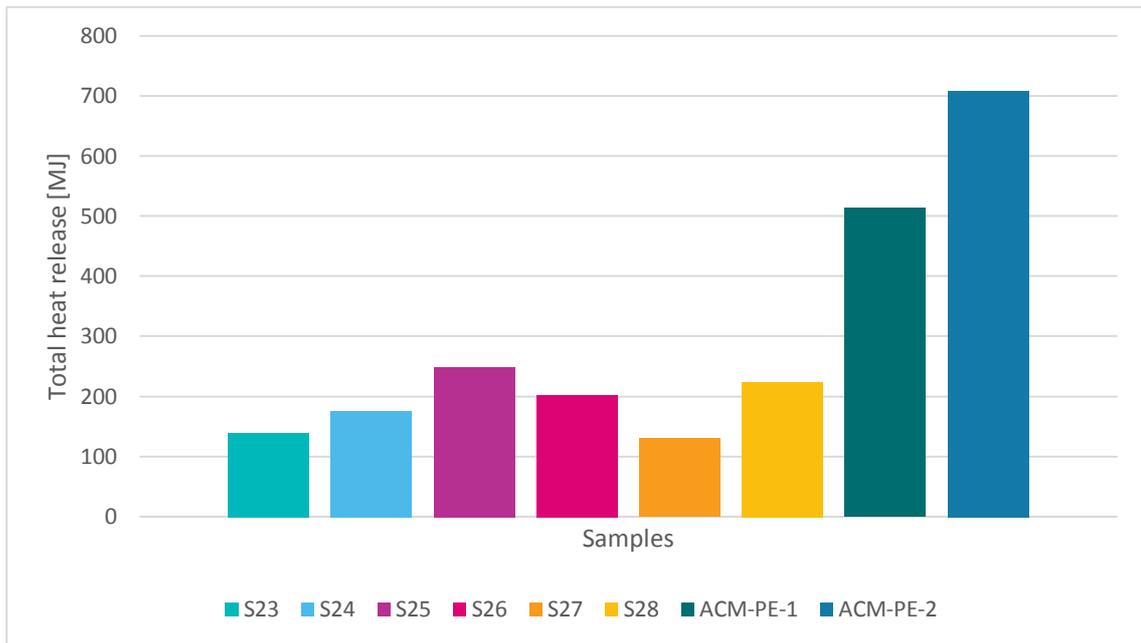
Figure G33 shows the measured total heat release excluding the fire source (≈ 450 MJ) for all the tested samples in comparison with the PE ACM.

Figure G33 – Total heat release for all samples compared with PE ACM samples

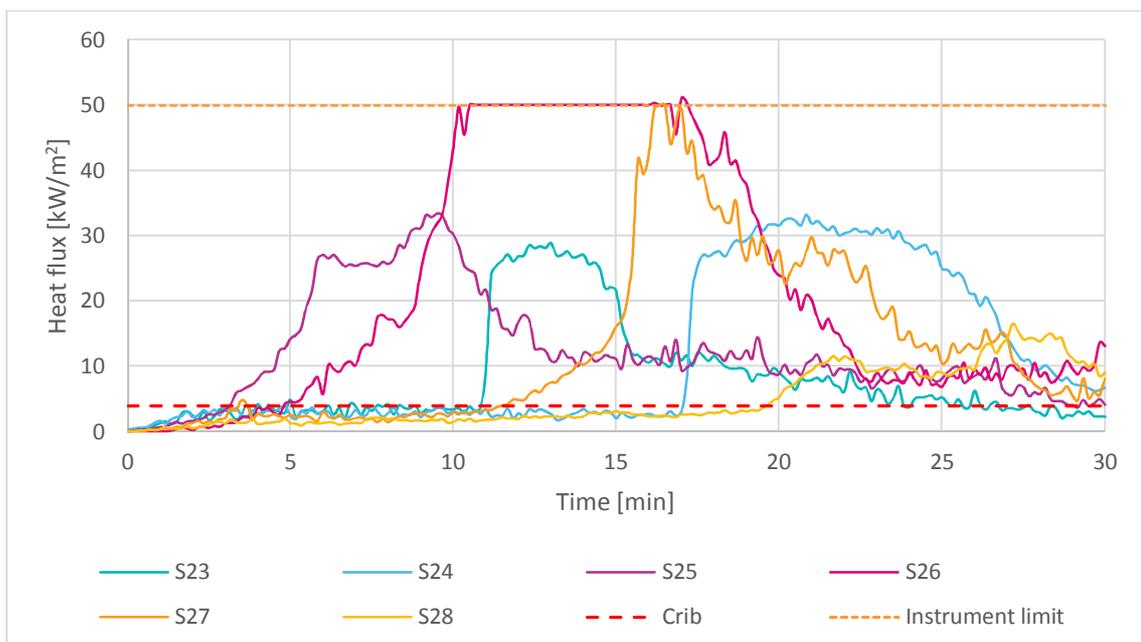
Figure G34 shows the measured value of heat flux on the centre line at a height of 3 m from the ground for all samples. The baseline contribution of the ignition source is indicated on the figure as a constant value of 4 kW/m².

Figure G34 – Measured heat flux for all samples at 3 m from the ground on the centre line

Figure G34 shows a significant difference in the heat flux measurements at the top of the rig for all samples. The values of 50 kW/m² and the termination of the readings are where the maximum capacity of the heat flux meter was exceeded. The primary use of the heat flux measurements was in quantifying the time for the fire to break through into the cavity. The assessment of the heat flux measurements need to consider the issue of break through both in terms of time to breach the cavity and the intensity of the cavity fire once a breach has occurred and the potential impact on any materials contained within the space behind the front panel. The time to break through can be assessed in relation to the measured values and the observed behaviour. The severity of any subsequent fire within the cavity can be related to the temperature measured within the cavity and to some extent, the peak heat flux measured at the top of the sample. As with the assessment of the contribution to fire development, it is important to consider the results relative to the results from a material with a known level of performance. Figure G35 shows the measured values alongside the results from the two PE ACM samples considered as part of the calibration process. The values of 100 kW/m² and the termination of the readings for the two PE ACM calibration samples are where the maximum capacity of the heat flux meter was exceeded. Based on the anticipated fire growth and flame spread for the ACM PE samples used in the calibration programme, a heat flux meter with a higher range (up to 100 kW/m²) was used. For all the other samples, where the fire growth and flame spread was anticipated to be lower, a heat flux meter with a lower range (up to 50 kW/m²) was used to improve the sensitivity of the measurements.

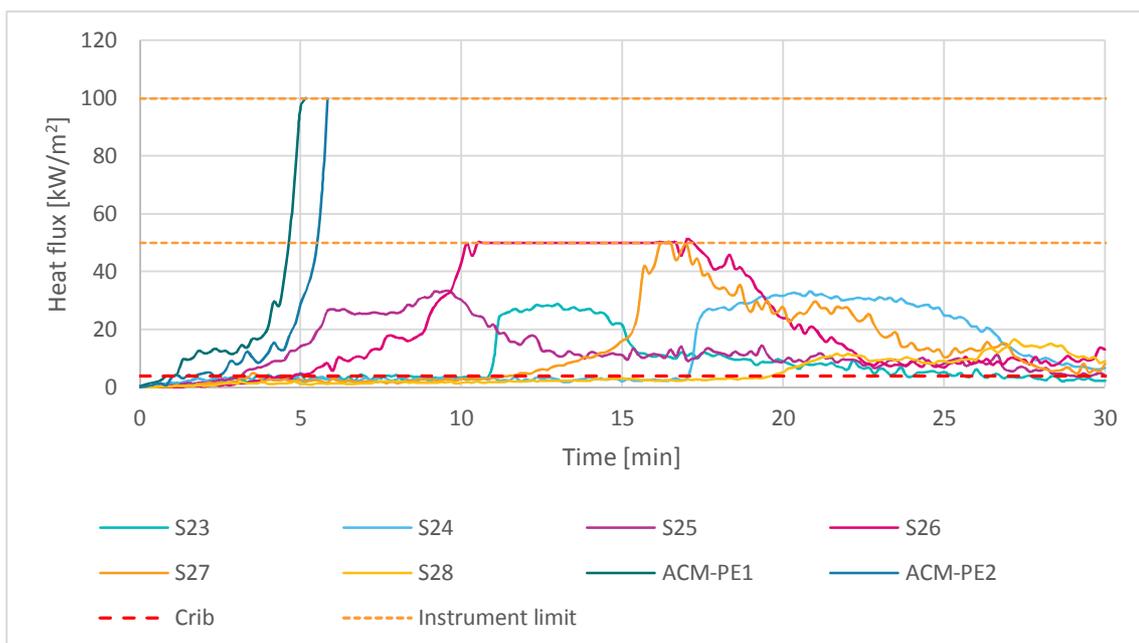
Figure G35 – Measured heat flux for all samples at 3 m from the ground on the centre line

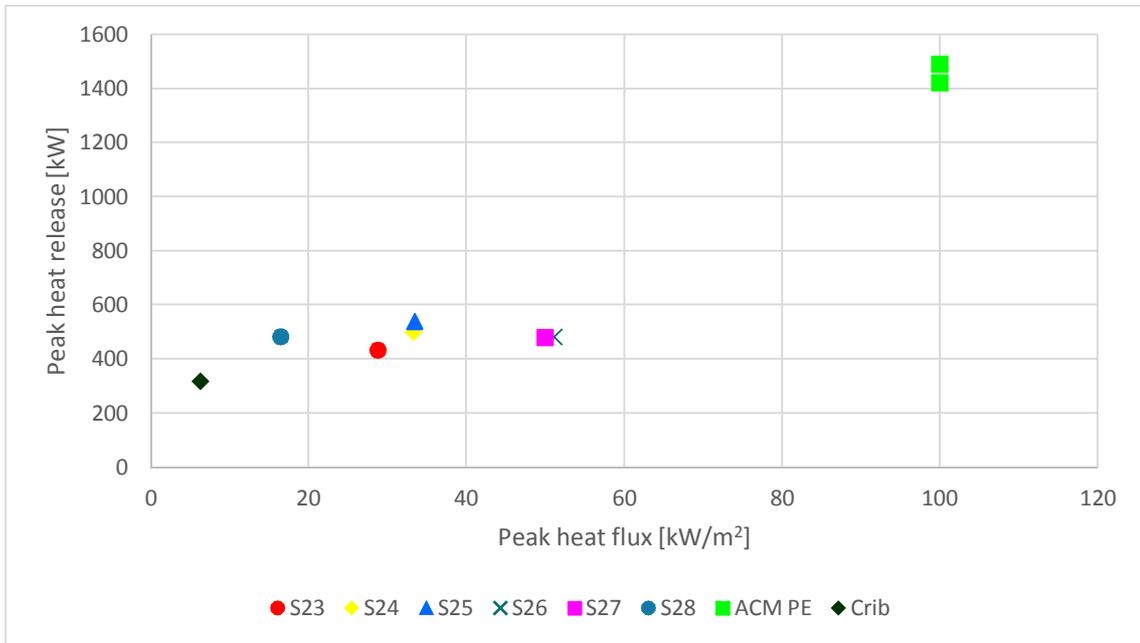
The relative contribution of each sample in relation to both fire growth (peak HRR) and break through into the cavity (peak heat flux) is illustrated in Figure G36. Figure G37 shows the measured peak heat flux and the time to burn through of the panels.

Figure G36 – Results related to measured peak heat release rate and measured peak heat flux including PE ACM panels used for calibration

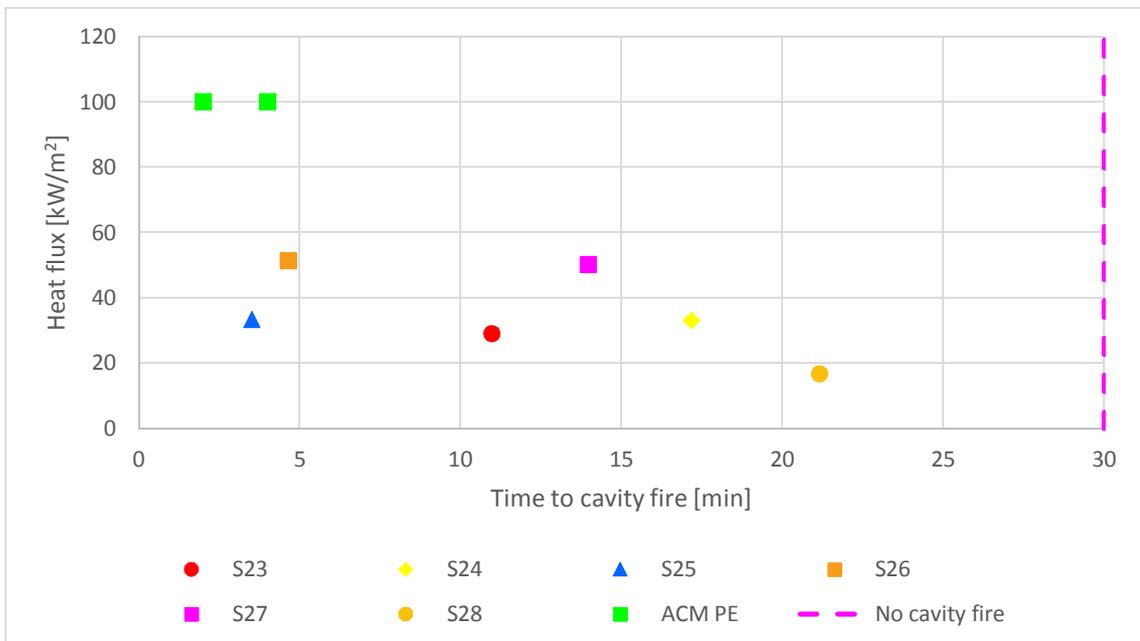
Figure G37 – Comparison of measured peak heat flux and time to burn through of the panels

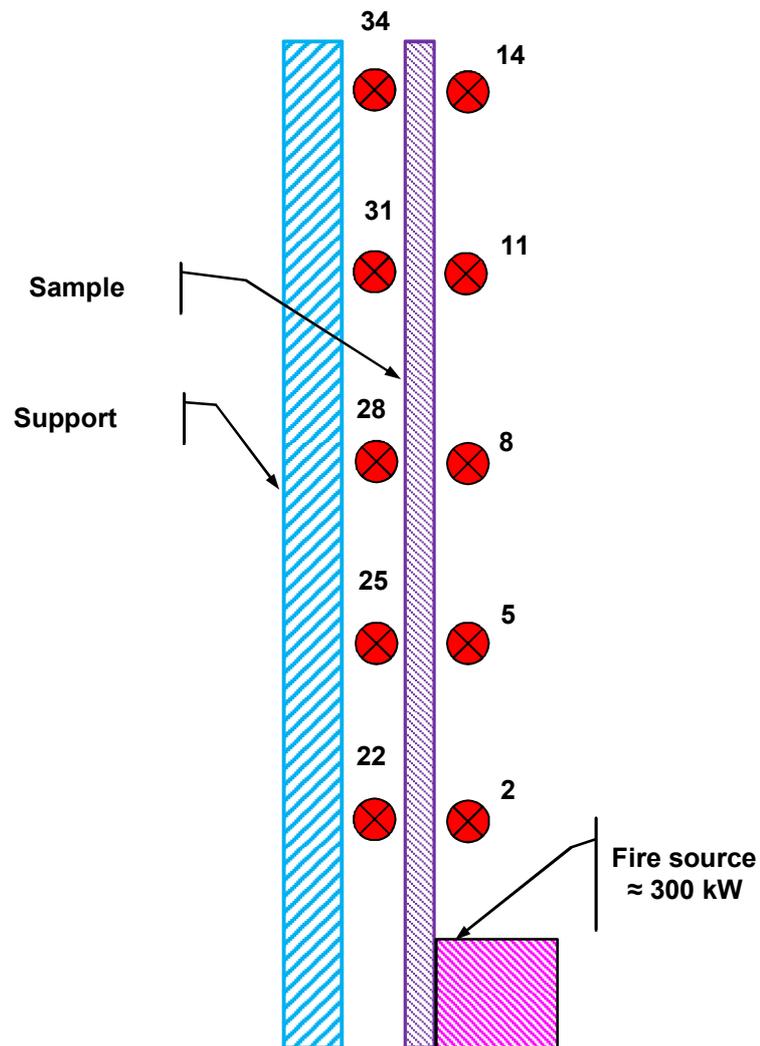
This appendix presents the measured external and cavity temperatures on the central axis of the experimental rig for all the additional samples. The location and designated number of the installed thermocouples is illustrated in Figure G38.

Figure G38 – Thermocouple locations for the samples

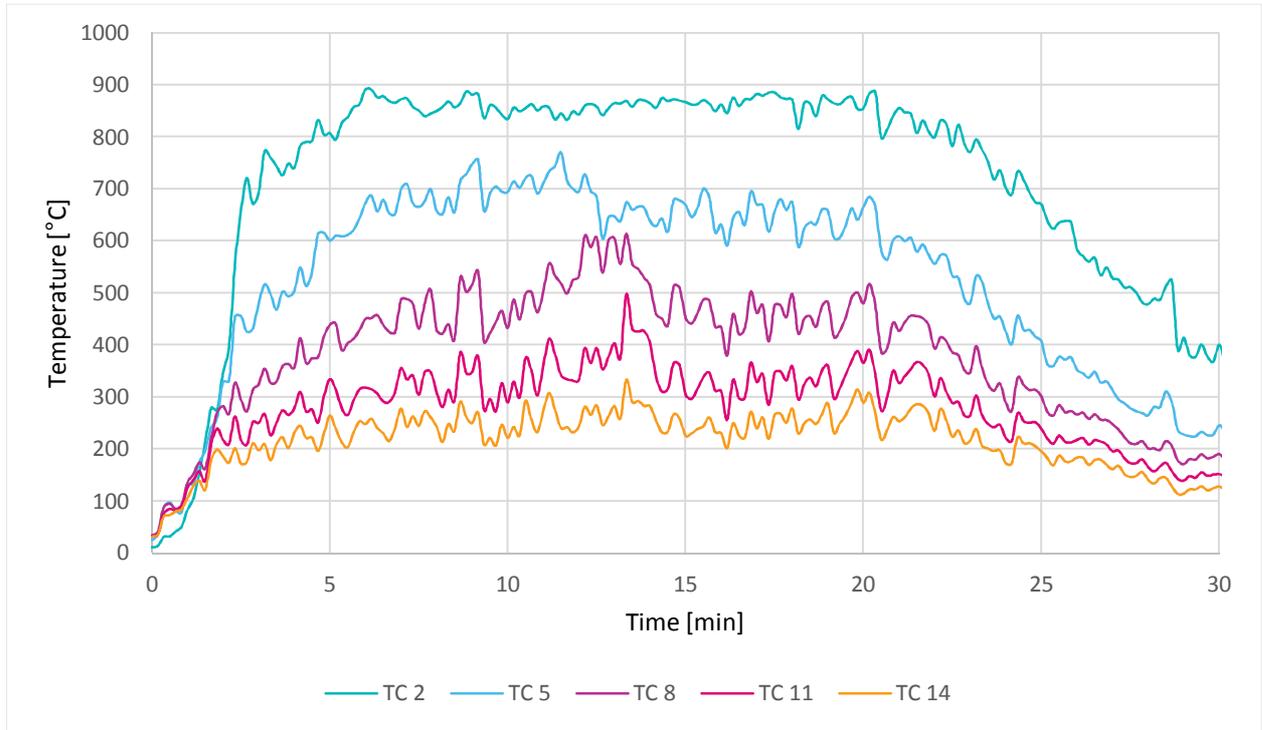
Figure G39 – Temperatures measured on the external central axis for S23

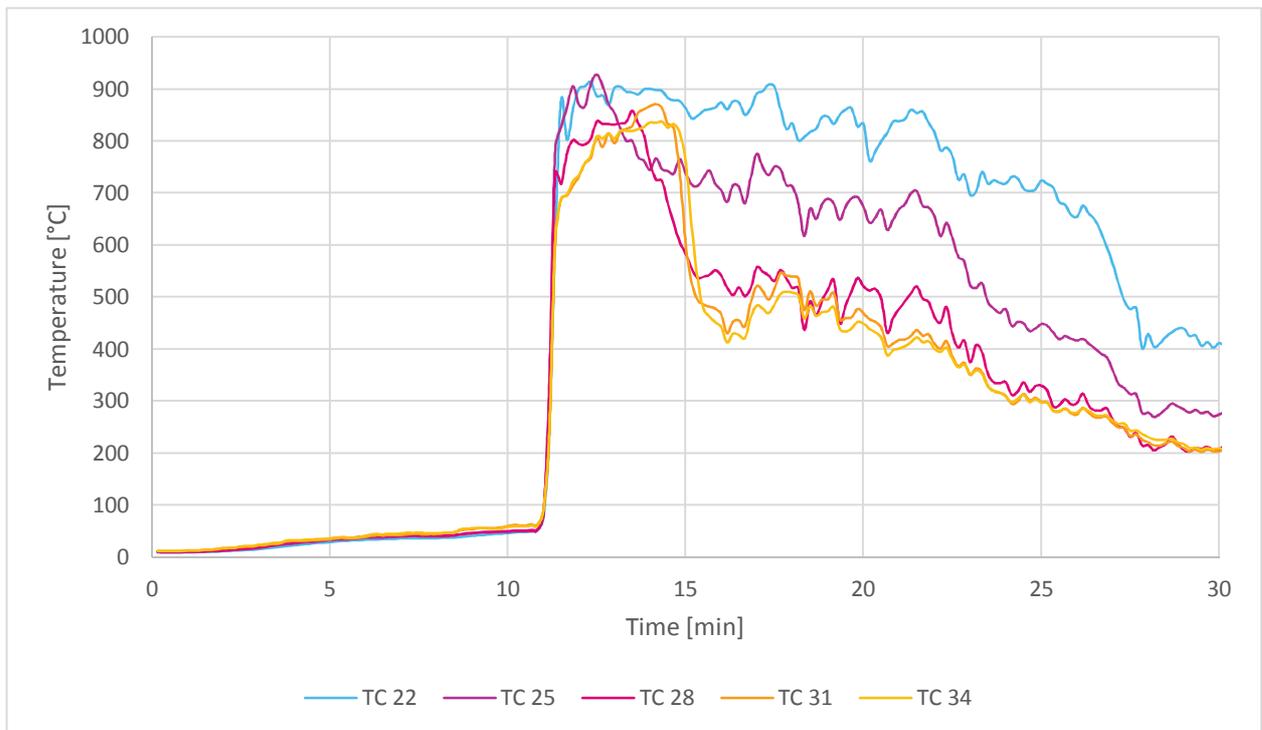
Figure G40 – Temperatures measured on the cavity central axis for S23

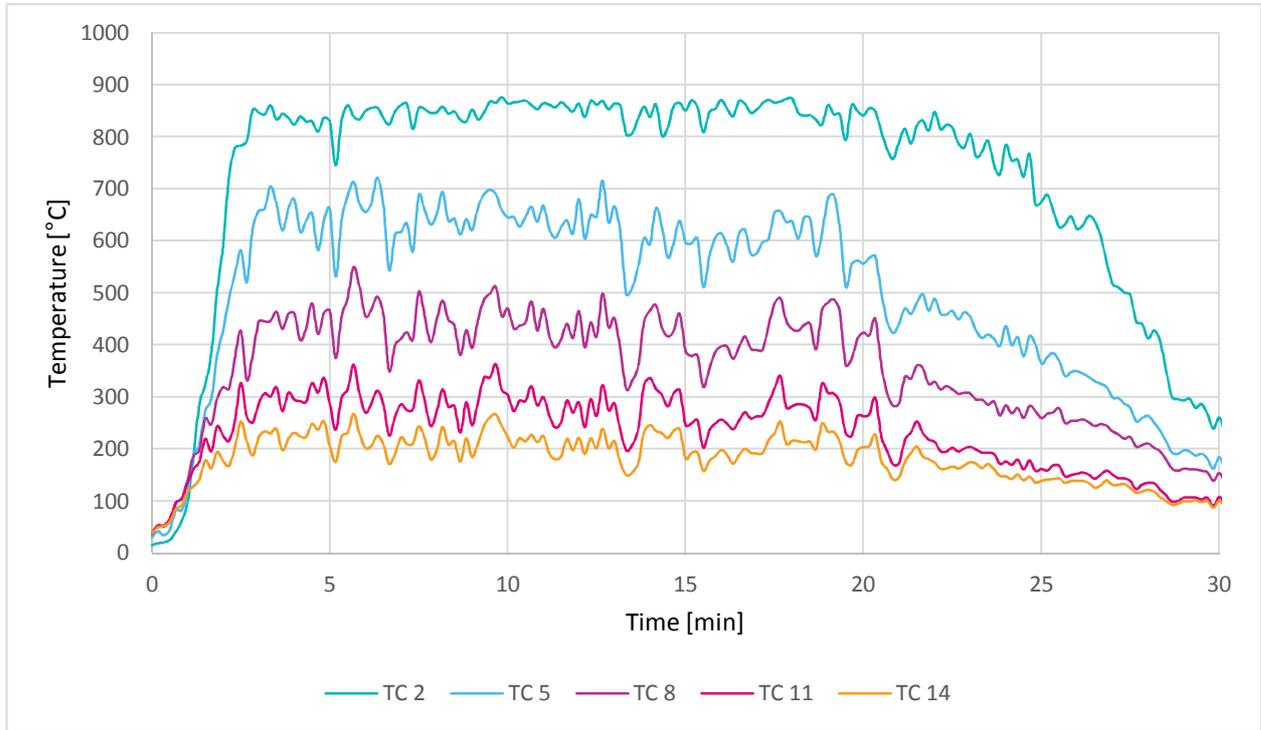
Figure G41 – Temperatures measured on the external central axis for S24

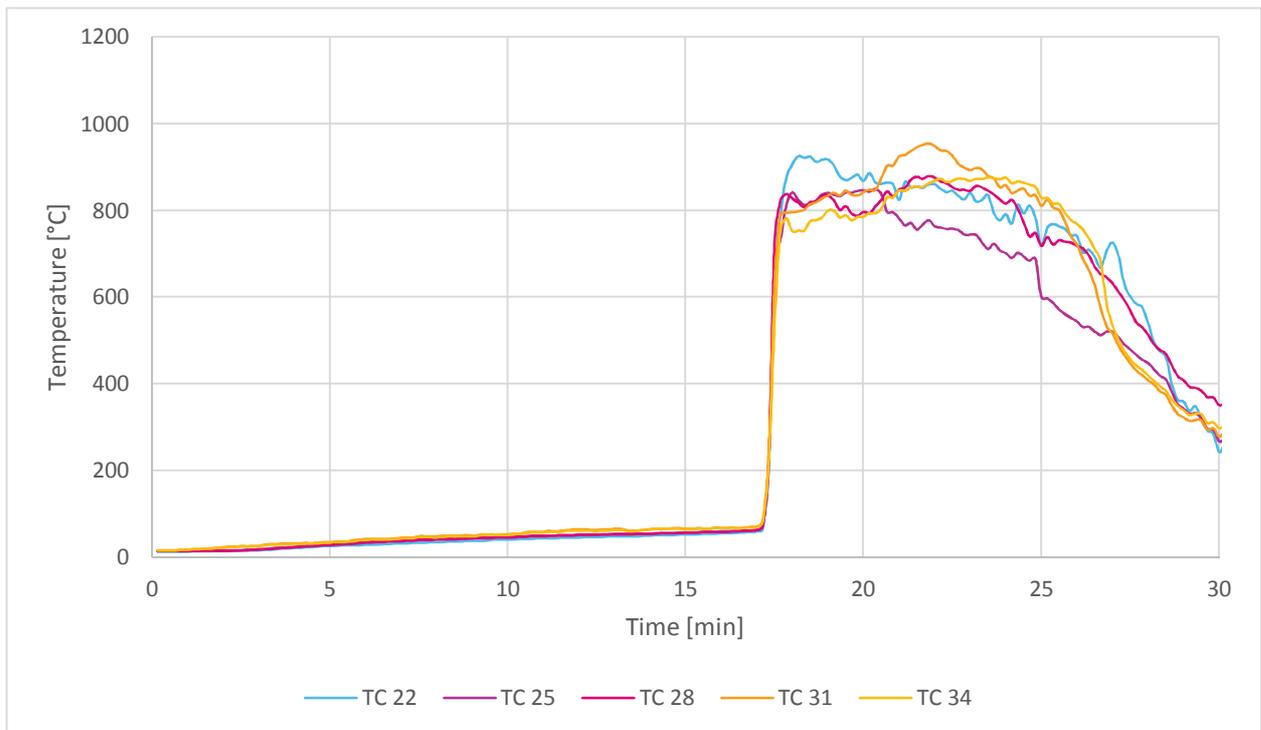
Figure G42 – Temperatures measured on the cavity central axis for S24

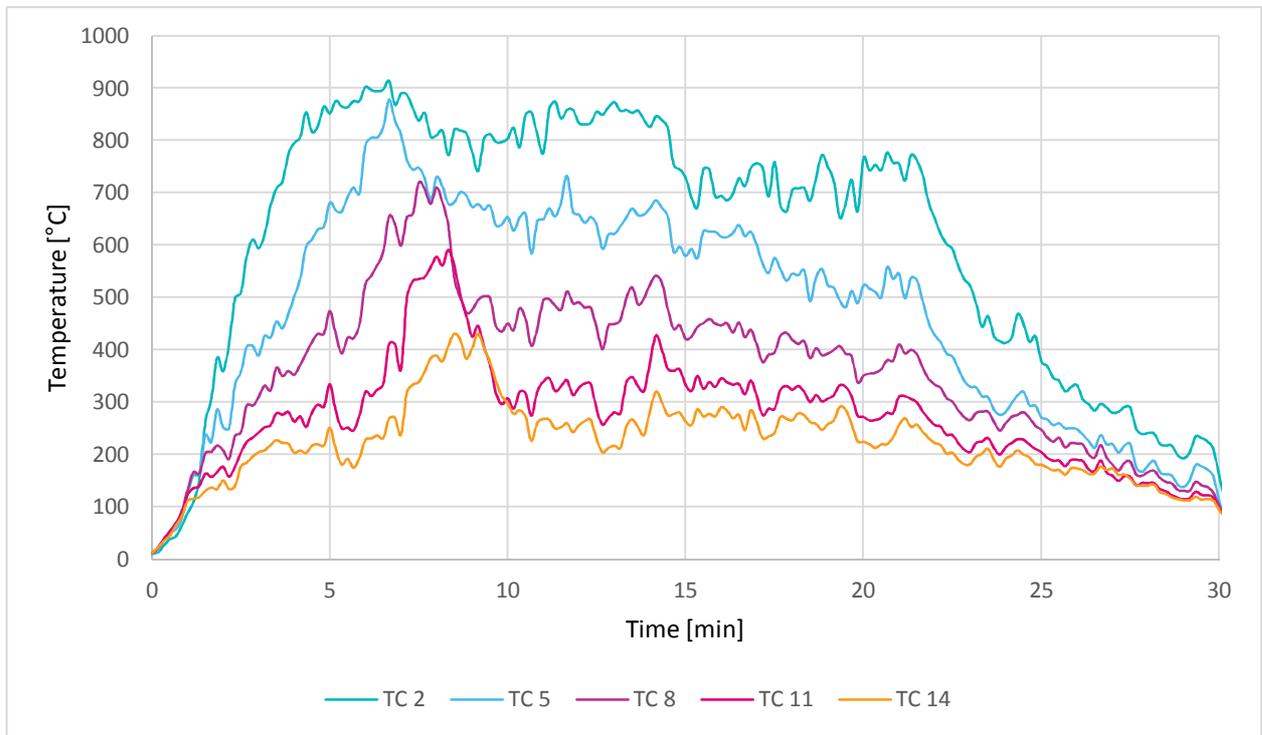
Figure G43 – Temperatures measured on the external central axis for S25

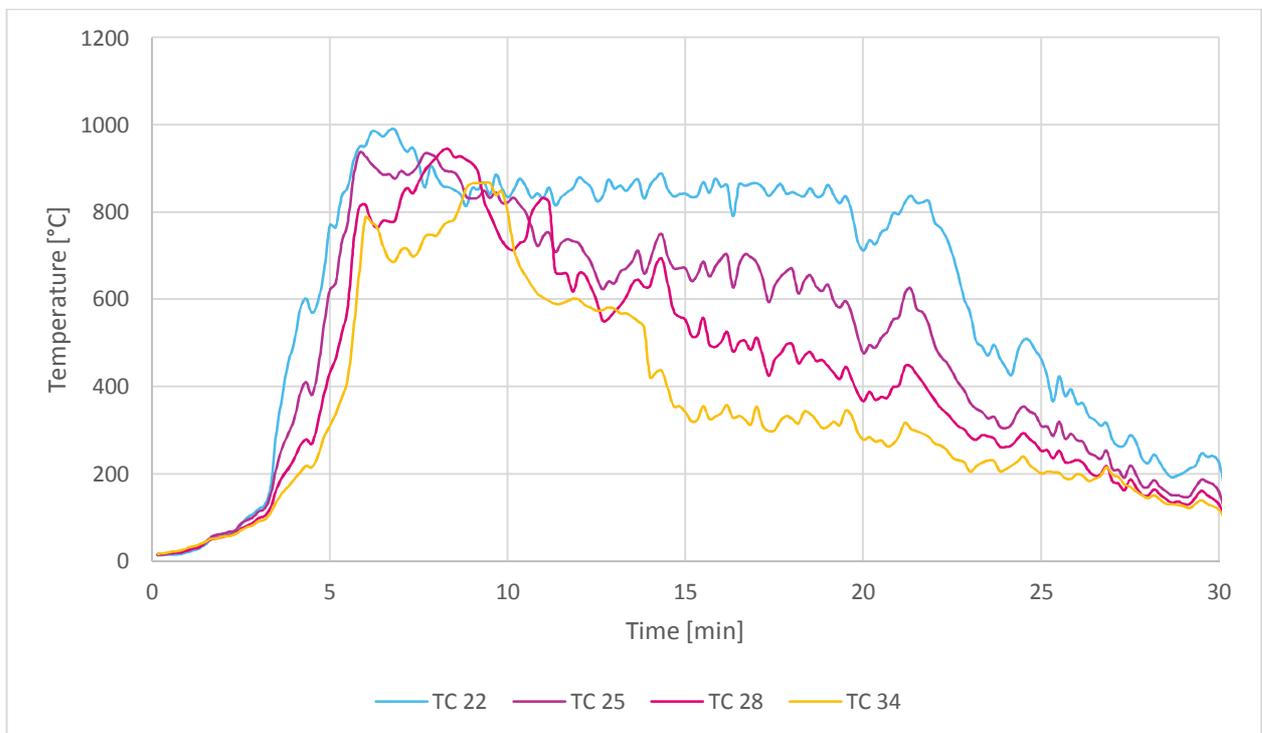
Figure G44 – Temperatures measured on the cavity central axis for S25

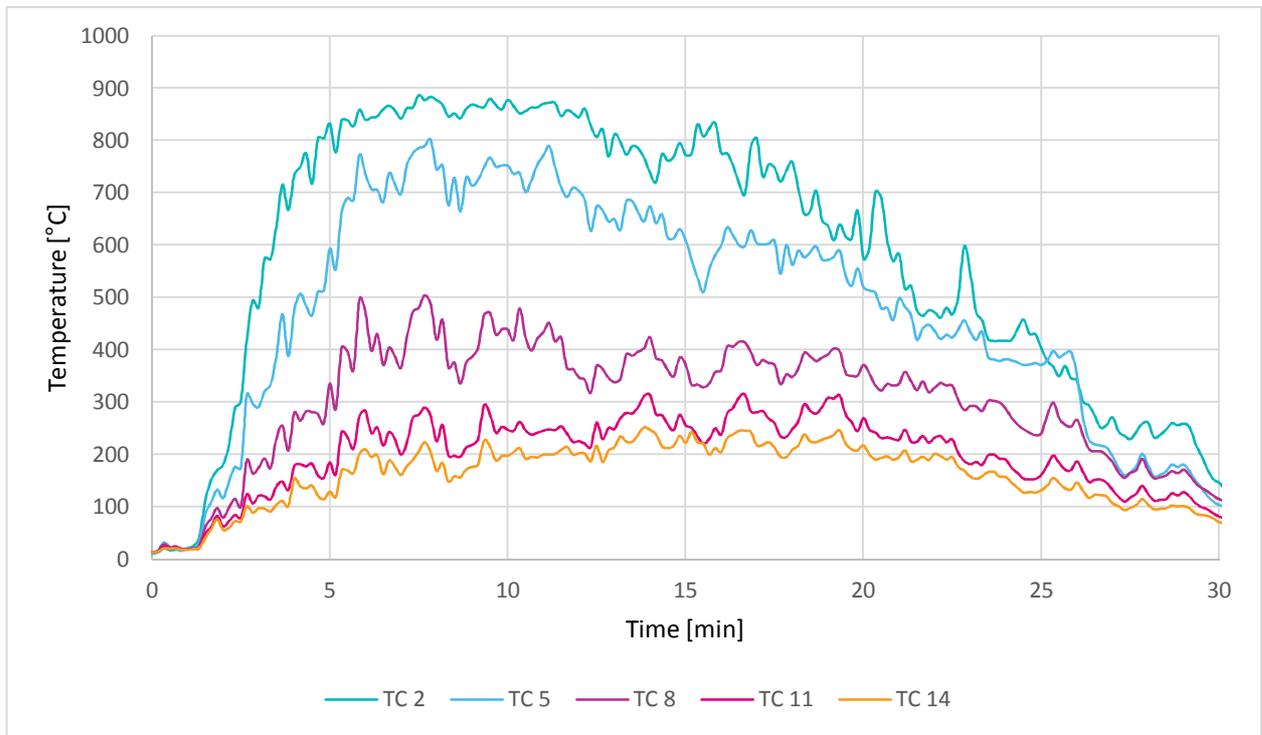
Figure G45 – Temperatures measured on the external central axis for S26

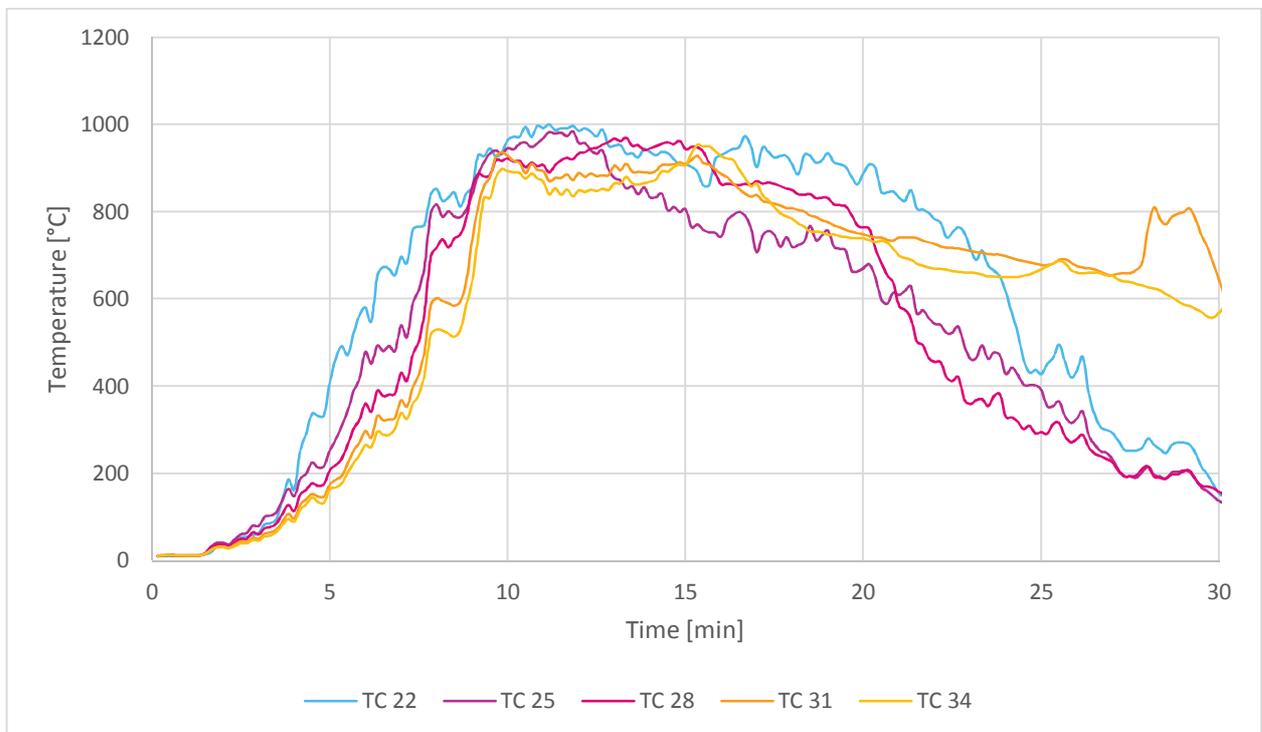
Figure G46 – Temperatures measured on the cavity central axis for S26

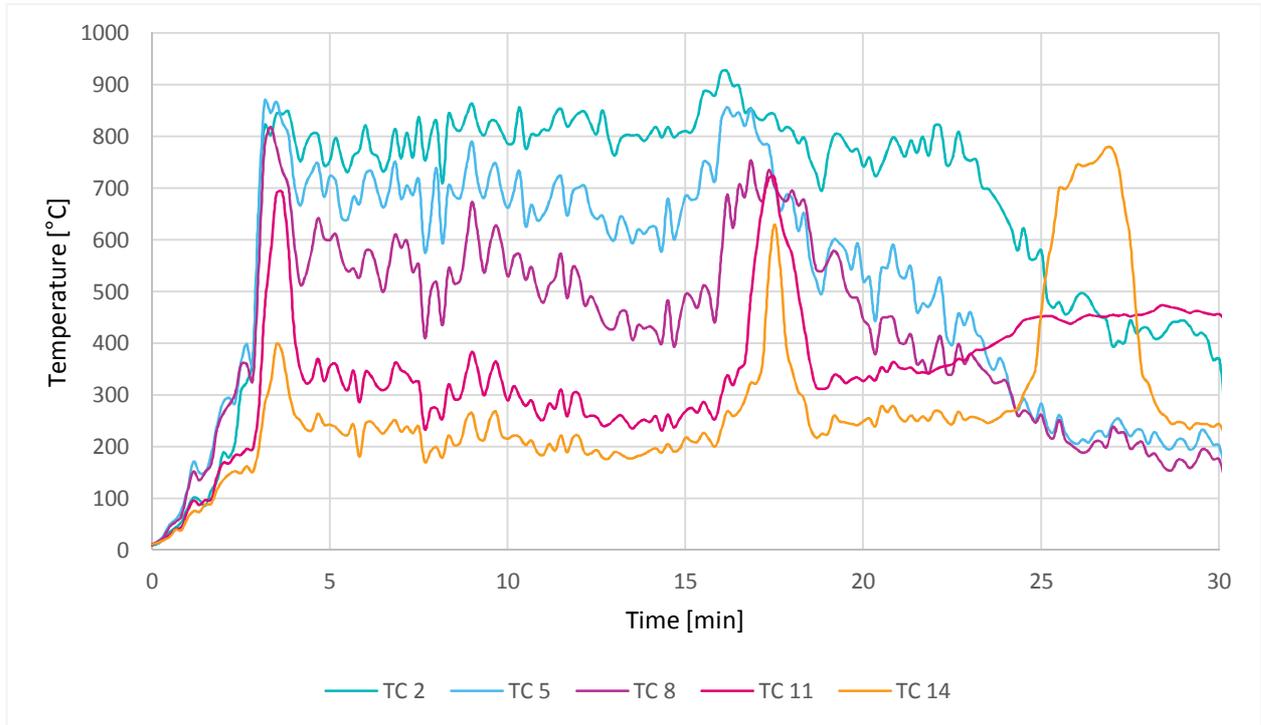
Figure G47 – Temperatures measured on the external central axis for S27

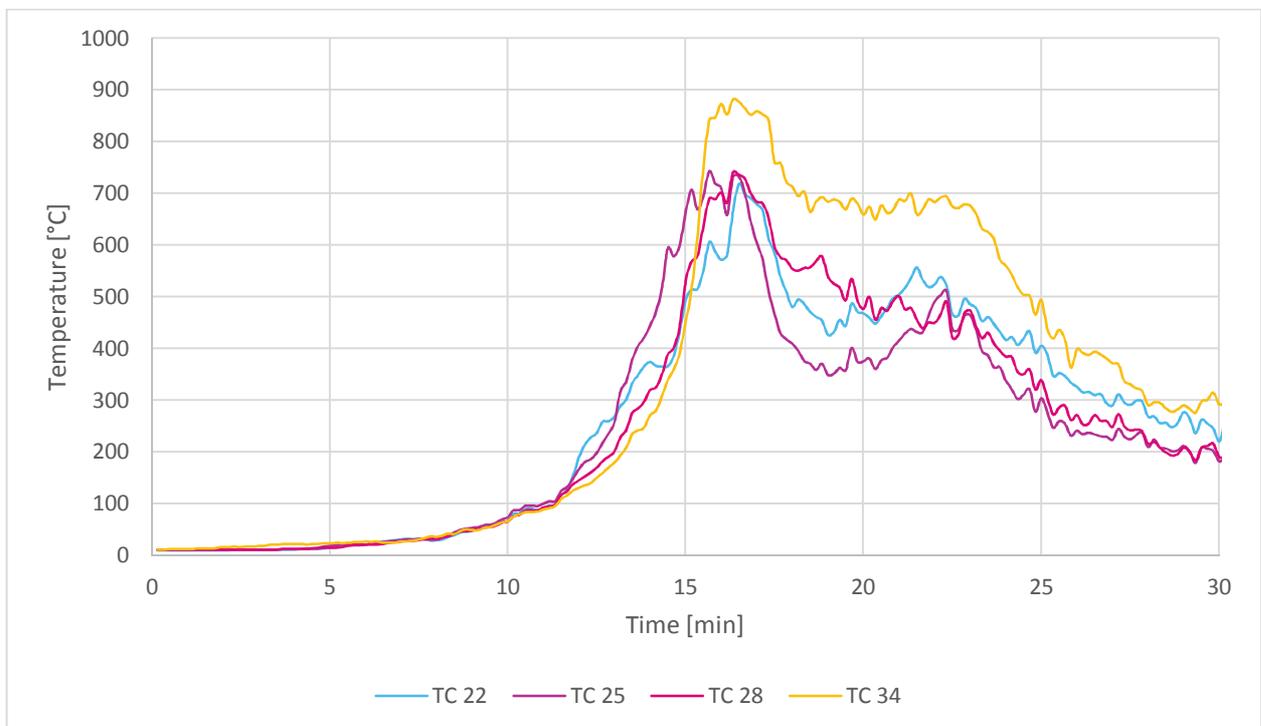
Figure G48 – Temperatures measured on the cavity central axis for S27
