Ministry of Housing, Communities and Local Government Final Research Report

Fire Performance of Cladding Materials Research – Appendix G Supplementary experimental work

MHCLG Contract: CCZZ17A36

Report Number: P111324-1024 (M19D21V3)

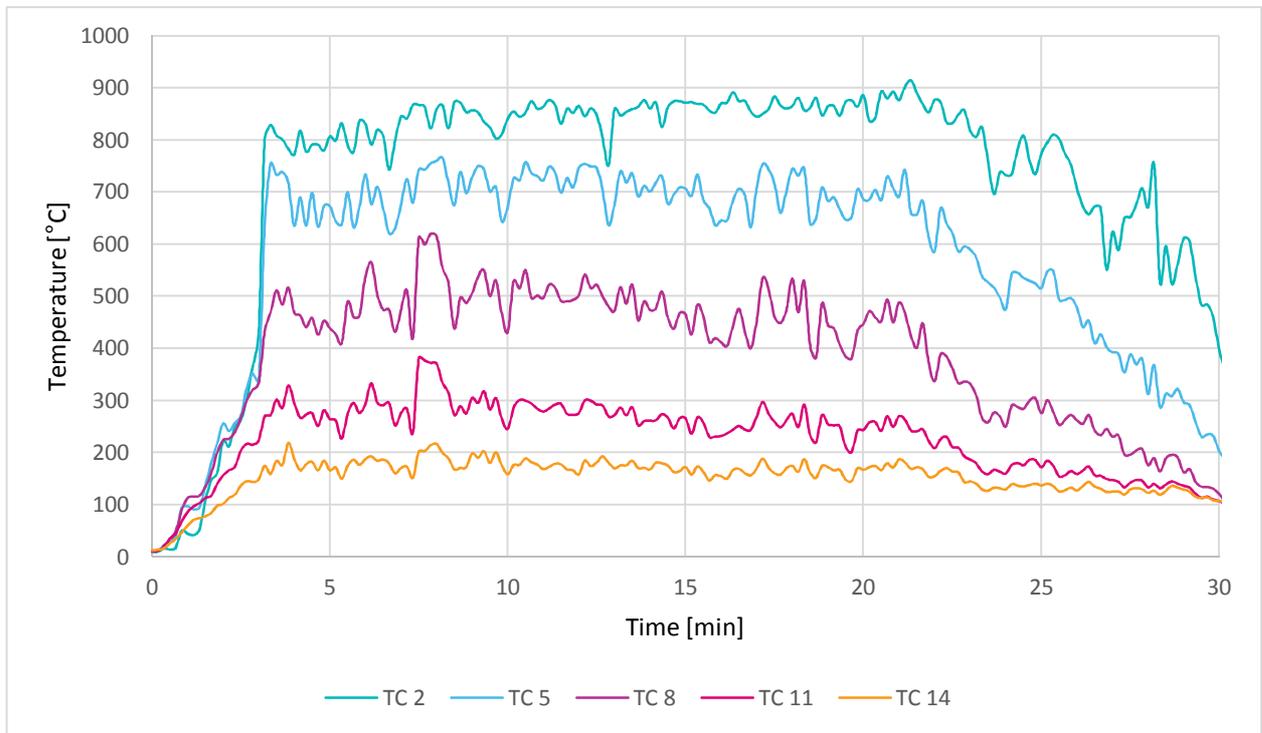
Figure G49 – Temperatures measured on the external central axis for S28

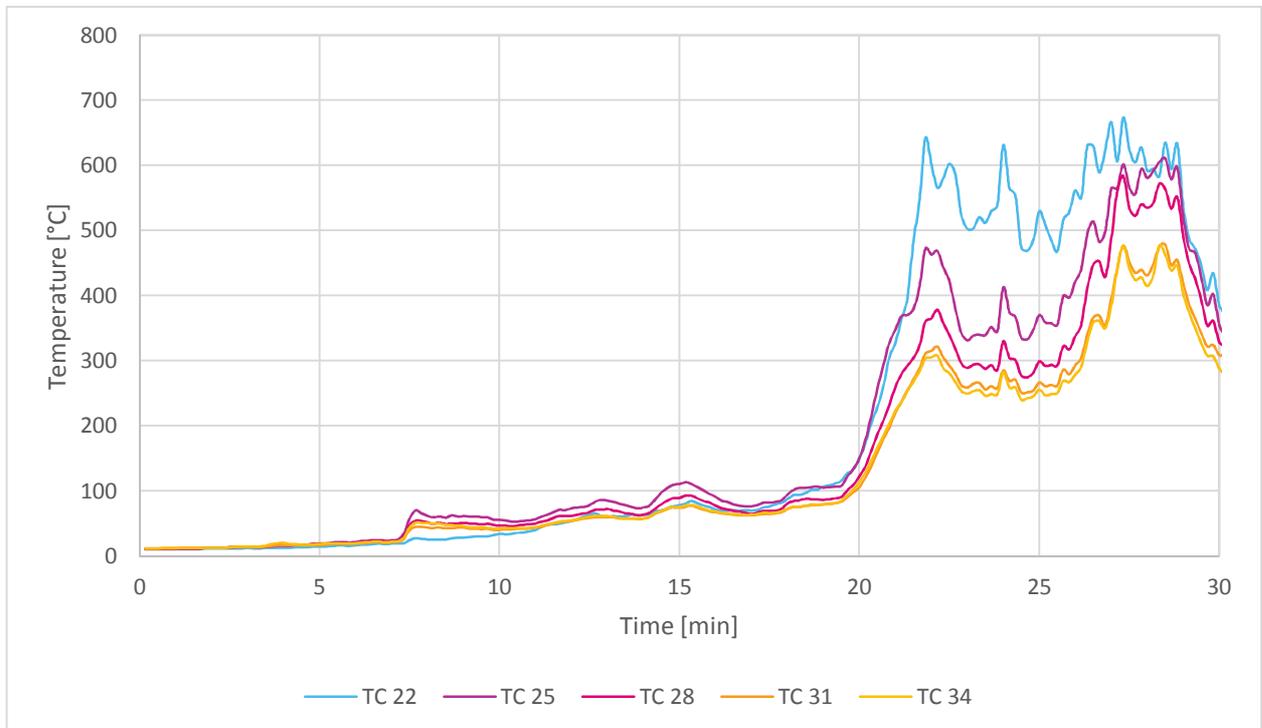
Figure G50 – Temperatures measured on the cavity central axis for S28
