Defence
Safety
Authority

Service Inquiry

Loss of Watchkeeper
(WK043) Unmanned Air
Vehicle over Cardigan Bay
in West Wales

24 Mar 17

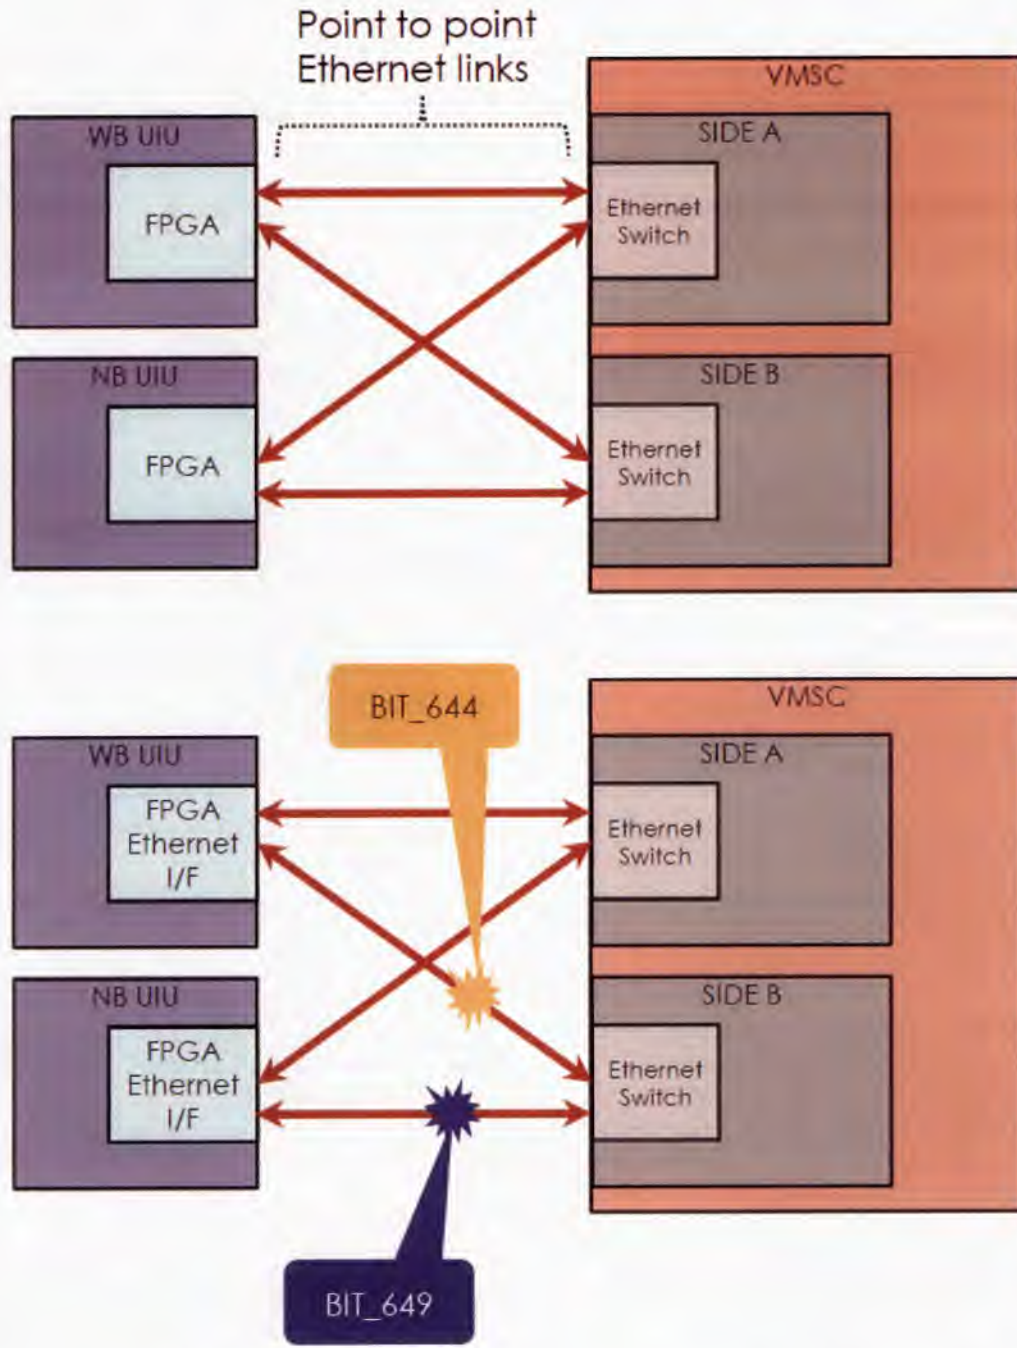
Figure – 15 Diagram of Ethernet connections between VMSC and data-links (UIUs).

1.4.44. Figure 15 is a diagram representing the Ethernet connections in the AV between the VMSC and the data-link interface, the User Inter-face Units (UIUs). The WB and NB UIUs, housed in the Air Data Terminal, are independent and both use Ethernet Field Programmable Gate Arrays (FPGA) to connect to the independent sides of the VMSC; a total of four connections. The BIT codes 644 and 649 mean no Ethernet connection to the data-link UIU has been established to one side of the VMSC, Side B as illustrated.

1.4.47. When the active Side A of the VMSC failed over to the redundant Side B, all control of the AV was transferred to Side B. However, Side B was in standby mode and had not received the command informing it that the AV had taken off and that it was at altitude over Cardigan Bay. Consequently, there were no active commands from Side B to the flight control system to keep the AV in level flight; this is supported by the WCA presented in the last minute of flight relating to servos and ADU, as Side B was processing data that should not be correct if it was still on the ground (see Figure 15).
