ROYAL AIR FORCE

WORKING PAPER 08/03

RAF SCAMPTON LAND QUALITY ASSESSMENT PHASE 1 - DESK STUDY

VOLUME 1 (OF 2): REPORT

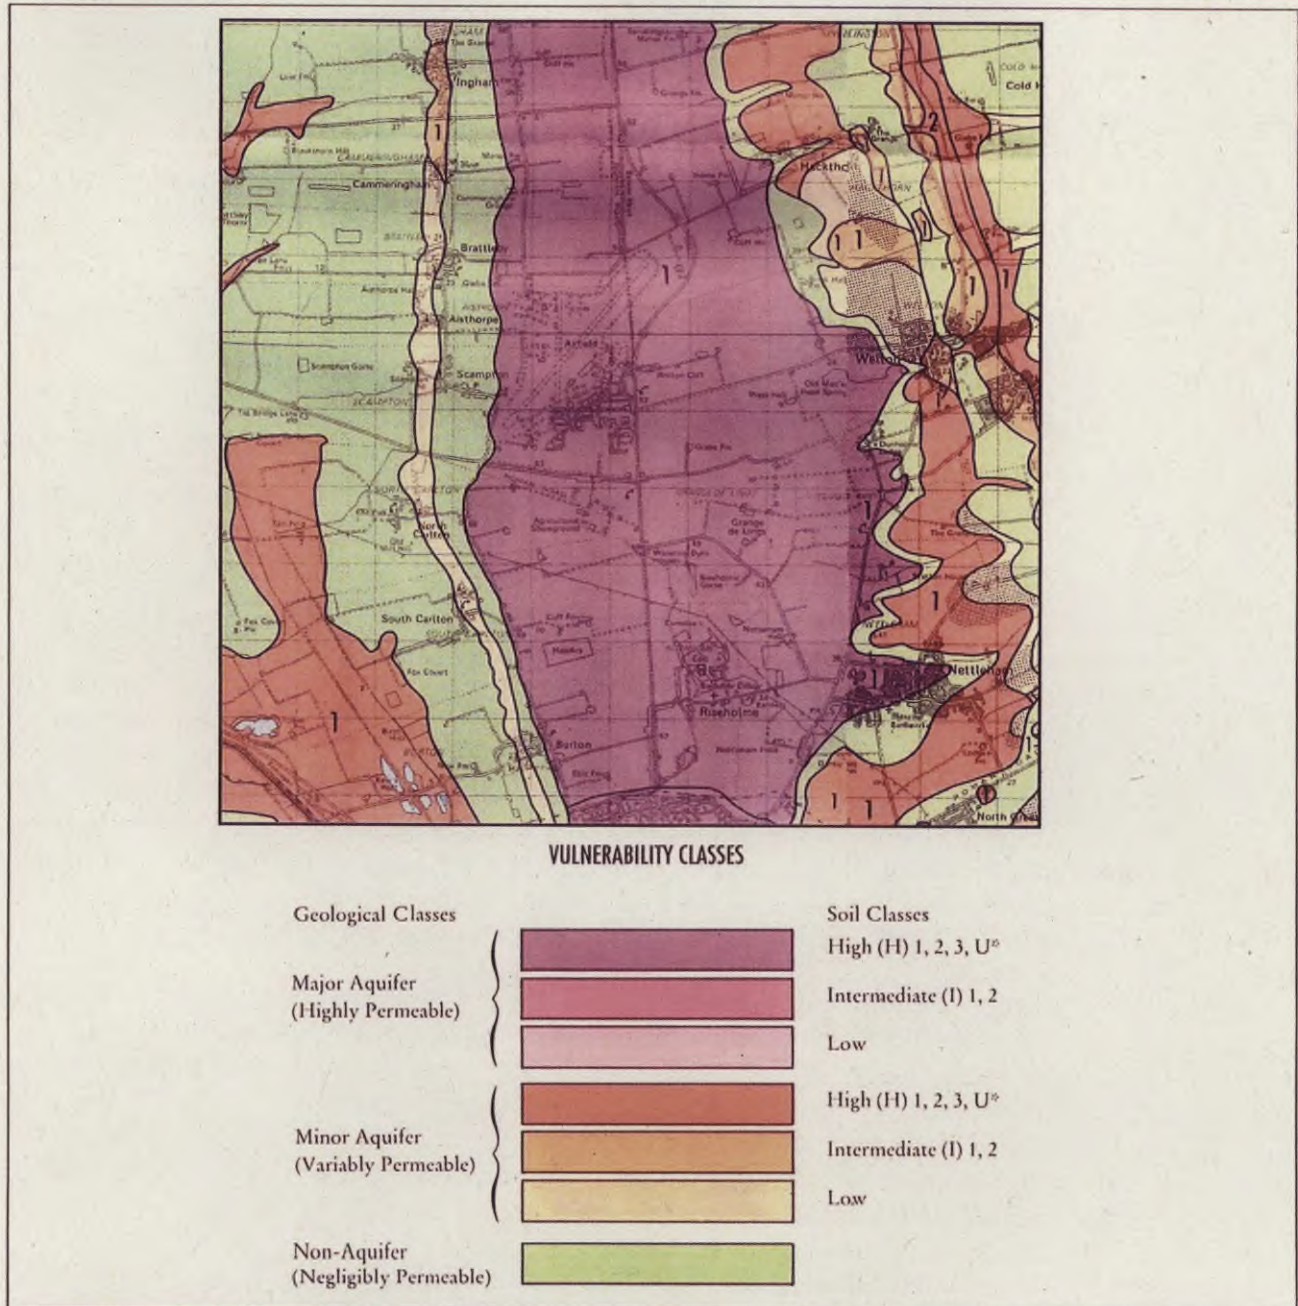
50. Groundwater Vulnerability. The published 1:1 000 000 Groundwater Vulnerability Maps Sheets 18 & 19 (Figure 3) show that the entire site is located on a major aquifer overlain by soils with a high leaching potential (H1). Major aquifers are defined as highly permeable formations usually with a known or probable presence of significant fracturing. They may be highly productive and able to support large abstractions for public supply and other purposes. A soil classified as having a high leaching potential describes soils with little ability to attenuate diffuse source pollutants and in which non-adsorbed diffuse source pollutants and liquid discharges will percolate rapidly to the aquifer below.

Figure 3. Groundwater Vulnerability Maps (Sheets 18 and 19) showing RAF Scampton situated on a Major Aquifer with H1 class soils.

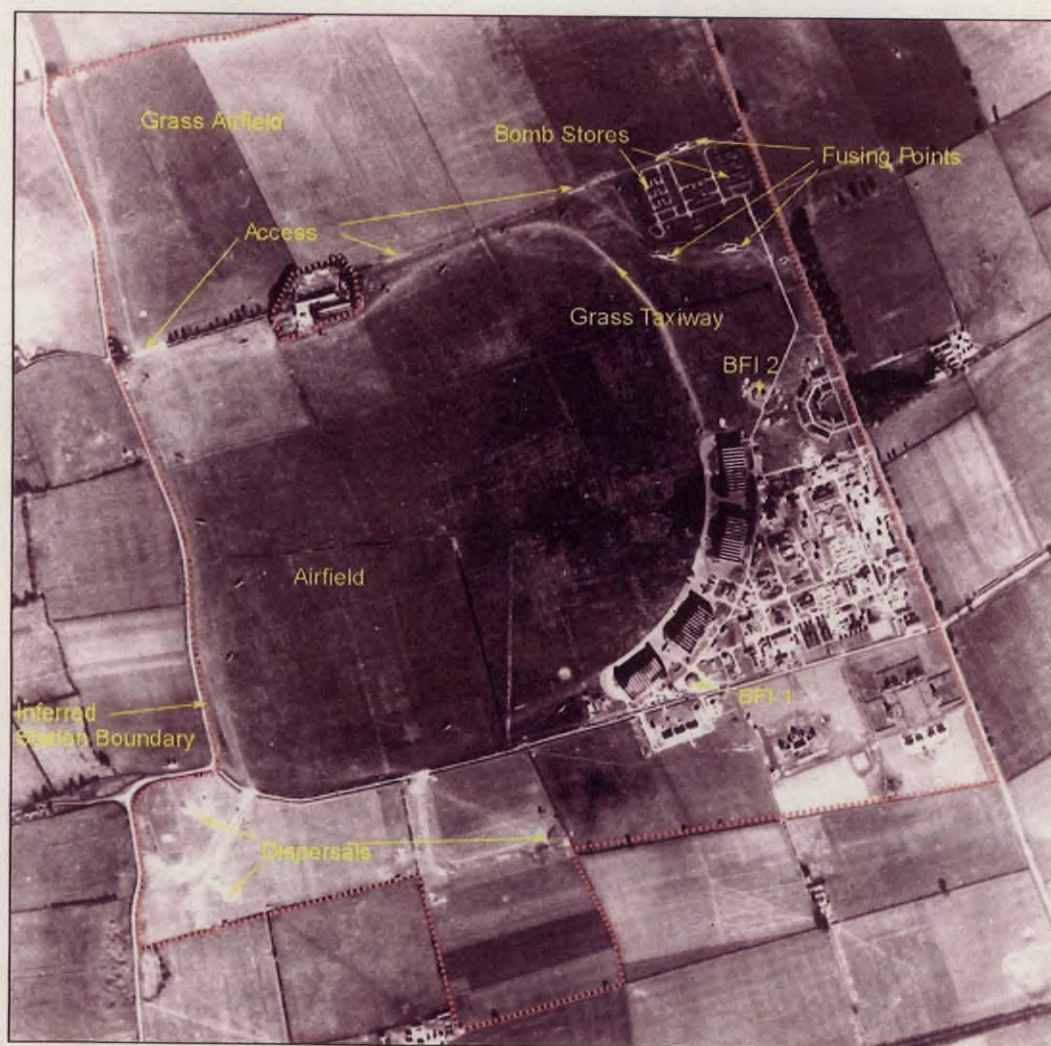
72. An aerial photograph (Figure 8) taken between 1939 and 1942 shows the site boundary extended to the north. There can also be seen the addition of three fusing points adjacent to the bomb stores. It also shows the expansion of the landing ground to the north and south-west of the site, including the addition of two dispersal branches south of Pollyplatt Lane. A grass taxiway route is also established around the old 1939 perimeter margin. Loss of hedgerow segments and wearing of the turf at two points could indicate access points into the fields to the north of Aisthorpe House, which was possibly being used as a runway.

Figure 8. RAF Scampton between 1939 and 1942.

73. There are scattered deposits of unidentifiable materials surrounding the BFI situated to the north of the technical site. There are also similar deposits of unidentifiable materials

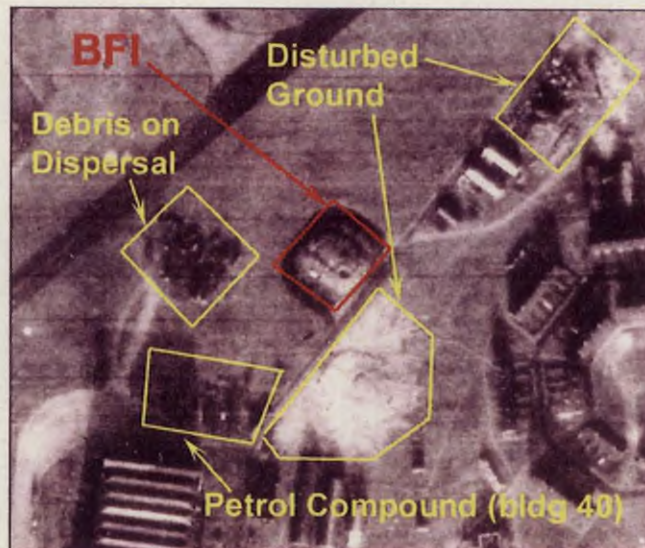
Figure 13. Aerial Photograph of BFI 2 in 1946.

78. The 1946 aerial photograph (Figure 13) shows areas of disturbed ground just south of the BFI and approximately 50m north-east of the BFI is the Air Ministry Works Department (AMWD) compound, which is most likely a contractors yard. Also, unknown debris is apparent on the dispersal 20m east of the BFI, which appears connected to the northern C-Type hangar by a path.

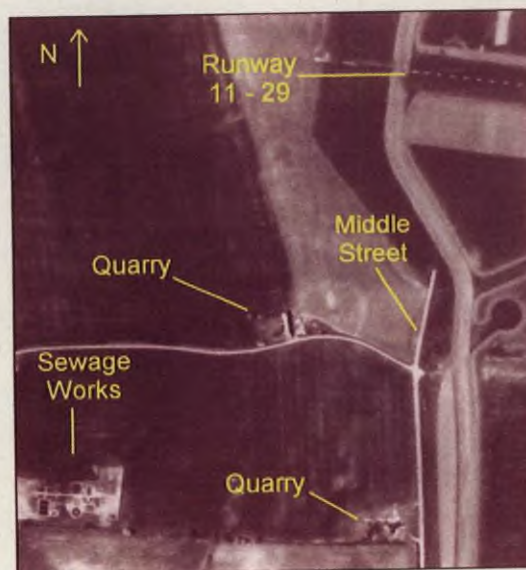
81. The 1948 aerial photograph shows two small areas of disturbed ground located approximately 10m and 50m from the western site boundary, with access via paths from Middle Street (Figure 16). The areas were previously marked on the WWI site plan as old quarries. The old quarries could potentially be the site of fly tipping and also burning activities. This photograph also shows the location and extent of the sewage works.

Figure 16. Ground disturbance at the location of the two quarries in 1948.

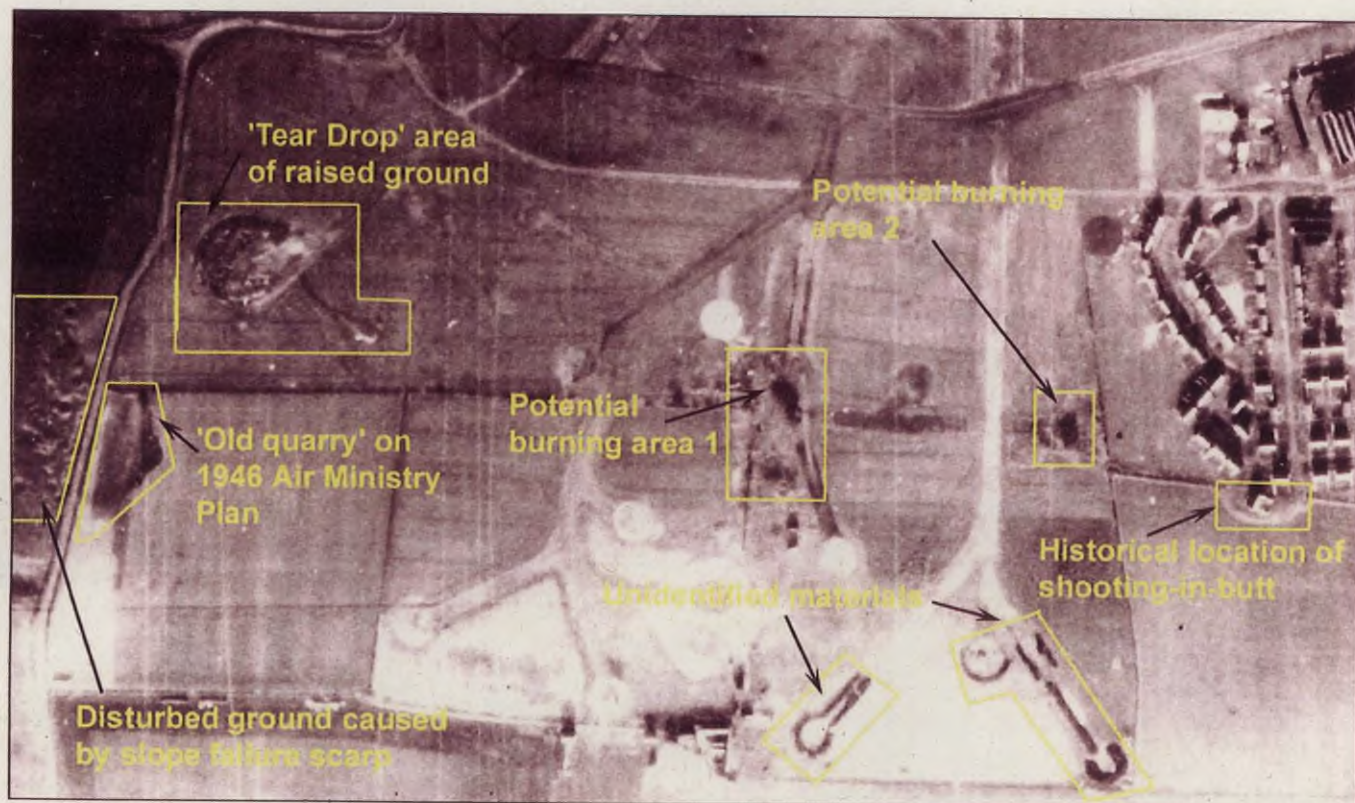
82. The 1954 Aerial photograph (Figure 17) shows continued disturbance in the south-west dispersal area. A 'tear drop' shaped area still displays evidence of ground disturbance in the location of the areas identified in the 1948 aerial photograph (Figure 14). It is possible that this location was used for the localised tipping of station waste as a track is clearly visible leading to the disturbance.

Figure 17. Areas of potential concern identified on the 1954 aerial photograph.

83. There may also be an additional smaller 'off-shoot' mound emerging to the south-east of the 'tear drop' mound. The three dispersal limbs of the eastern branch (bottom right of Figure 17) have some dark unidentified material(s) lining the hardstanding margins. A number of new married quarters in the far right of the picture have been built over a 1942 dispersal branch and the WWII Shooting Butt.

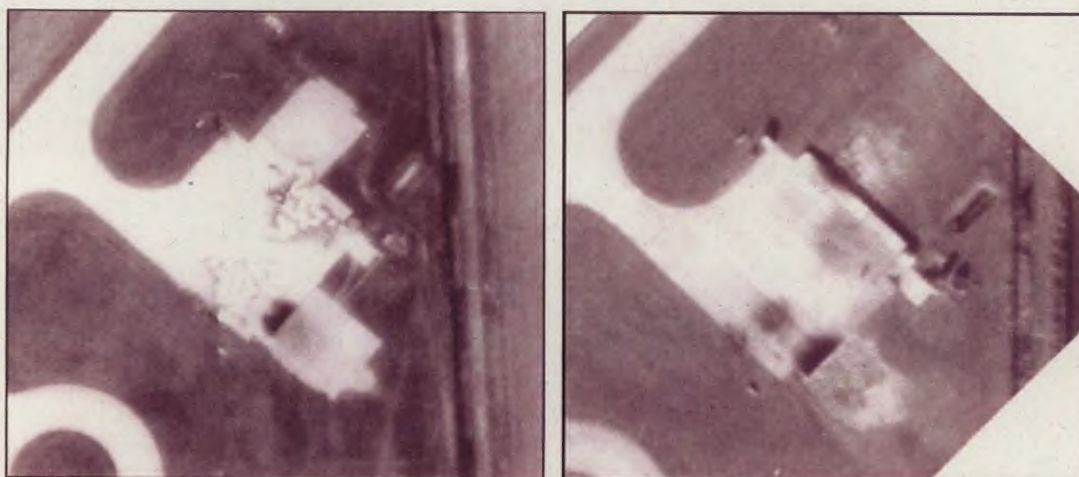
89. Aerial Photographic information and F540 records depict no significant changes to the site infrastructure between 1963 and 1971. The 1971 aerial photograph shows Vulcans at the ERP. There is a black staining on the hardstanding to the rear of the aircraft, which is likely to be soot from the engines exhaust. The mottled areas of grass beyond probably results from the scorching hot exhaust emissions (Figure 19).

Figure 19. Aircraft at the ERP.

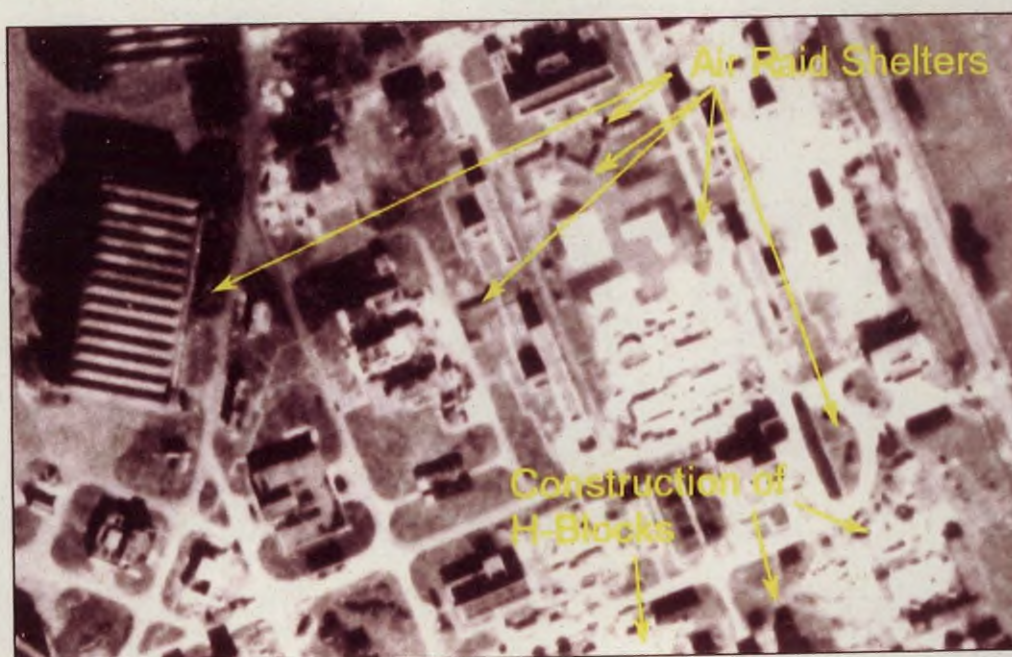
98. The historical aerial photograph taken between 1939 -1942 shows a number of independent ARS to be present dispersed around the RAF Scampton technical site (Figure 23). The ARS are generally of Stanton-type or larger accommodating up to 100 people.

Figure 23. Aerial photograph of RAF Scampton technical site with several ARS annotated.

99. On the 1948 aerial photograph many of the War time Air Raid Shelters are no longer seen indicating they were removed shortly after WWII. Historically old Air Raid Shelters, when demolished, were backfilled with any available material. This may have led to

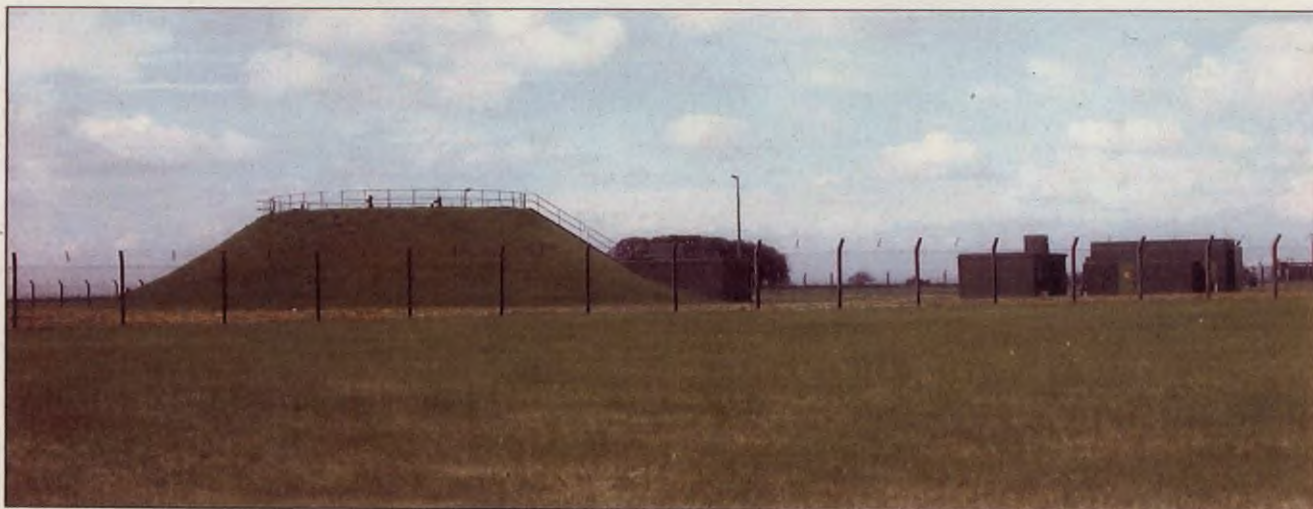
115. Current Aviation Bulk Fuel Installations (BFIs). At present RAF Scampton has one operational BFI, listed as BFI 7 (Figure 25). The installation has always been used for the storage of AVTUR with a nominal capacity of 1 250 000 litres and was constructed for NATO in the 1980s. The installation was refuelled from the Government Pipeline and Storage System (GPSS), which entered the site from the west via the Pipeline Receipt Enclosure (PRE). AVTUR (F-34) fuel was pumped to the PRE from a pumping station on the coast at PSD Mistarton. On closure, the Oil Pipeline Agency (OPA) removed the section of pipeline between the PRE and the western boundary fence. The section of pipeline between the PRE and BFI 7 was decommissioned in March 1997. The PRE itself has been decommissioned and the main items of equipment removed including the back flush tank. On reactivation of the station the BFI was refurbished and converted to receive fuel via road tankers. The AVTUR is then conveyed from the BFI to the aircraft by bowser as required by RAFAT. The drainage system surrounding the receipt and despatch area is intercepted with two 10 000 litre full retention interceptors. BFI 7 was last cleaned in April 2003. There have been no reported incidences involving leakages from the GPSS and the site investigation did not note any issues of concern.

Figure 25. BFI 7 and the redundant Pipeline Receipt Enclosure (PRE).

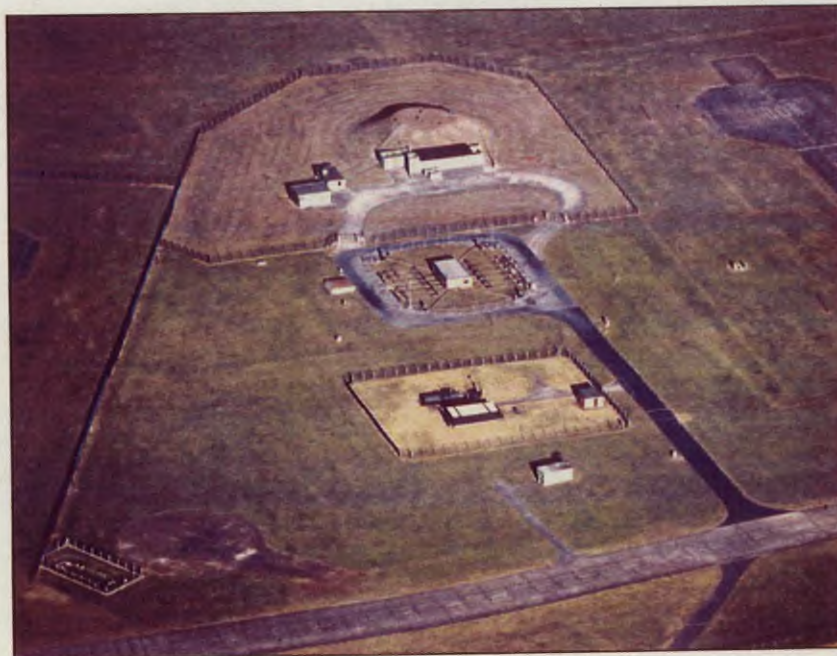
132. The installations consisted of six underground tanks each of approximately 52 500 litres nominal capacity (except BFI 5, which consisted of 12 tanks – Figure 28), together with an above ground pump house. The BFIs held AVTUR F-34, which contains icing and corrosion inhibitors. Each tank was mounted on a concrete base resting on the bedrock. At the time of decommissioning no soil samples were taken. On inspection of the tanks at BFI 4, a repair was noted at Tank 2, suggesting that it had leaked in the past. Minor contamination was found (described as an oily/petrol aroma and grey/black in colour), below the tanks on the concrete bases and around the edge of the bases. The contamination was removed off site to a licenced landfill. Contamination was also reportedly found at the loading points but this was left in situ. The excavations were backfilled using processed hardcore from the pump house and aggregate and sand. The areas were subsequently covered with topsoil and grassed.

Figure 28. PRE, BFI 5 and BFI 7 at RAF Scampton.

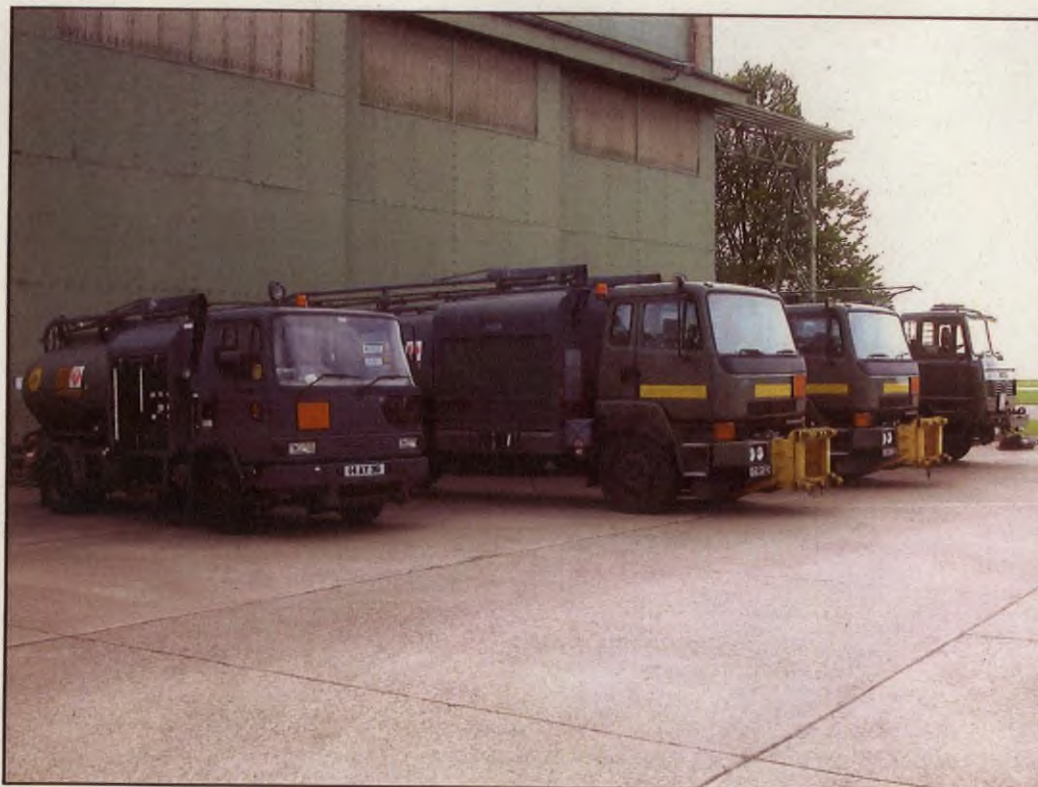
138. During the site visit it was established that fuel bowzers are usually parked on an intercepted hardstanding at the northern end of No 3 Hangar by day (Figure 31). On visual inspection it was noted that the edge of the hardstanding outside the hangar area is only partially bunded by kerb stones and may pose a risk in the event of a spill on or at the edge of the hardstanding. At night bowzers are parked within a fenced area at BFI 7, although one often remains at the day park, in case after hours refuelling is requested. The BFI compound has recently been refurbished with two new full retention interceptors.

Figure 31. Current 'day park' for bowzers located north of No 3 Hangar.

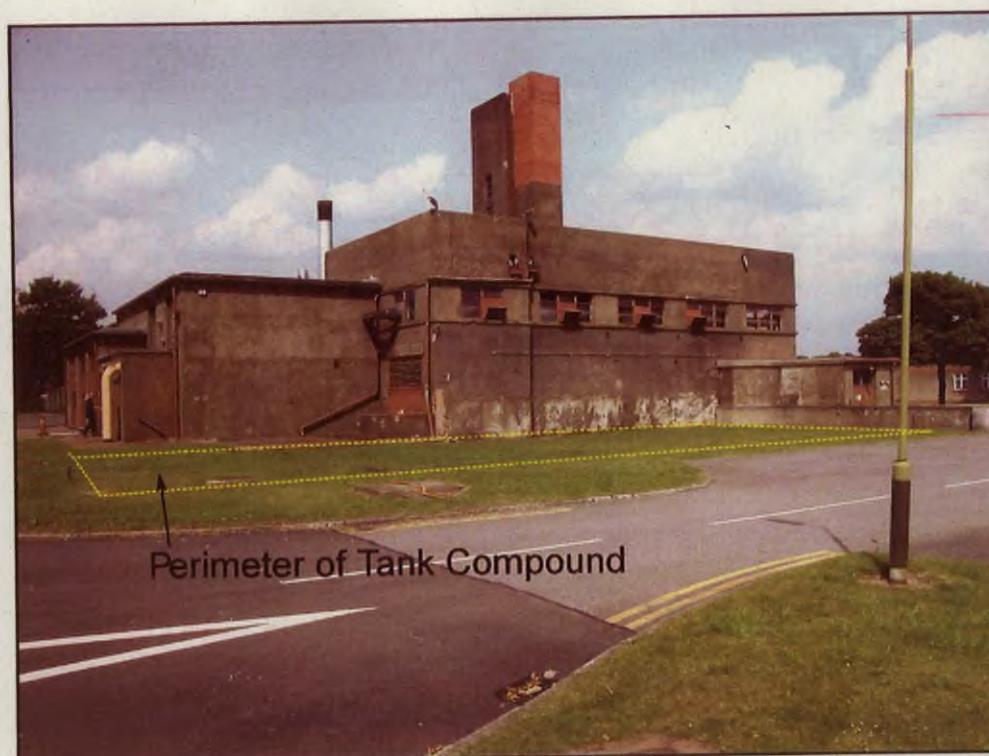
141. Removal of Redundant Fuel Oil Tanks from Bldg No 82. Following the transition of the central heating station (CHS) from oil fired to gas fired, the six fuel tanks associated with it were removed (Figure 32). An initial investigation of the tanks discovered asbestos materials in the oil valves and on the pipe leading to the boiler house, which was duly removed. Initial soil samples were taken from outside the above ground tank bunds and tested for total petroleum hydrocarbons (TPH). The highest levels for TPH were 1290 mg/kg (Tank no 5), indicating that the surrounding soils had been contaminated from activities at the CHS.

Figure 32. Building 82, Central Heating Station with the area where fuel tank compound was formally located.

142. The tanks were emptied to dispose of the remaining heavy fuel oil they contained and wastewater was collected from the bund before tank removal. The tanks were then removed (Jun 97) and all remaining structures (bunds etc) were subsequently demolished.

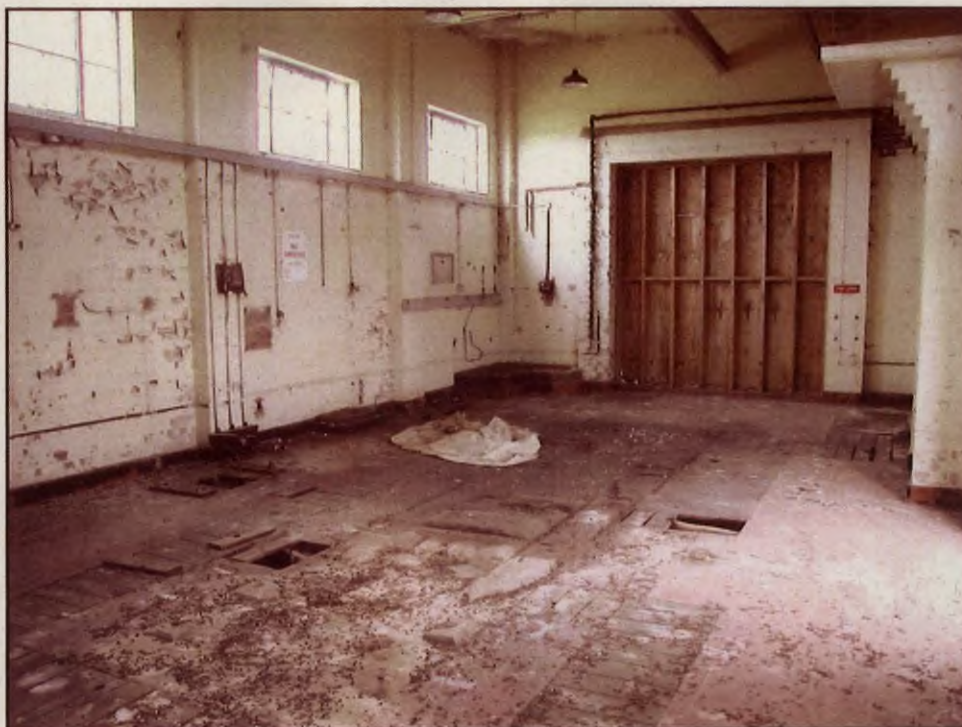
149. The generator building (Figure 33) was accessed for a visual inspection during the site visit. Residual oil staining was found on the floor of the building despite the generator having been removed. It is possible there may also be some residual contamination in the ground under the building and soil sampling will be required.

Figure 33. Inside the Emergency Power House (Bldg No 416) at the SSA.

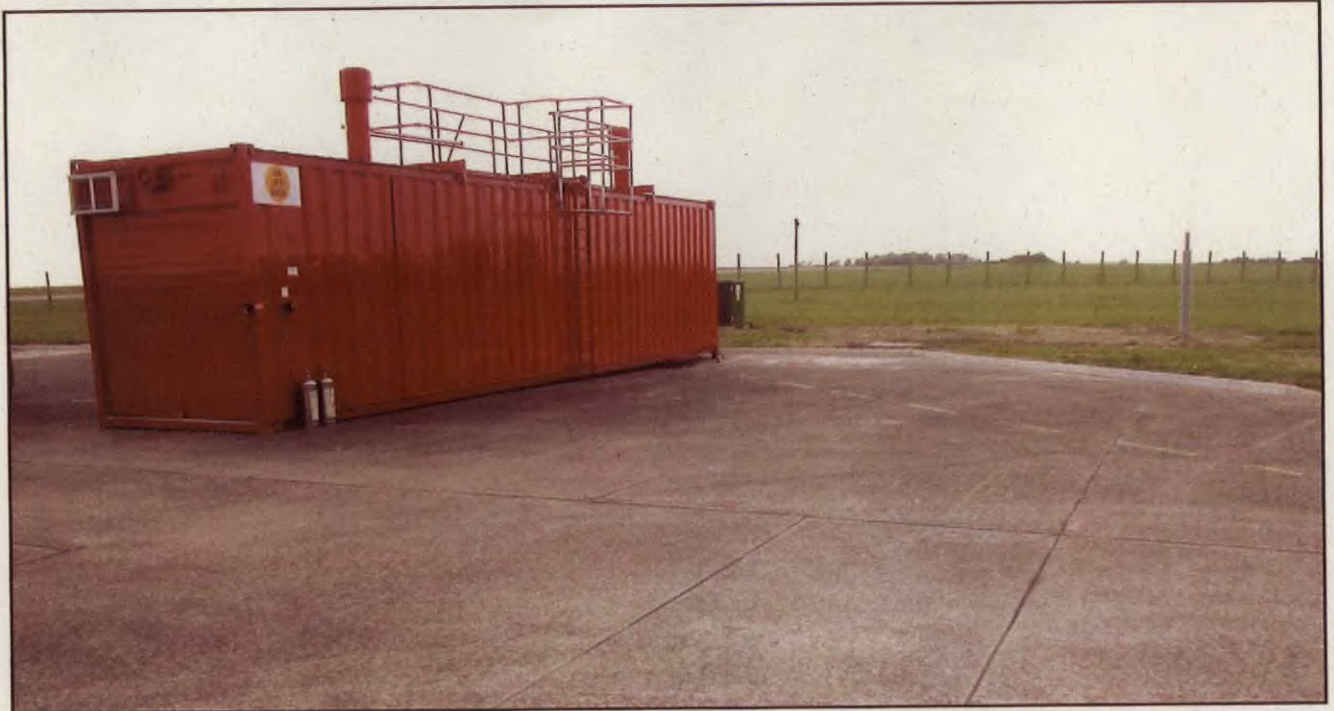
151. Current MT fuel storage. The current MT fuel storage area is a kerbside facility located on Hardstanding No 17 at E Dispersal (Bldg No 617). The vehicle/Diesel bulk fuel facility is an all-bunded modular building (Figure 34). The facility holds MT Dieso in one 11 000 litre tank, and UK Dieso in a second 25 000 litre tank. The UK Dieso is for mixing with the dye used in aerobatic displays. The facility area is bunded by kerbs with surface water drainage falling to a local below ground full retention interceptor of 10 000 litre holding capacity.

Figure 34. Current MT fuel storage facility located on hardstanding No 17 at E Dispersal.

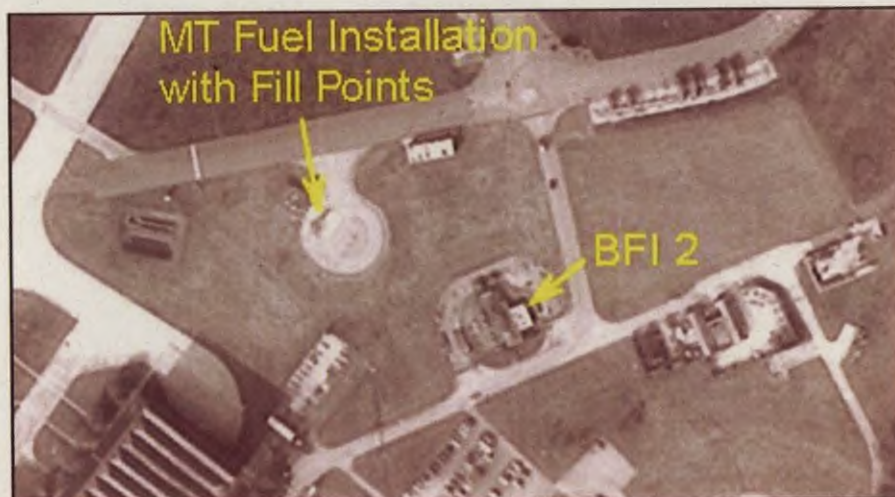
152. Recently Removed MT BFIs. Three underground MT tanks were installed in 1965 (Bldg No 507) located at the vicinity of a round dispersal just off the main taxiway in front of No 4 Hangar and west of BFI 2 (Figure 35). The hardstanding of the dispersal provided access for fuel tankers and MT vehicles, which were filled by kerb side pumps. The installation included pumps, distribution pipework, electrical services, pump rooms, standing areas for tankers, drainage and water services. The tanks had capacities of 5 000 gallons (22 700 litre), 3 000 gallons (13 600 litre) and 4000 gallons (18 000 litre), with the 5000 gallon tank containing MT Gas and the other two containing UK DIESO.

Figure 35. Showing the location of the recent MT fuel installation (Bldg No 507) in 1992.

landfill. The tanks were mounted on a concrete base resting directly on the Limestone bedrock, and so no soil samples from under the tanks were obtained. Hydrocarbon contamination of the soil was found at the loading points; this was subsequently removed off site to licenced landfill. The tank excavation damaged a nearby water main, which was subsequently repaired. The excavation was backfilled using the material surrounding the tanks and soil from BFI 2, the area was then topsoiled and grassed.

154. The available records do not state whether there was any contamination present around the tanks themselves, therefore it is unknown whether any contamination exists under the tanks. A historical 1950s contamination risk plan (held by the EWC) states that Bldg No 507 had no drainage. During the removal of the installation contaminated soil was found at the fill points. This soil was excavated and removed off site. However, since the hardstanding had no drainage, any spilt fuel could have potentially leached into the ground beneath the hardstanding.

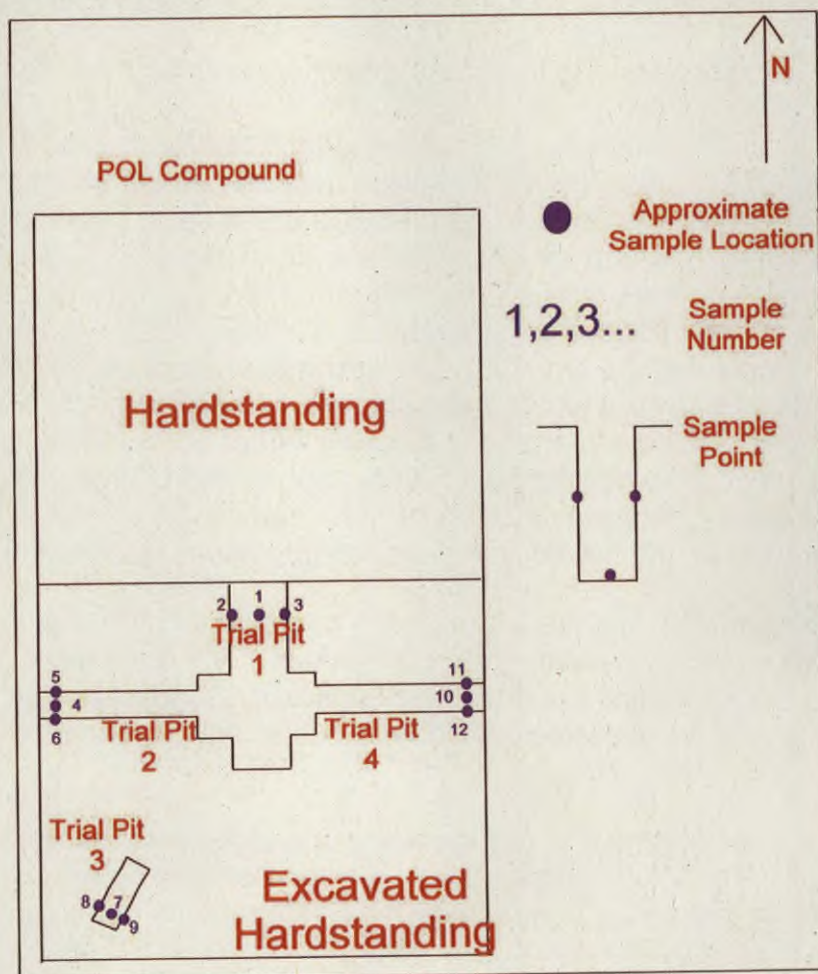
161. When the drain was excavated for refurbishment, hydrocarbon contamination was discovered in the soils beneath the concrete hardstanding. Following a meeting with the contaminated land officer at the Lincoln office of the Environment Agency, four trial pits were dug down to bedrock (max depth of soil approximately 1.75m) and soil samples were taken in order to assess the presence and degree of hydrocarbon contamination. Trial pits 1, 2 and 4 were dug from the centre of the excavated hardstanding outwards (Figure 38). It was considered that to determine how far the contamination may have migrated, it would be necessary to take the samples as close to the edge of the compound as possible. Therefore trial pit 3 was dug as a single hole, independent from the rest of the excavation and did not display any evidence of contamination. Samples were taken at approximately half the depth of the trial pit on either side and a third sample was taken at the soil/bedrock interface at the base of the pit.

Figure 38. General plan of intrusive investigation (not to scale).

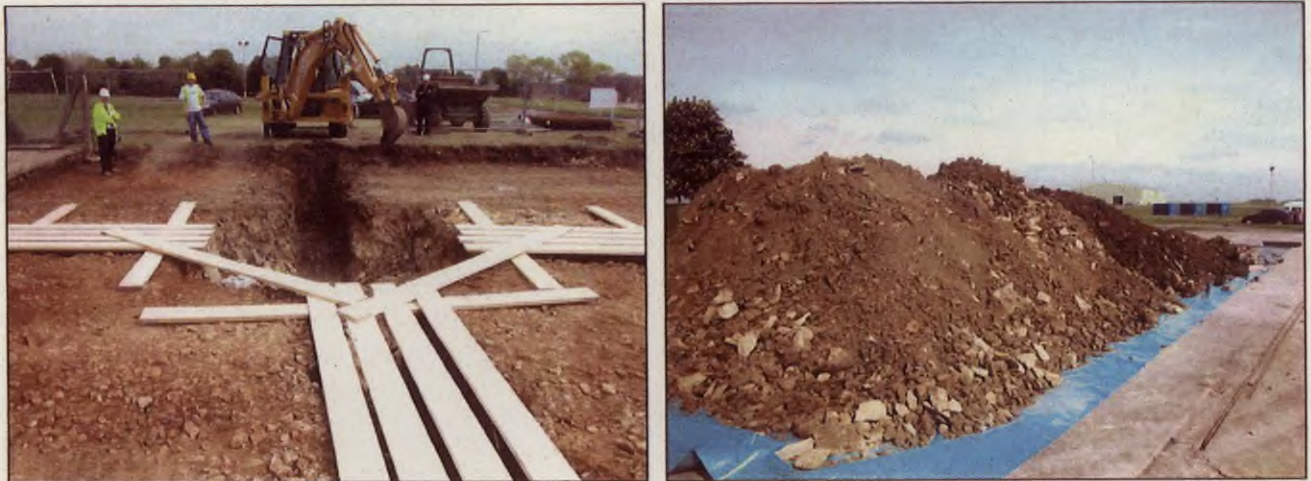
162. During the excavation a smelly odour and black/grey residue was observed, to varying degrees throughout the soils. Contamination was also suspected where residual product rested on a sandy clay horizon at the rock head. Contaminated soil was excavated from the area and stored in a temporarily bunded area at the former Motor Club before being removed to licensed landfill (Figure 39). The remaining excavation pit was temporarily covered with a tarpaulin to prevent the ingress of rainwater and limit the migration of remaining product.

Figure 39. (left) Trial pits dug to assess extent of contamination and (right), resultant spoil.

163. The initial soil samples were screened for Total Recoverable Petroleum Hydrocarbons (TPH), with the highest value detected as 1882 mgkg^{-1} at a depth of 1.6m (at bedrock). Preliminary laboratory interpretation of the soils, based on olfactory observation, suggested hydraulic oil and weathered aviation fuel might be present. The approximate sampling points and a general schematic of the area under investigation (together with analytical results) is provided at Enclosure 9, Volume 2. It should be noted that due to the constraints imposed at the time of the sampling exercise it was not possible to take a sample of soil as a control and the sampling equipment was not to British Standard. In addition, an oily residue was noted in the JCB digger bucket following washing with tap water. This was due to contamination from asphalt and bitumen remaining stuck to the inside of the bucket from previous works. The sampling exercise was not satisfactory to accurately inform on the actual concentration of contaminants in the ground.

164. It is highly likely that the main source of contamination was from the leakage of cracked drain sections that served the compound. The drain flows into an underground separator, which is itself in good working condition. Sources of contamination at the compound could potentially include various POL products, solvents, de-greasing agents etc.

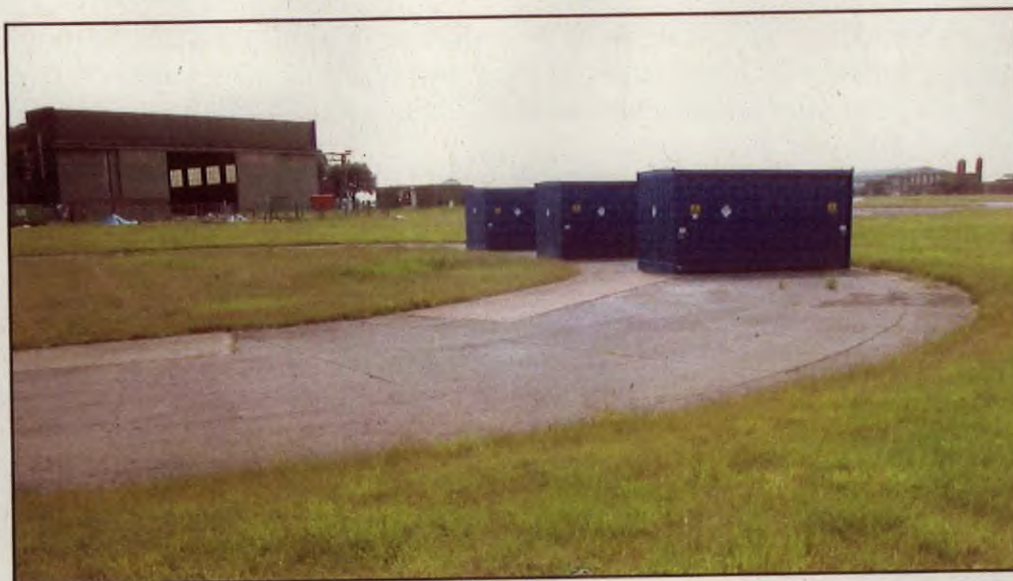
166. Waste POL is currently stored in self-bunded steel containers on the access road of the former BFI 2 (Figure 40).

Figure 40. POL storage containers on hardstanding at the former BFI 2.

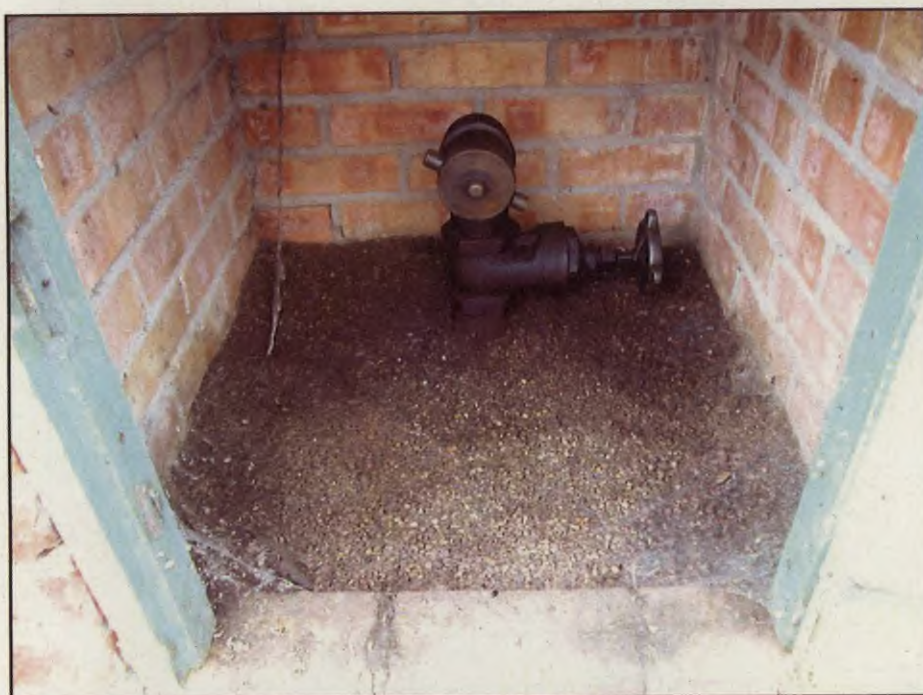
170. Additional Fuel Storage. An unmarked fuel fill point (Figure 49) exists in the visitors car park at the main site entrance. Anecdotal evidence suggests that the point is used to fill a fuel tank situated at RAF Scampton Primary School via an underground pipeline. On inspection it was noted that the unbunded fill point was stained with black oil and that the ground beneath the point had minor contamination. Neither the age of the fill point and tank or the capacity of the tank was ascertained. It is unknown what the current condition of the pipeline is, whether there has been any maintenance/testing carried out on the pipeline or any spillage incidents reported.

171. A visual inspection could not ascertain whether the pipeline was suitably protected against corrosion (for example with cathodic protection) or equipped with a leakage alarm indicator. The pipeline is suspected of having mechanical joints underground that are not easily accessible by removing a hatch or cover and the fill point is not fitted with a drip tray. The pipeline is very close to a controlled water (the underlying aquifer). It is possible that the Regulatory Authority will consider that it contravenes The Control of Pollution (Oil Storage)(England) 2001 Regulations that came into force in September 2003 for installations within 10m of a controlled water for some of the points above.

Figure 49. Fill point for the fuel tank at Scampton Primary School, located in the RAF Scampton visitor's car park.

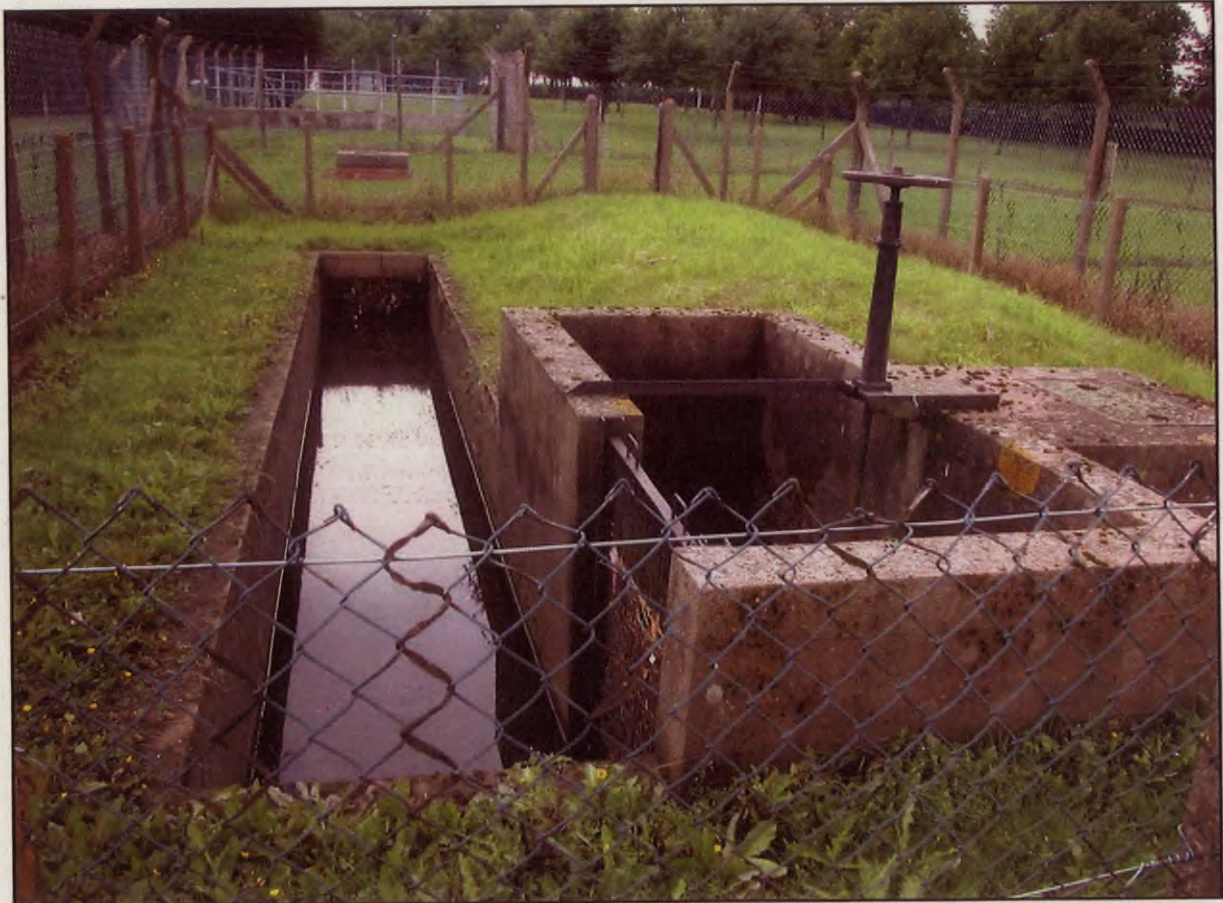
174. The condition of the drainage network is considered to be poor at RAF Scampton. At the time of the Site Visit a CCTV site survey of all surface and fowl drains was being undertaken in order to assess the condition of the drains and determine the extent of the active drainage network. The results of this survey are available from the Establishment Works Consultant (EWC). There are 10 oil traps listed in the current RAF Scampton building register. In addition there are three oil separators on the site. It is believed that not all the surface water drainage from the site is intercepted. Soakaways are located at each of the oil interceptor except the main interceptor at [REDACTED] (Figure 50), which discharges to outfall. The interceptors are inspected annually by the works service staff and cleaned as appropriate.

Figure 50. Interceptor at Canberra Drive.

176. A Supply report dated 19 Oct 93, gives reference to a considerable amount of flooding which submerged the Canberra oil trap installation. The record also states that there was oil product floating on the water surface, which may have derived from the interceptor catchment area. The report goes on to suggest that the oil-based product may cause contamination of the surrounding ground when the water subsides. There may be a residual contamination issue in this area.

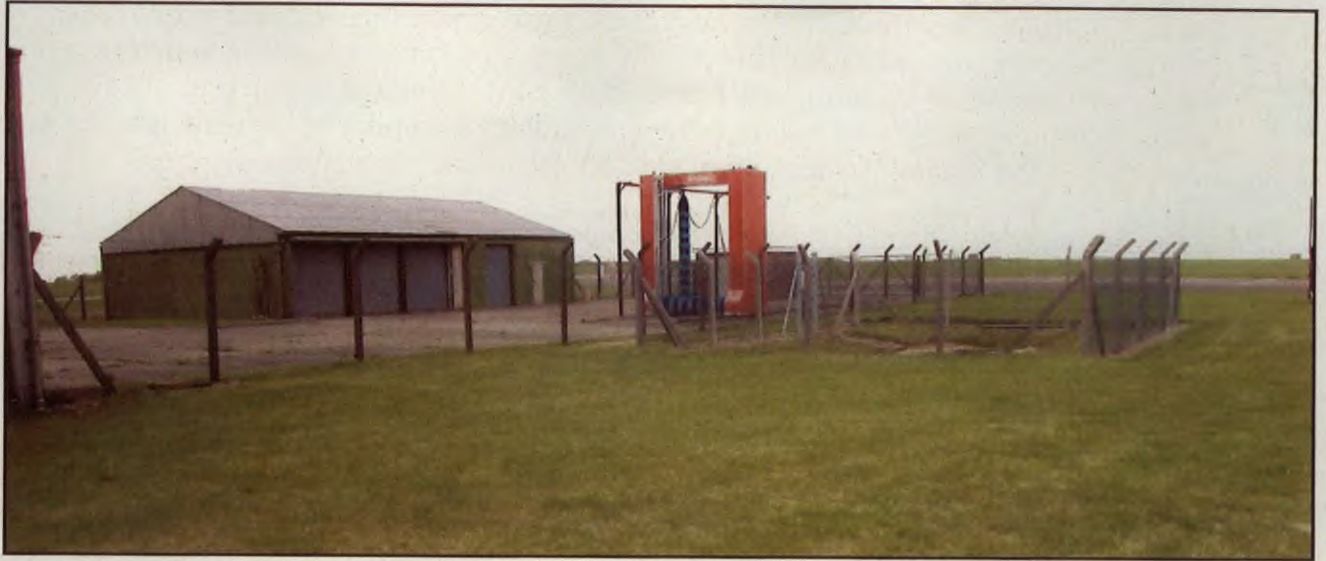
199. Vehicle Wash Plant. The vehicle wash plant (Bldg No 460) located at the MTSS has not been used for some time (Figure 54). The wastewater from the facility is recycled, with the resulting waste being collected in a tank and disposed of off site. As previously discussed vehicle washing is currently only permitted at the consented aircraft wash plant located in No 2 Hangar.

Figure 54. MT vehicle wash plant (Bldg No 532).

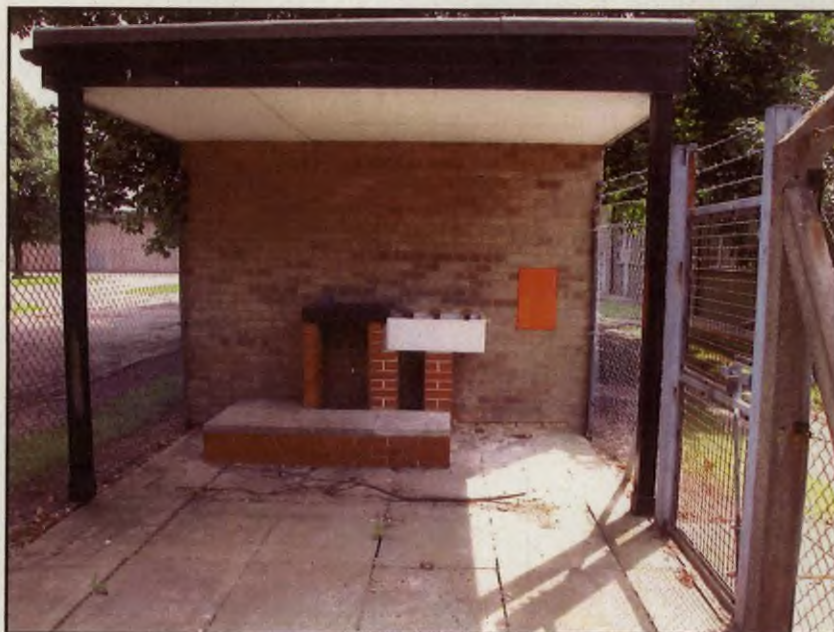
201. Electrical Engineering. The station site plan of RAF Scampton indicates that battery servicing took place at two locations on the site. Firstly, at the Battery Recovery Shop (Bldg No 133A), next to the main workshops (Bldg No 133) on the main technical site (Figure 55), and secondly at a Battery Charging Room (Bldg No 404) located within the SSA complex. There is a potential for lead contamination at both these sites from battery acid leakage and disposal. During visual inspection of the Battery Recovery Shop it was noted that the acid was drained into a ceramic sink, but the disposal route for drained waste acid is unknown.

Figure 55. Battery Recovery Shop (Bldg No 133A).

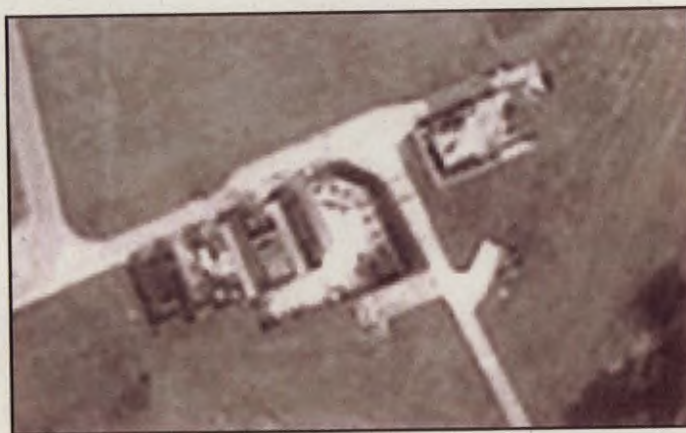
207. Historical Ground Maintenance Yard. From the WWII site up until closure there has been a contractors stores and compound at Bldg No 22. The compound was demolished on station closure and a concrete base now only remains, the yard is clearly visible on the 1942 aerial photograph, showing signs of disturbed ground in the northern quarter of the compound. A picture of the compound in 1992, shows the layout of the compound has not changed markedly from that time (Figure 56).

Figure 56. Contractor's facilities consisting of buildings and yard areas (1992).

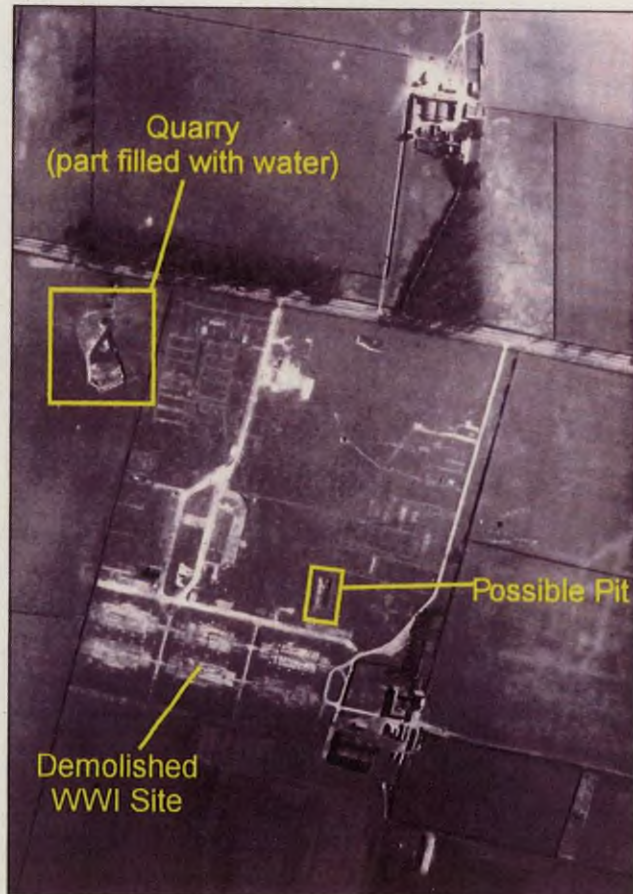
Figure 57. WWI Training Depot Station with quarry annotated.

216. WWI 'on site' Tip. The 1891 Ordnance Survey plan shows an "Old Quarry" within the original site boundary and the aerial photographs from 1918 show ground disturbance in the same area (Figure 57). It is possible that the station could have used this void for tipping of technical and domestic wastes between 1916 and 1920. The area is now relatively flat and is grassed over. The available evidence suggests that the area has never been built on. The centre of the large rectangular shaped area is interpreted from the old plans and photographs as being located at approximately NGR SK 9720 7982. The size of the area is estimated at 340 feet long (along its east/west axis) by 80 feet wide (along its north/south axis). A smaller area of disturbed ground that appears rectangular in shape is visible within the area of the former WWI technical site.
