ROYAL AIR FORCE

WORKING PAPER 08/03

RAF SCAMPTON LAND QUALITY ASSESSMENT PHASE 1 - DESK STUDY

VOLUME 1 (OF 2): REPORT

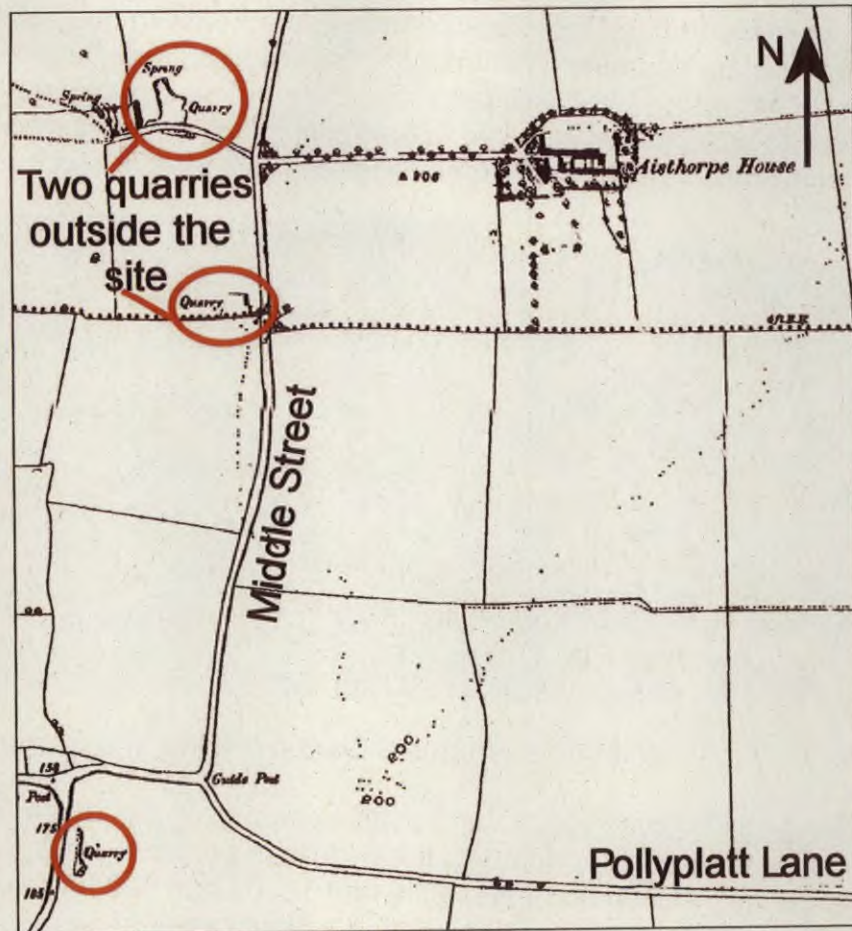
225. Two potential areas that have been subject to tipping activities are located to the west of the station. On the historical OS map these areas were designated as quarries (Figure 60). The site investigation extended to these quarries and noted that the southernmost quarry was virtually flat and covered in trees and other vegetation, and the northern quarry contained a three metre high mound of tipped material. Neither of these quarries were within the historic or current site boundary at RAF Scampton and may have been used to tip materials before the mid 1950s.

Figure 60. Two quarries located to the west of the site.

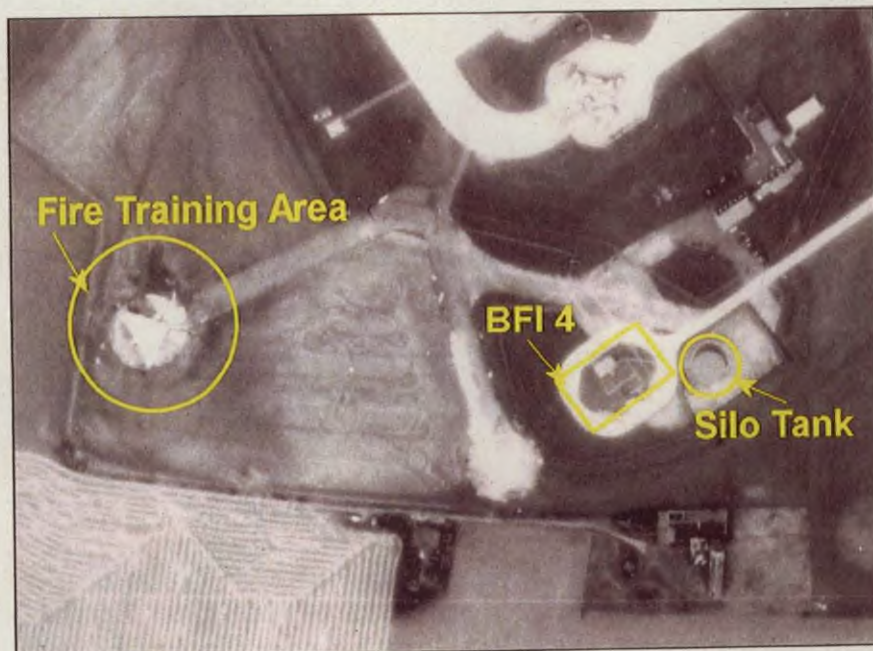
236. Aircraft and Vehicle Fire Training Areas. Two areas used for fire training have been identified. The first, a training site situated on an old WWII round concrete and asphalt dispersal located in the south-west of the site at NGR SK 958 787. The 1975 aerial photograph shows an obsolete Vulcan aircraft parked on this dispersal (Figure 63).

Figure 63. Obsolete aircraft used for fire training exercises (1977 aerial photograph).

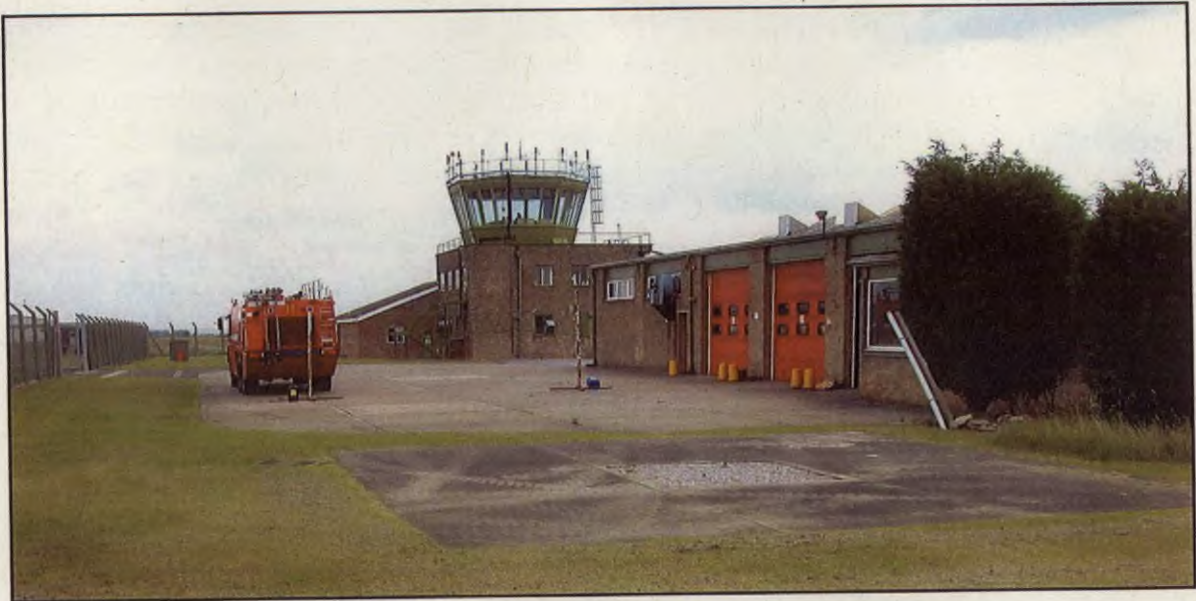
243. Minor Fire Training Areas. A "fire training pit" is listed on the buildings list as Bldg No 529 (Figure 66). This is located within the airfield, no more than 50m to the west of the present Fire Section building (Bldg No 106). This area is most likely to have been used for small practice fires since the Fire Section has in the past been responsible for general fire training of station personnel. This probably involved extinguishing small fuel fires. No evidence of burning was noted in the area during the site walkover.

Figure 66. The fire training pit, used to train personnel how to deal with small scale fires.

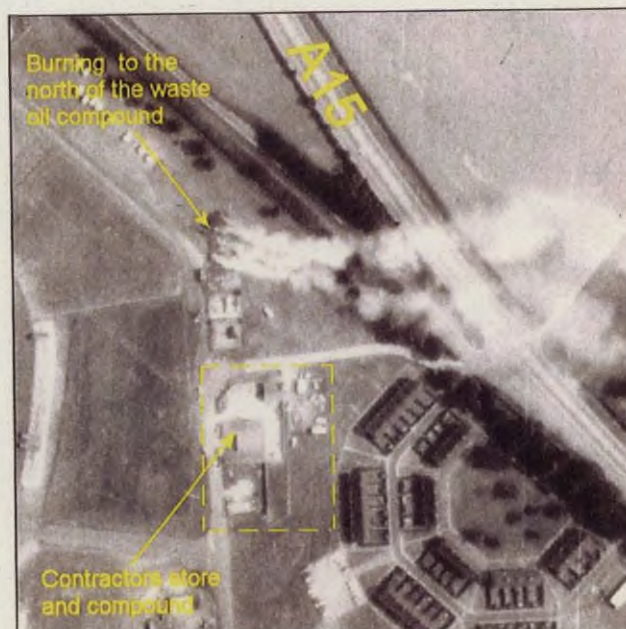
244. Suspected Minor Burning Activities. There is also photographic evidence of burning activities in the vicinity of the WWII Air Ministry Works Department (AMWD) compound (Bldg No 21 on the Air Ministry building list), currently a waste oil compound (Bldg No 498). The 1983 aerial photograph captures smoke coming from the area (Figure 67). It is thought that this compound was an Airfield Maintenance yard. However it is unknown what substances were actually burnt in this area and there remains the possibility that thermal decomposition products and heavy metals could have contaminated the soils in the vicinity from burning activities.

Figure 67. Evidence of burning to the north of the waste oil compound (1983).

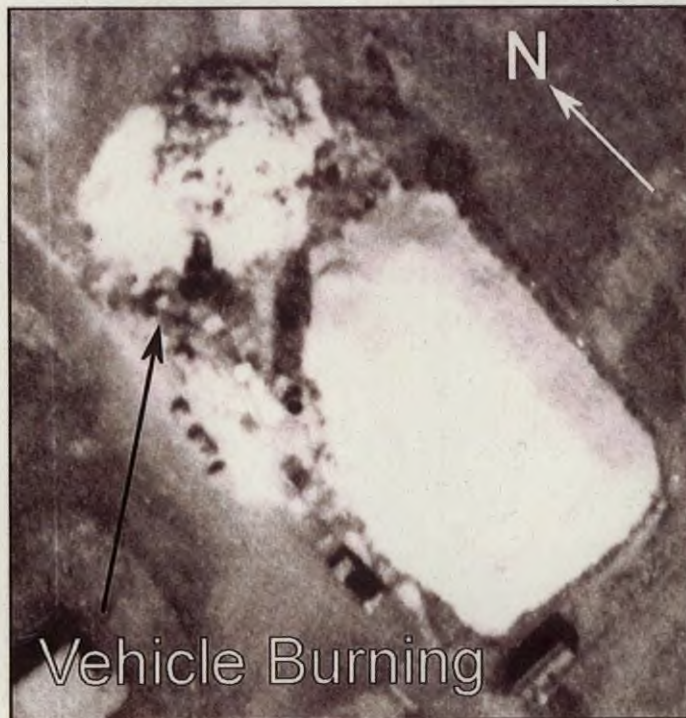
245. Station Personnel report that there has been some vehicle burning (Figure 68) in the vicinity of the NATO aggregate store just south of the modern 25 yd firing range (Bldg Nos 253/254).

Figure 68. Potential area of vehicle burning.

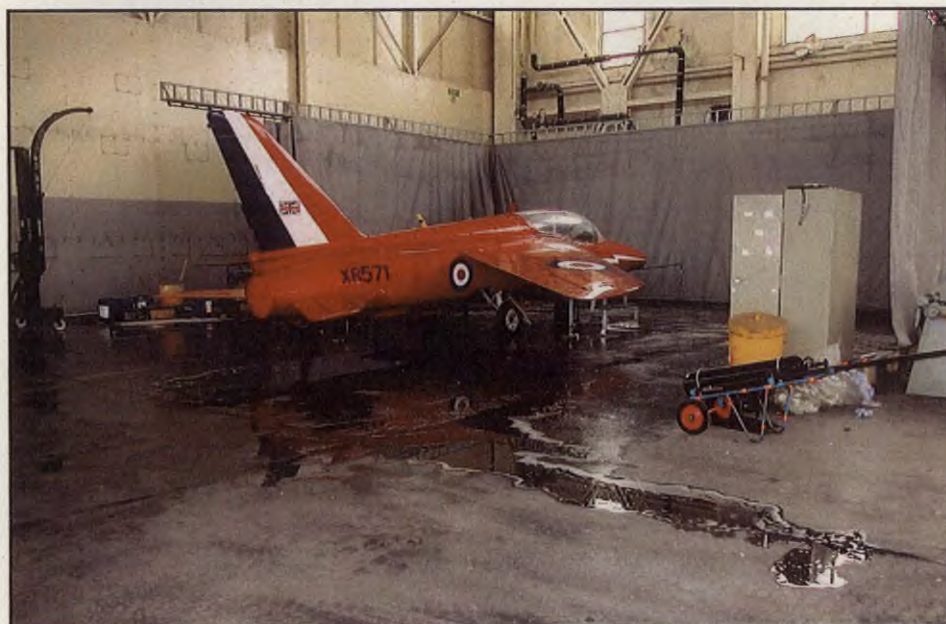
249. Aircraft Wash Facilities. Aircraft and vehicles are currently washed at a dedicated facility in No 2 Hangar (Figure 69). Aircraft were previously washed at the Engine Running

Platform. There is the potential for aircraft wash water to contain elevated levels of cadmium that has leached from the aircraft. The ERP is drained by storm drains, which flow into an interceptor (Bldg No 494). It is unclear whether wastewater containing surfactants (detergents) also flow into the oil trap. If this is the case, it could render the oil trap less effective. There have been no documented pollution incidents involving aircraft wash water at RAF Scampton.

Figure 69. Gnat aircraft in the aircraft and vehicle wash plant in No 2 Hangar.

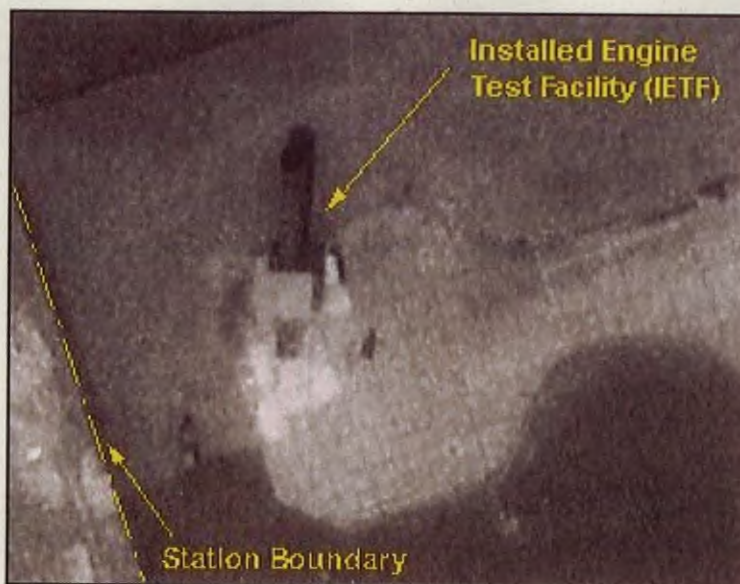
253. The IETF consists of a large horizontal chamber connected to a vertical exhaust stack (Figure 70). In previous aerial photographs fuel staining and phytotoxic stress is evident on the surrounding grass. The dispersal is not bunded but is intercepted by drains and so there is a slight possibility that any free fuel could leach into the ground surrounding the hardstanding. Therefore, it is possible that the soils surrounding and under No 11 (octagonal) hardstanding could be potentially contaminated with aviation fuel.

Figure 70. The installed engine test facility the hardstanding at C dispersal (July 1990).

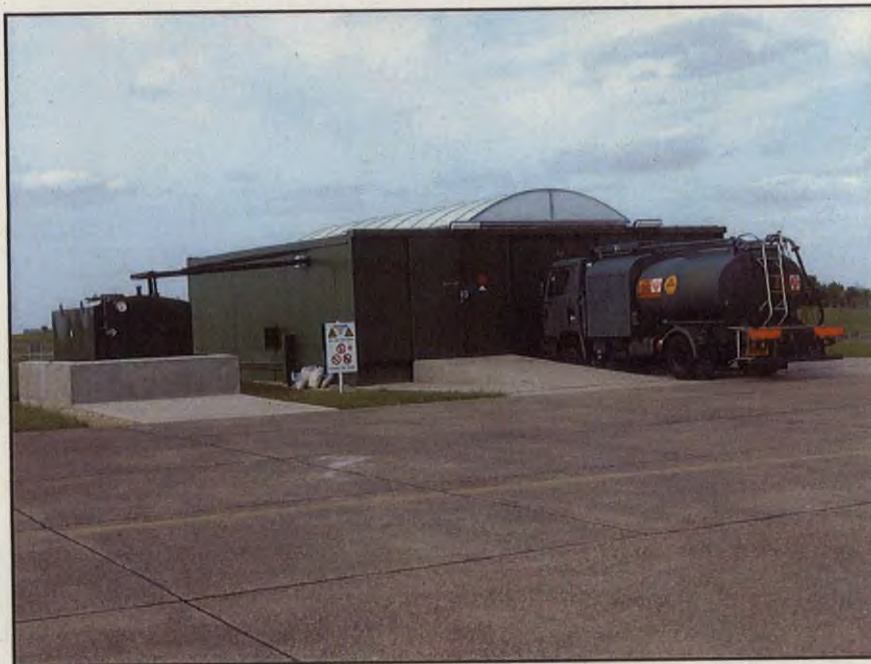
diesel from the pods (Figure 71). Any dye effluent that is spilt collects in the floor sump, the contents of which are pumped into a 6 000 litre tank. The pumps automatically stop when the tank is nearing its working capacity, preventing over flow into the surface watercourse. The tank is emptied by a specialist contractor and disposed of as special waste.

Figure 71. Modular banded building housing the Red Arrows Dye Bay.

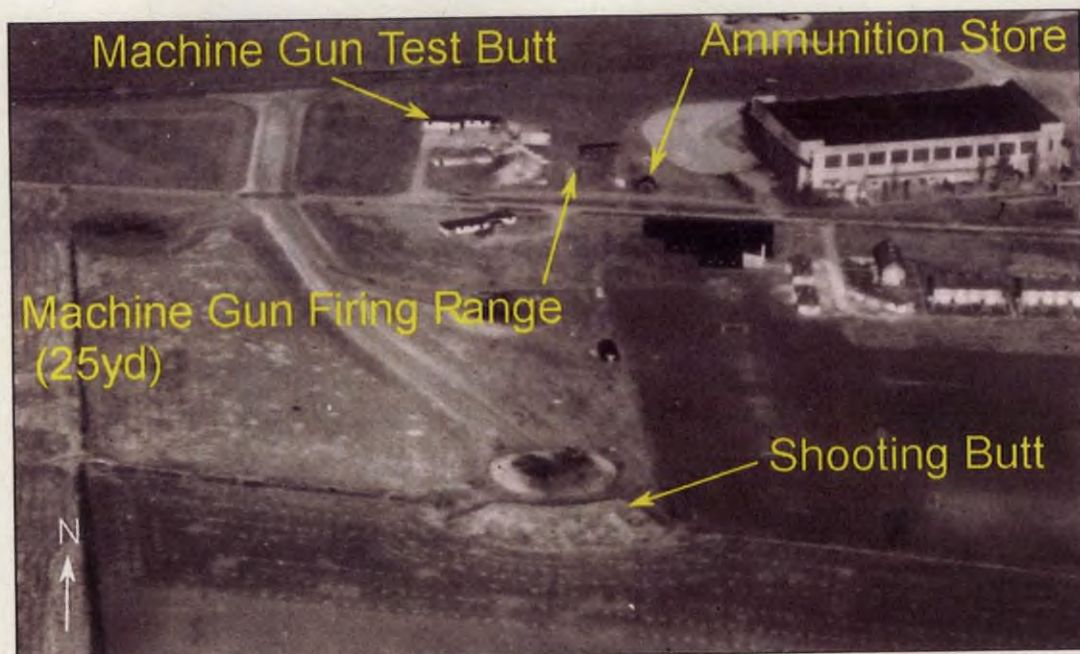
271. Weapons Ranges and Test Butts. Lead bullets are a source of lead contamination. For this reason all areas of former weapons firing are considered potential sites where elevated levels of lead may be found.

274. A 1948 oblique aerial photograph shows the historical location of some of the above facilities (Figure 72).

Figure 72. Showing the location of firing ranges in 1948.

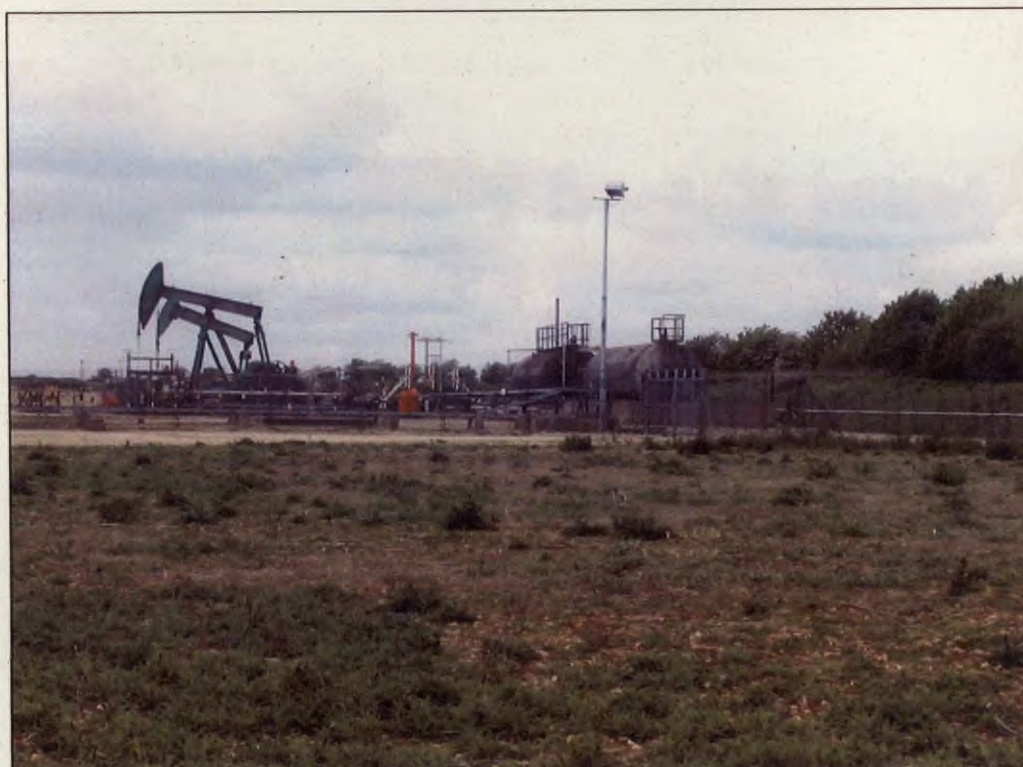
296. A former exploratory oil well is located to the immediate west just off the station boundary (Figure 74). This well operated for approximately 6 months, however, two additional and operational oil wells are located between the site and the village of Welton to the east. There is the potential for leaks and spills of crude oil and drilling related substances to impact on the land quality and adjacent surface/ground water at RAF Scampton.

Figure 74. Functioning oil well and infrastructure.
