Rail Accident Investigation Branch

# Rail Accident Report

## **Derailed at Grayrigg 23 February 2007**

# Derailment at Grayrigg, 23 February 2007

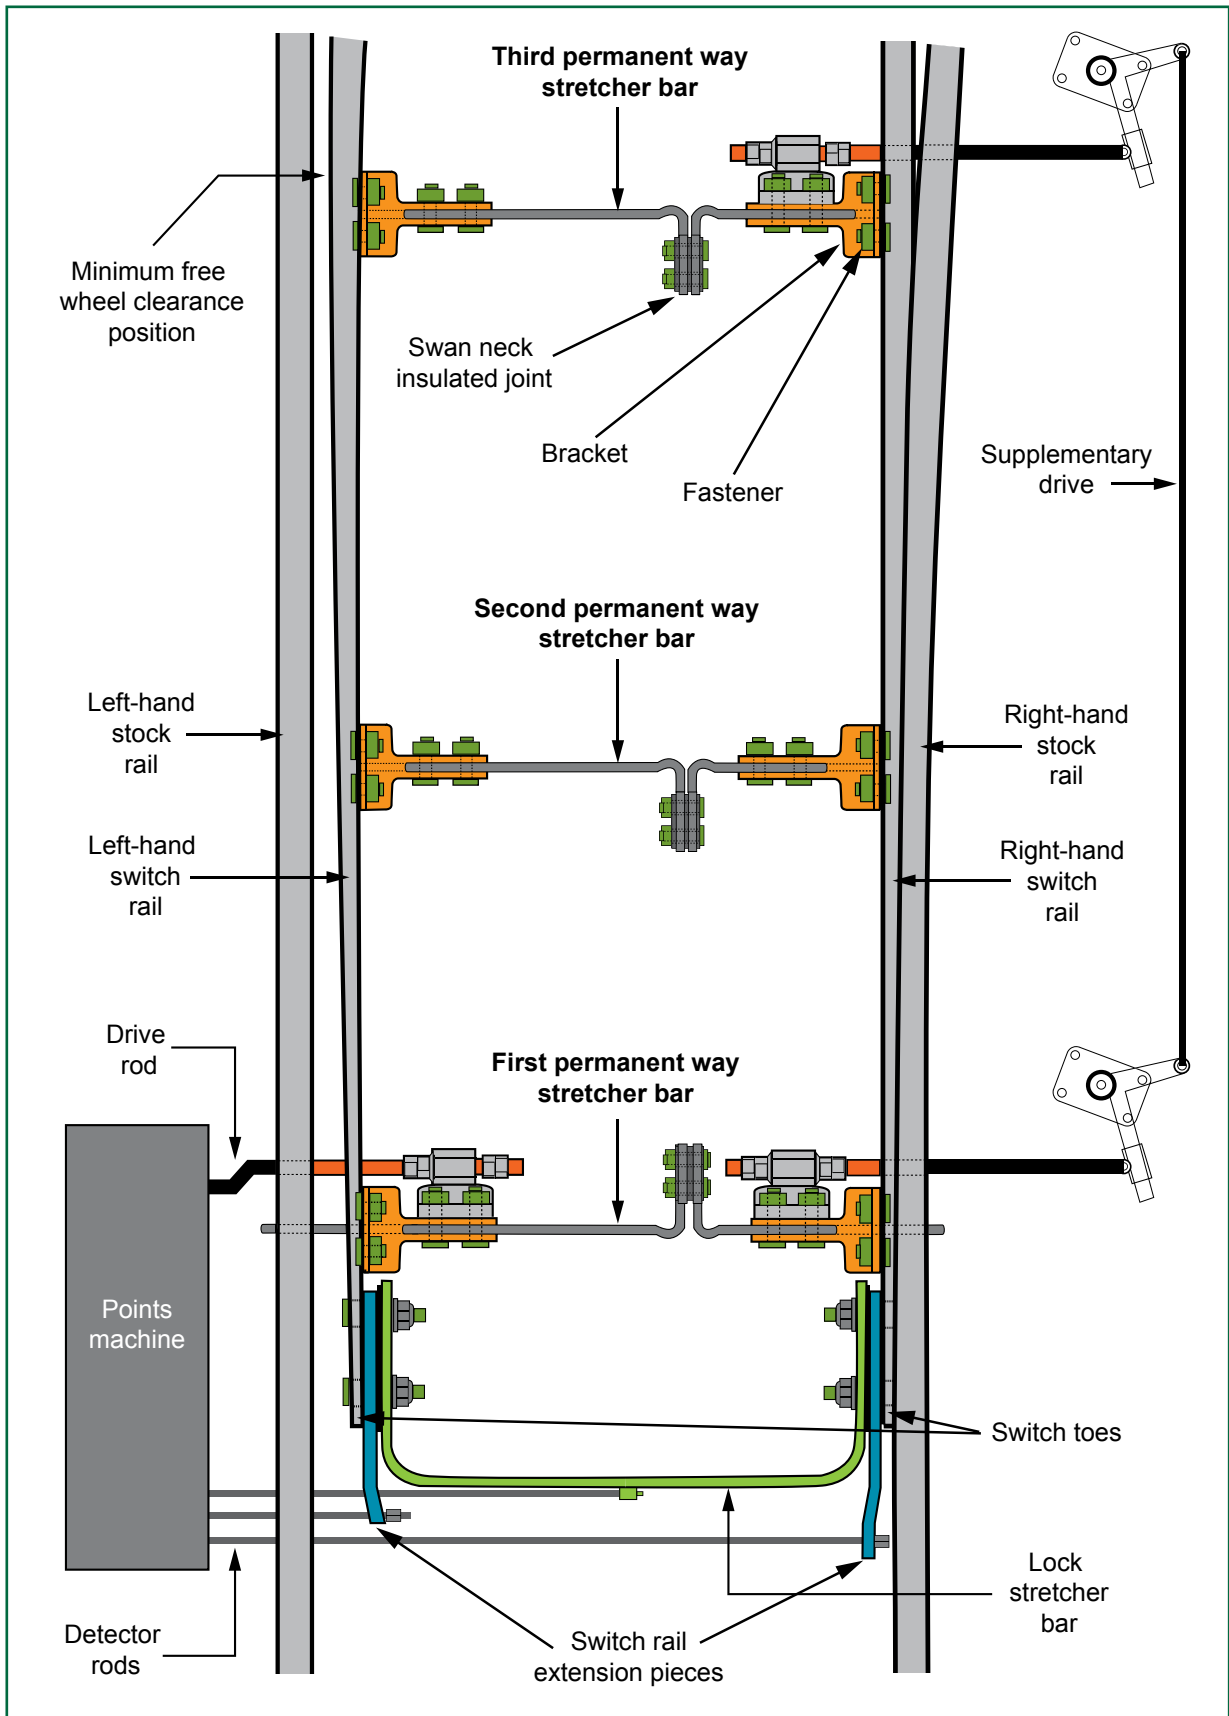
Figure 3: Layout of points showing switch and stock rails and stretcher bars

- 13 The train derailed as it passed over 2B points which were in an unsafe state. A combination of failures of *stretcher bars* and their joint to the *switch rails* allowed the left-hand switch rail to move, under its natural flexure, towards the left-hand *stock rail*. The left-hand wheels of either the first or second *bogie* on the leading vehicle (it is not clear which) passed the wrong side of the left-hand switch rail and were forced into the reducing width between the switch rails. The wheels then derailed by climbing over the rails. All the other vehicles of the train derailed as a consequence. Figures 3 and 4 show the key details of the points.

- 15 The bolts holding the third permanent way stretcher bar to the right-hand switch rail became loose, and subsequently completely undone. As a result of this, and the excessive residual *switch* opening, the left-hand switch rail was struck by the inner faces of passing train wheels, giving rise to large cyclic forces. As a consequence, rapid deterioration of the condition of the remaining stretcher bars and their *fasteners* occurred. This led to the left-hand switch rail becoming totally unrestrained.

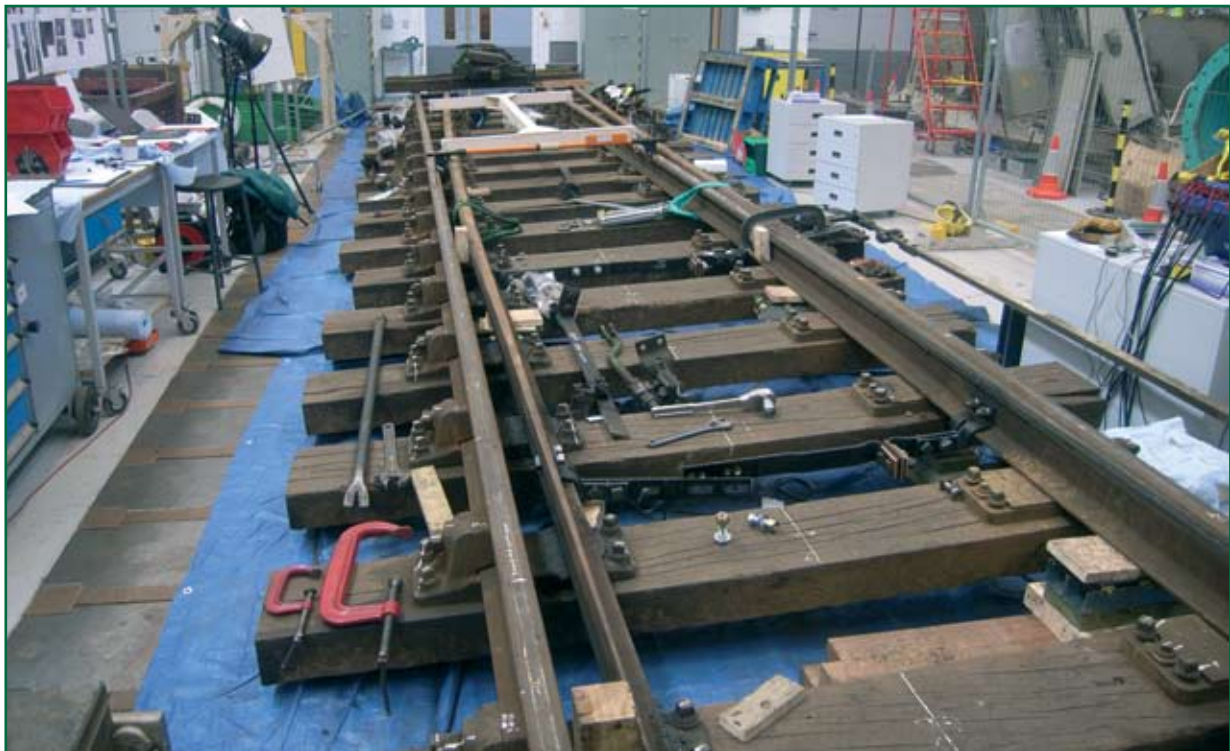
Figure 6: Points 2B switch section in laboratory

- The RAIB carried out all other aspects of evidence collection.
- 101 Following detailed on-site surveying, photography, measurement of the track under unloaded and loaded conditions, examination of the signalling system, taking of forensic samples and recovery of detached items of evidence in the vicinity, the whole switch section of 2B points (Figure 6) was secured for transport and removed as a complete panel to a secure laboratory for testing and analysis.

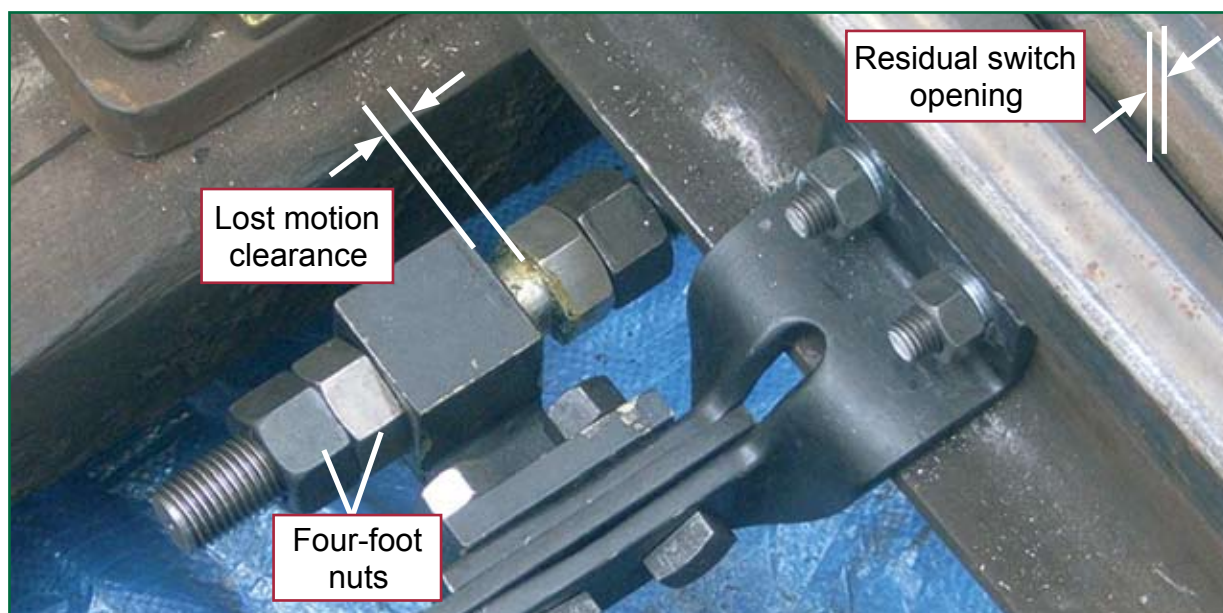
Figure 26: Escapement joint on a reconstructed stretcher bar

- 132 The supplementary drive is shown in Figure 26 and its role is described in Appendix D. The supplementary drive was complete and undamaged and all of its components were operating correctly.
- 133 Where the supplementary drive connects to the stretcher bar there is an *escapement joint*. Clearances within this joint, known as lost motion, isolate the supplementary drive and the toes of the switches from forces induced by the passage of trains. There was 16 mm of lost motion at the escapement joint at the third permanent way stretcher bar. Although this is above the maximum specified values<sup>2</sup>, the amount of lost motion itself was not significant to the accident as it provided the necessary isolation of forces.
- 134 The position of the escapement joint's four-foot nuts was such that it allowed a residual switch opening of 8 mm between the right-hand switch and stock rails.

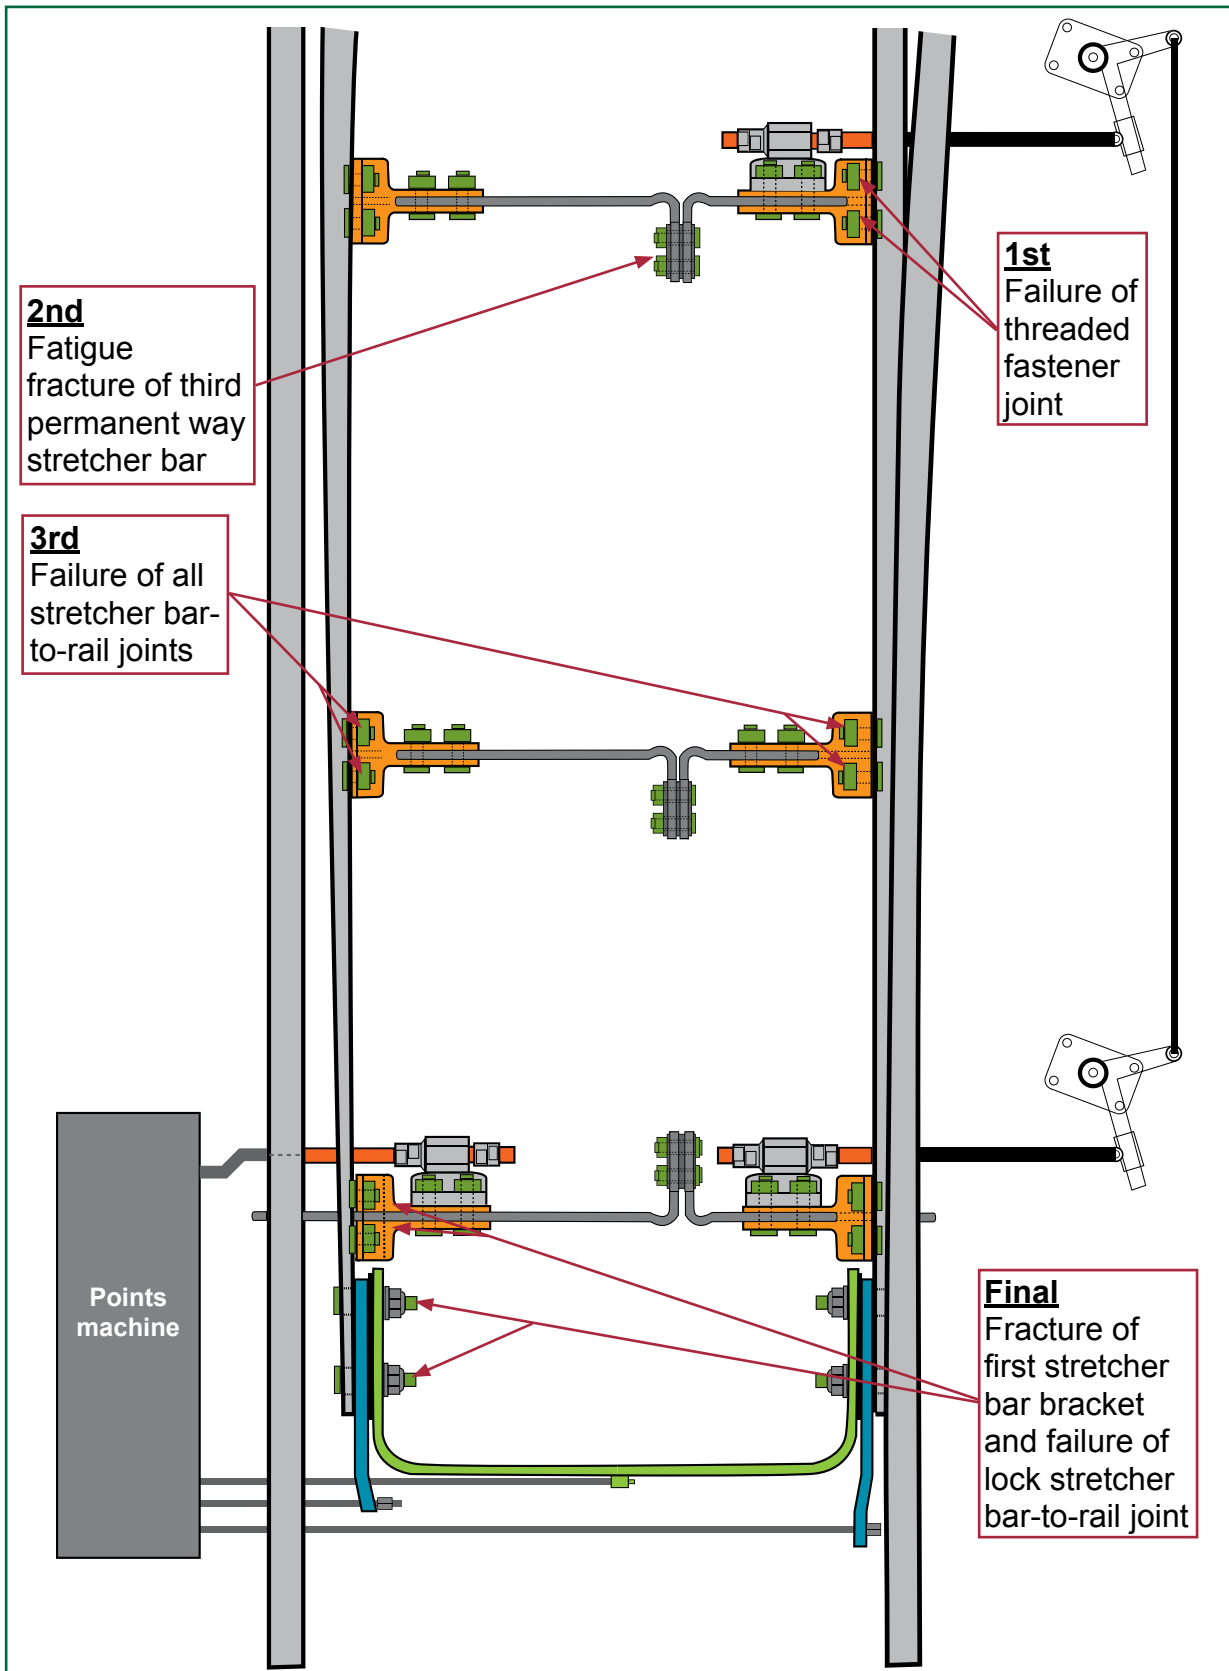
Figure 27: The sequence of failures - schematic diagram of points

135 This section describes the probable sequence of failures within 2B points, as summarised in Figure 27, and their possible causes.

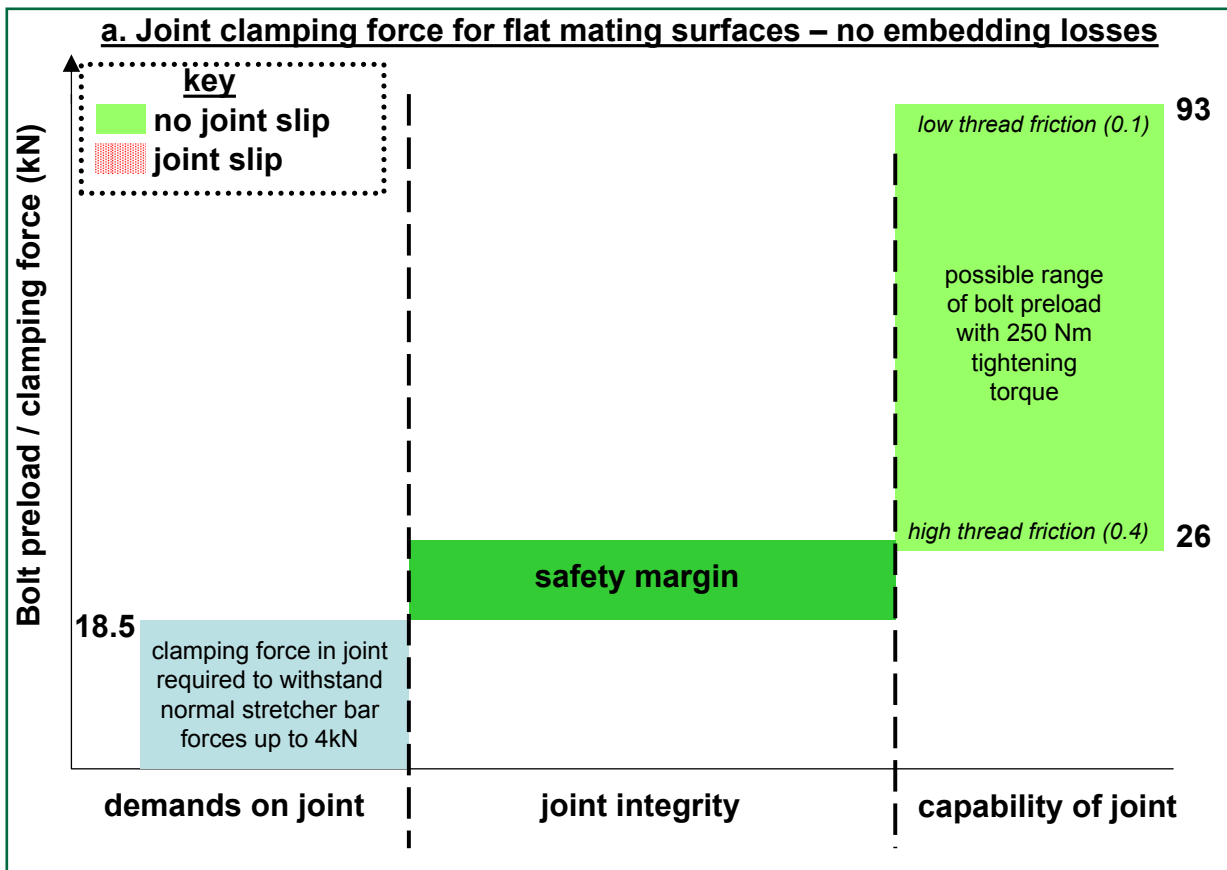
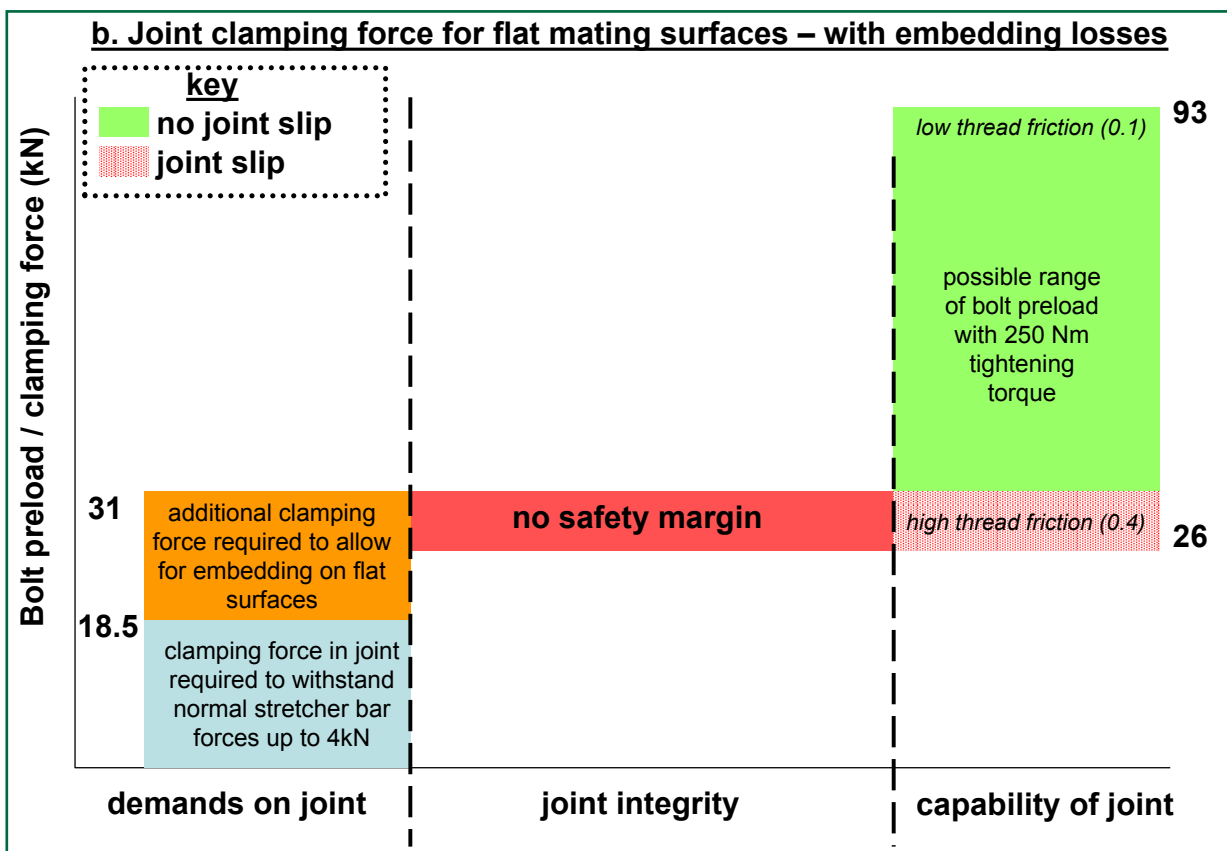
Figures 28a and 28b: The relationship between clamping force required to withstand realistic service loads and the clamping force achieved

- 148 Calculations demonstrate that this amount of embedding results in a loss of preload in each fastener of 12.5 kN. Thus to ensure sufficient clamping force to prevent joint slip, the preload in each fastener must exceed the sum of this value and the 18.5 kN referred to in paragraph 144, ie 31 kN (Figures 28a and b). No attempt has been made to predict the loss of preload due to other plastic deformation, and therefore this calculation indicates the minimum preload requirement.

- 149 The range of preloads achievable by the fastener was calculated to be between 26 kN and 93 kN. This was based on the 250 Nm tightening torque and a realistic range of friction (Appendix E). The relationship between the 31 kN minimum clamping force required to resist slip and the range of achievable clamping forces is shown in Figure 28b. This shows that for points of a similar configuration and traffic loading as 2B points, even if fully tightened, a safety margin cannot be guaranteed between the as-designed joint's clamping force and the forces it can experience in normal service, ie without any flange-back contact.

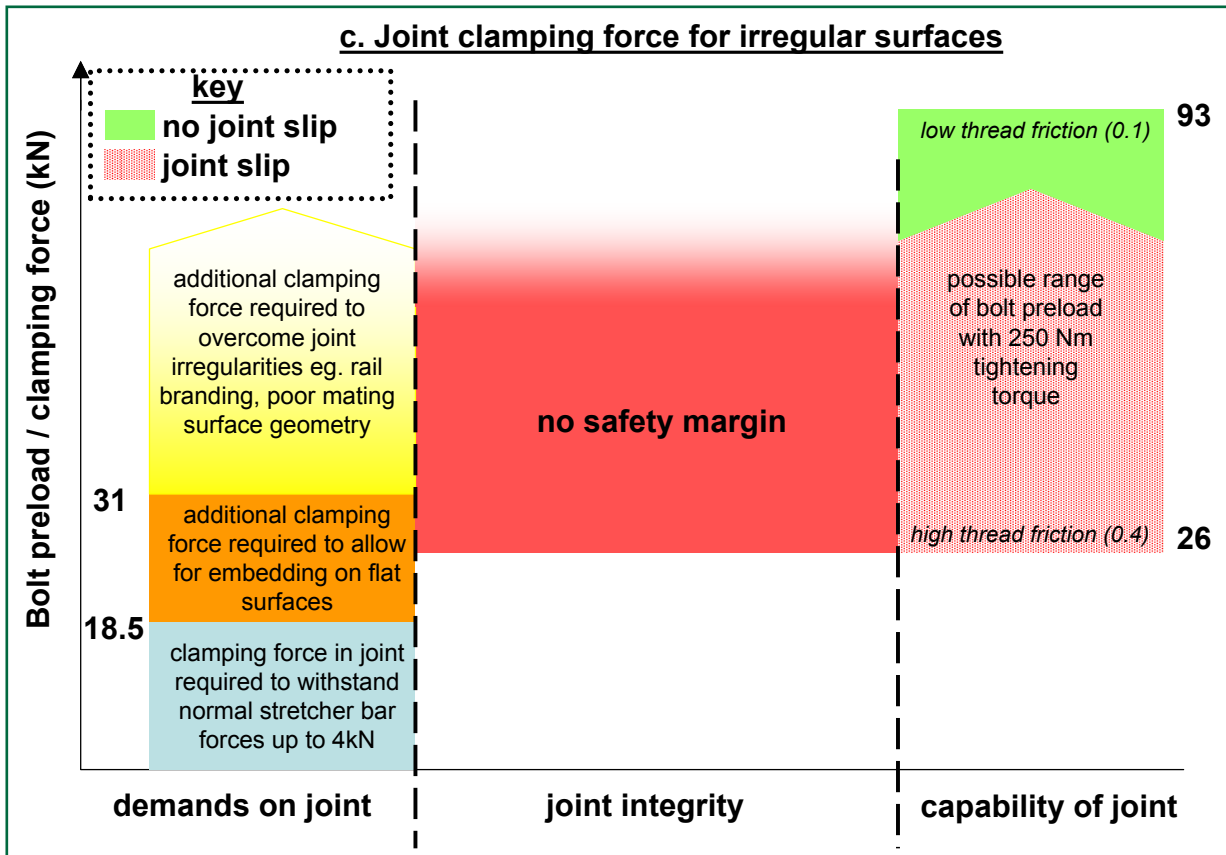
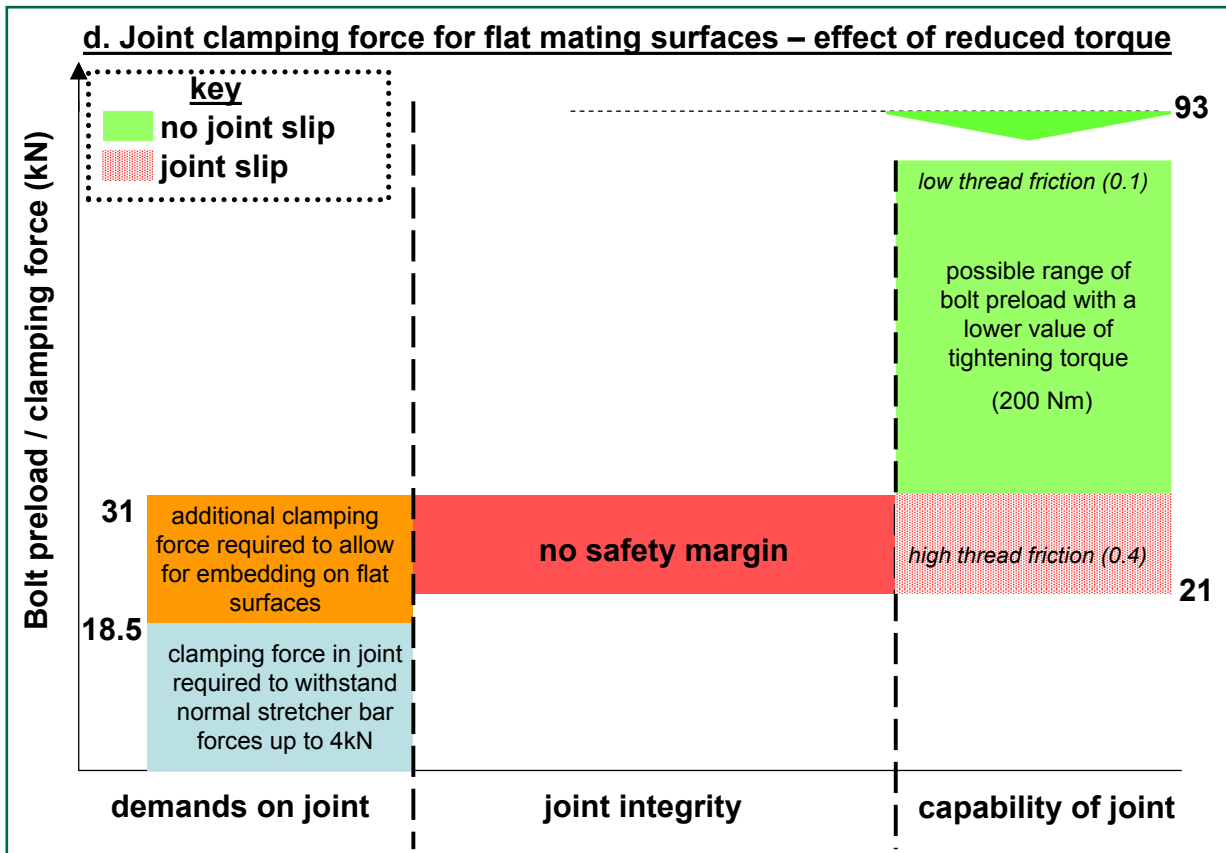
Figures 28c and 28d: The relationship between clamping force required to withstand realistic service loads and the clamping force achieved

- 150 This analysis is based on the nominal design, ie, flat mating surfaces, and the specified torque of 250 Nm. Other factors that may lead to plastic deformation of the surfaces and reduce the clamping force still further over time are described below (Figure 28c):

- 153 Tests undertaken by the RAIB on similar fasteners on other points found fastener torques as low as 20 Nm. The low torque indicated that there were significant reductions in the clamping forces in these joints, and an associated reduction in their resistance to slip failure (Figure 28d).

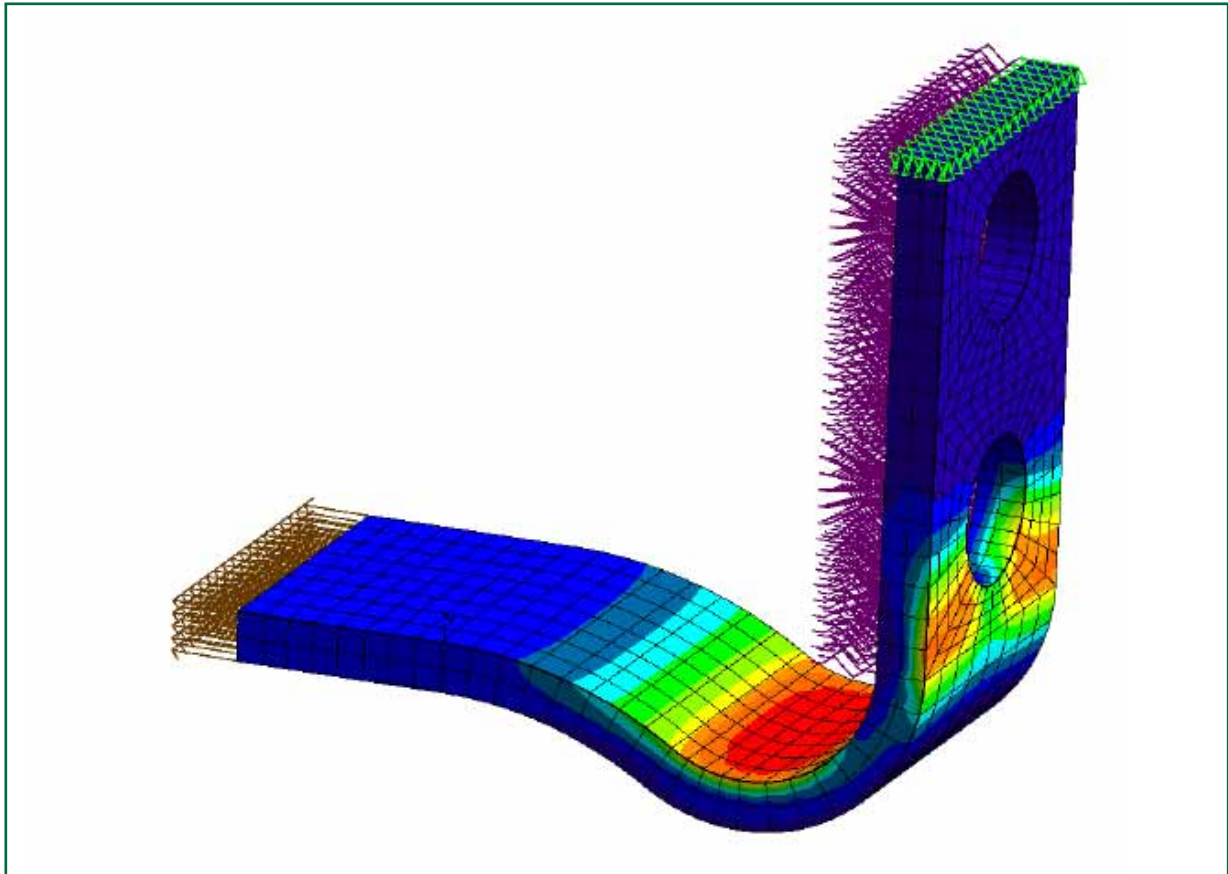
Figure 30: Stress contour plot of swan neck assembly

- 169 All of the cracks within the swan neck assembly were found to be growing outwards from the bolt holes. Therefore these cracks cannot be detected by visual inspection until the section has fully fractured.

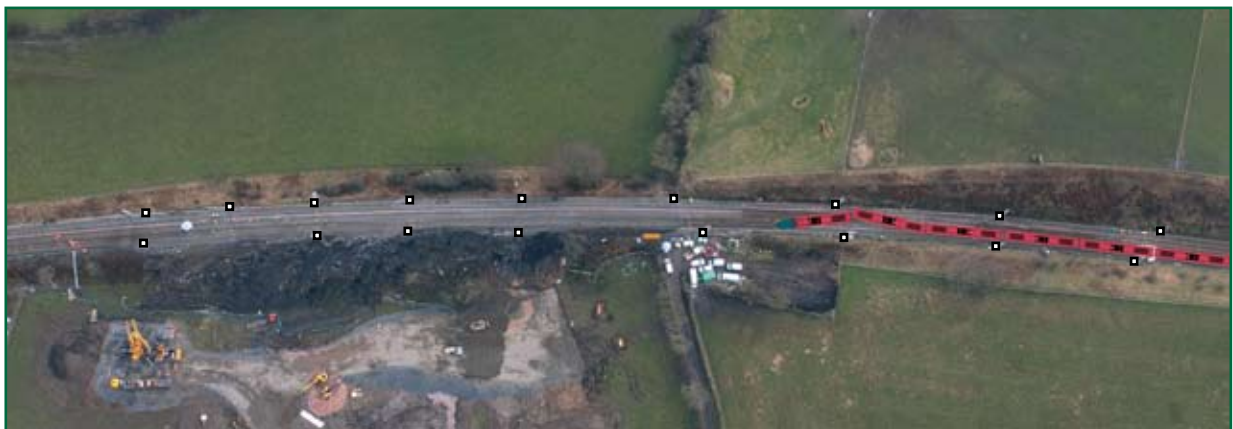
Figure 33: Diagram of the misalignment which developed between vehicles one, two and three after passing 2B points

540 Track damage showed that a number of wheelsets had crossed over and run close to, or in, the up line. These included wheels from bogie 2 and bogie 3. Whether or not bogie 1 derailed first, it stayed close to the down line and with bogies 2 and 3 running close to the up line, a misalignment formed between vehicles one, two and three, as shown in Figure 33.

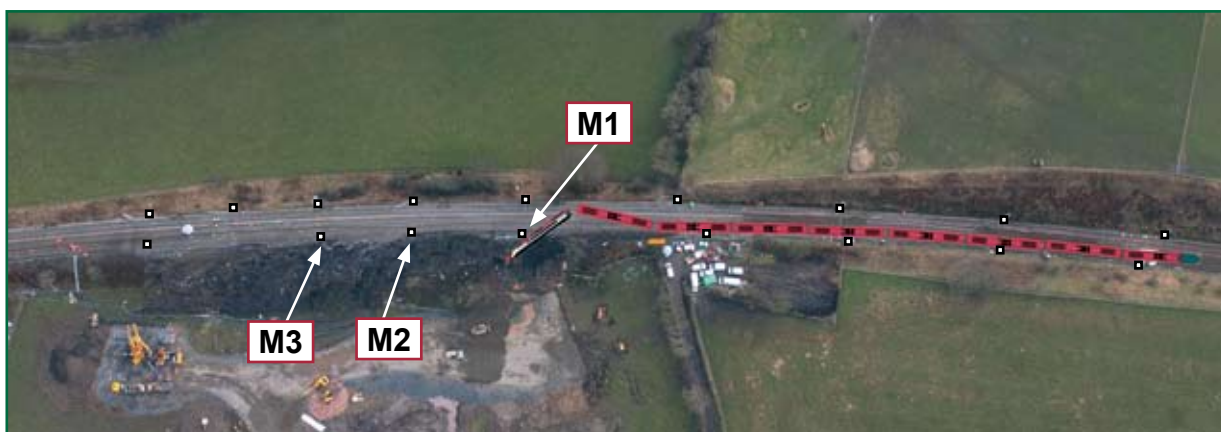
Figure 34: Diagram of vehicle one, partially rolled over and striking overhead line equipment mast M1

- 544 Vehicle one continued to yaw in an anticlockwise sense as it was pushed by the remainder of the train. When it was approximately perpendicular to the track and rolled over about 70 degrees onto its right-hand side, its trailing end struck mast M2 (Figure 34). More pushing from the vehicles behind it caused vehicle one to yaw even further until it lost contact with vehicle two and began to slide down the embankment slope. As it descended the embankment, it rolled over onto its side and continued to yaw. It came to rest at the foot of the slope, approximately 9 – 10 seconds after it first derailed, and having rotated through approximately 190 degrees to face backwards.

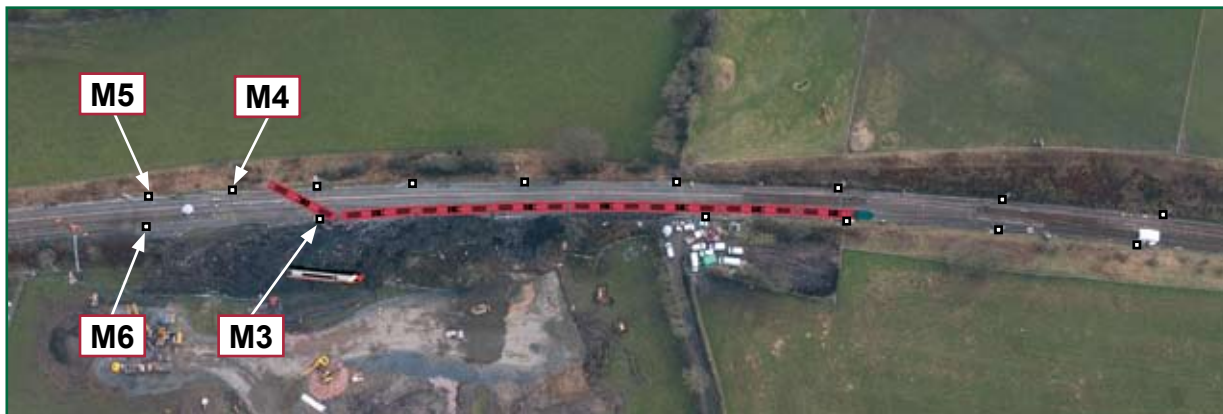
Figure 35: Reconstruction of vehicle two first striking overhead line equipment mast M3

545 Vehicle two, after becoming detached from the leading vehicle, continued to run misaligned and was pushed into yawing in a clockwise sense by the following vehicles. The trailing end of vehicle two struck overhead line equipment mast M3 as shown in Figure 35. Thereafter, it began to roll on to its left-hand side as the overturning forces resulting from the drag on its bogies increased. Its leading end then struck two overhead line equipment masts on the up line (M4 and M5 in Figure 35) and its centre section struck mast M6 on the down line. As it approached an orientation approximately perpendicular to the track, it was skidding on its left-hand side, perched on the crest of the embankment by the down line. Vehicle two came to rest shortly after with its trailing end at the foot of the embankment and its leading end overhanging the up line.

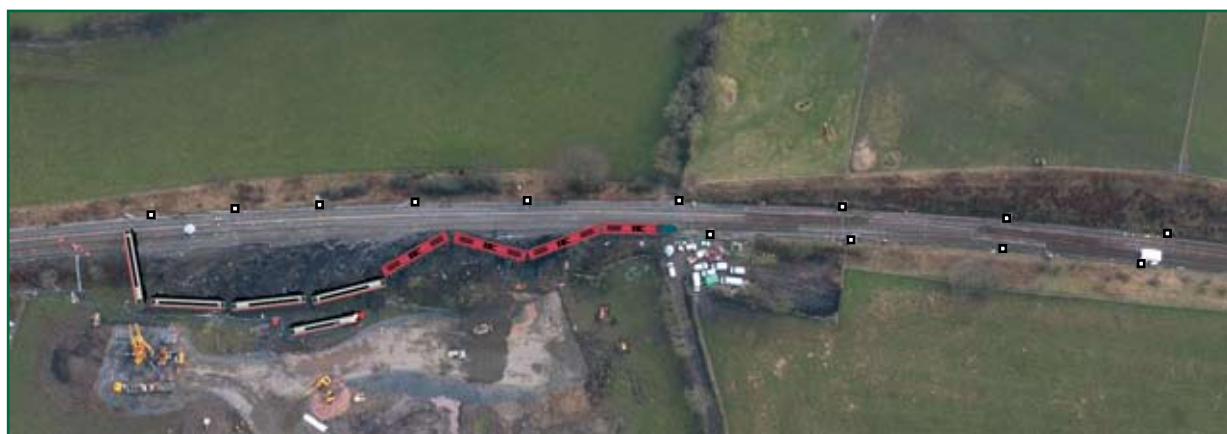
Figure 36: Final location of the vehicles from train 1S83 after the derailment

546 Vehicles three to five followed the trailing end of vehicle two down the embankment, rolling onto their left-hand sides just before coming to rest. Vehicle five struck the concrete foundation block from overhead line equipment mast M2 as it ran down the embankment. The couplers between vehicles two and three, and vehicles three and four parted but the interconnecting electrical cables remained intact, indicating that separation most likely occurred at, or near, the end of their travel.

547 Vehicles six to nine remained coupled and followed the preceding vehicles, coming to rest variously orientated on the embankment slope and in the down cess, with the cab of vehicle nine just past the toes of 3A points. The leading bogie of vehicle six was found on top of the concrete block first struck by vehicle five and, which formed the foundation for mast M2. Figure 36 shows the final location of the vehicles. The time from the moment of the derailment until all the vehicles came to rest was approximately 13 seconds.

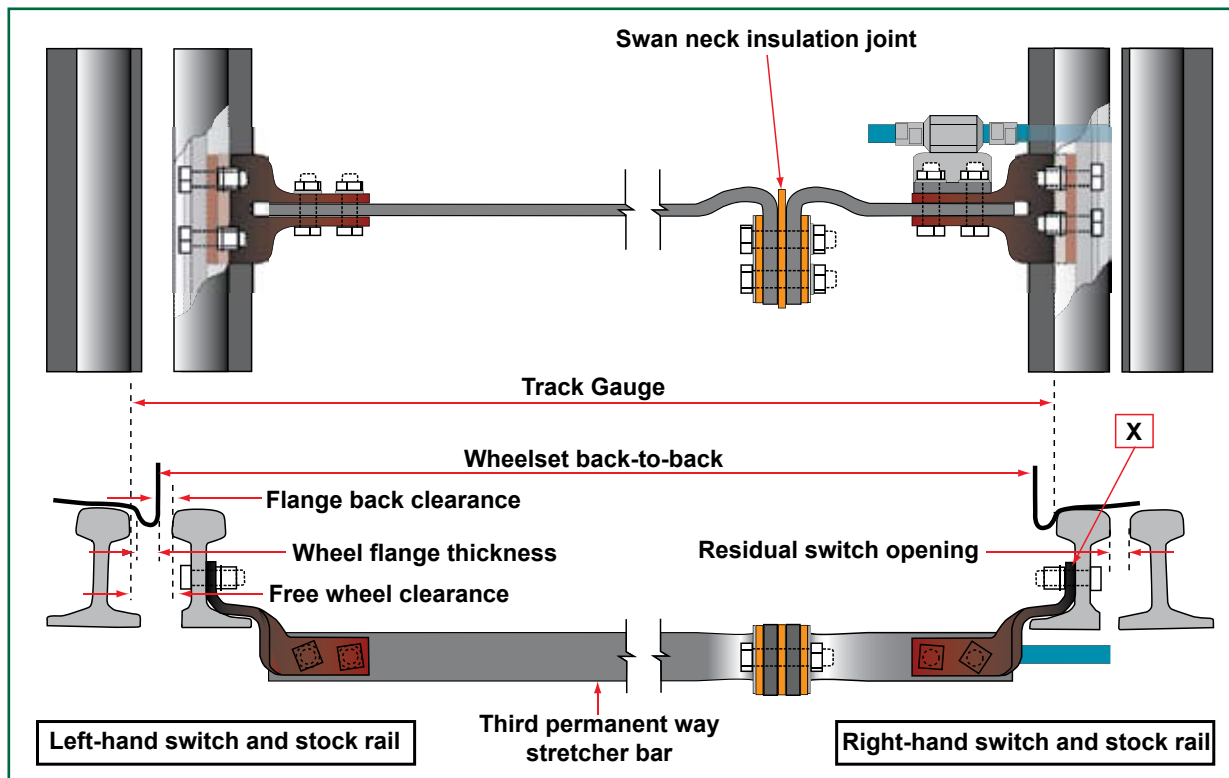
Figure 43: Schematic diagram of points indicating key terms

- 16 It can be seen from Figure 43 that with a set length of stretcher bar the degree of static free wheel clearance on the left-hand switch rail is affected by the amount of residual switch opening between the right-hand rails. However, passing trains are likely to close the residual switch opening, thus increasing the free wheel clearance as the left-hand switch rail is pulled further open by the stretcher bar.

- 17 If the joint between the stretcher-bar bracket and the right-hand switch rail fails (marked as X on Figure 43), the left-hand switch rail will tend, due to its natural flexure, to relax towards its stock rail and hence reduce the free wheel clearance. The position the rail now adopts is controlled solely by its connection to the supplementary drive, and by the remaining stretcher bars. When trains pass with the stretcher bar in this condition, the closing of the residual switch opening will no longer increase the free wheel clearance, increasing the likelihood of flange-back contact. The degree of flange-back contact will be related to the position of the four-foot nuts of the escapement joint (Figure 43) since this determines the amount of residual switch opening prior to any joint failure.

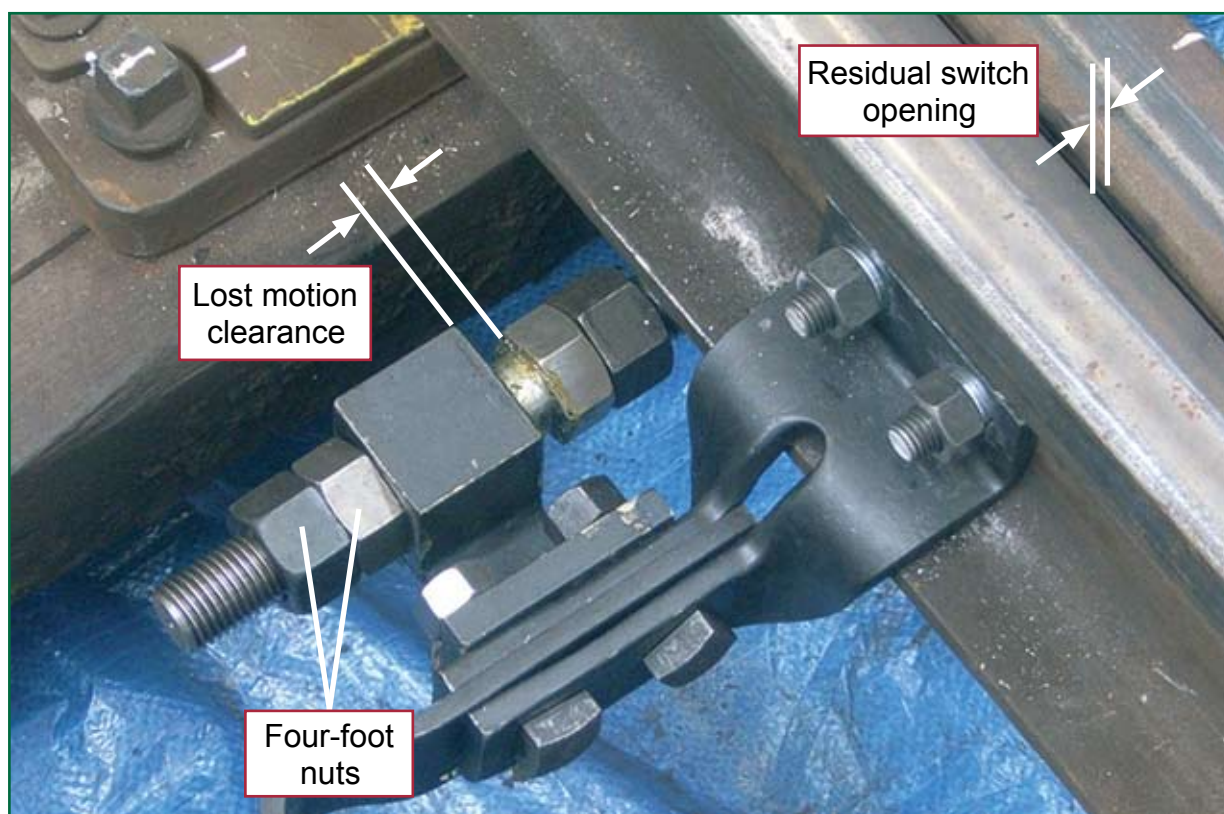
Figure 44: Escapement joint on a reconstructed stretcher bar

- 14 There is an escapement joint at the point of connection between the supplementary drive and the third permanent way stretcher bar (Figure 44). Clearances within this joint, known as lost motion, isolate the supplementary drive and the toes of the switches from any switch rail movements and associated forces induced by trains that could cause damage.

- 15 The adjustment of the clearance at the escapement joint allows installers and maintainers to alter the position of the closed switch rail relative to its adjacent stock rail. Any gap present between the two rails at this location is known as the residual switch opening (Figures 43 and 44). Network Rail found from experience that it was beneficial to have a small gap present between the rails at this location to prevent the points from seizing due to changes in temperature affecting the supplementary drive. Standard NR/GN/SIG/11772, applicable at the time of the accident, stated that the residual switch opening should be 1.5 mm; however, no tolerance or maximum figure was specified.

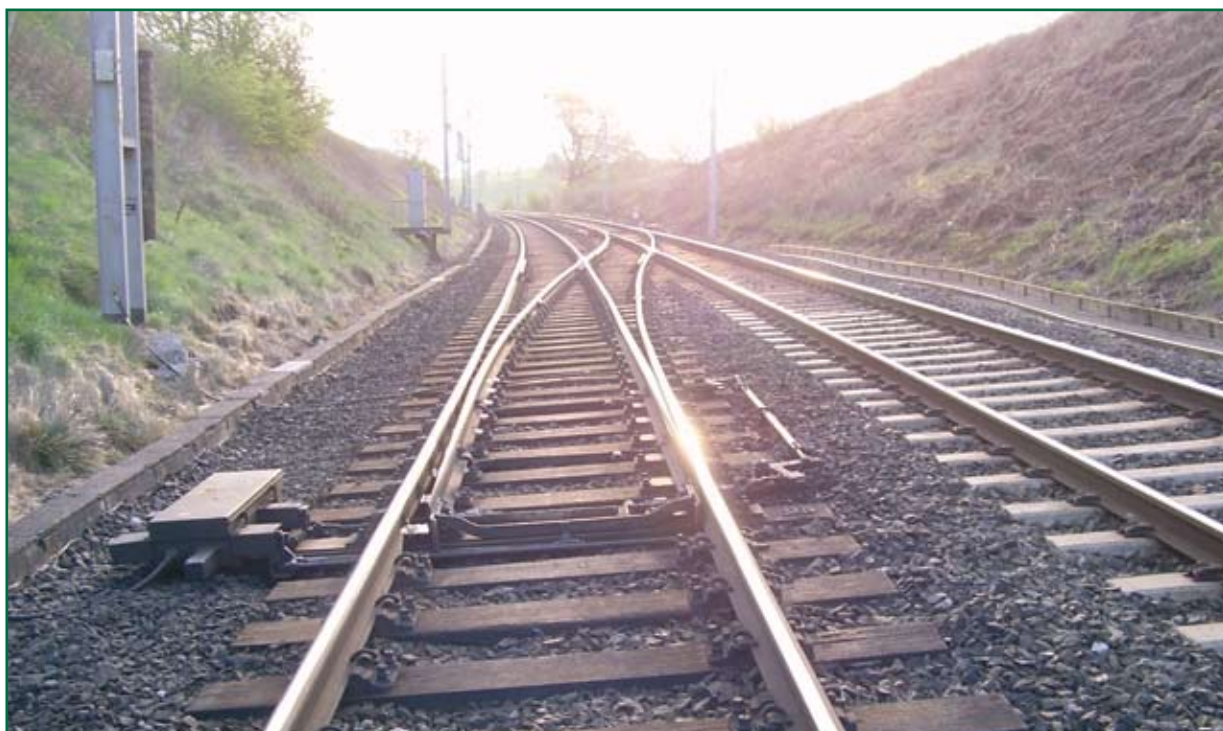
Figure 46: Lambrigg 2B points, May 2006 (courtesy of Network Rail)

- 3 It is possible to make scaled measurements from the Omnicom video and these can be calibrated against a known dimension in the photo.
- 4 During 2004, the Omnisurveyor3D route photography train ran past Lambrigg on the down line. The RAIB's study of the video taken on that run showed that all three stretcher bars in 2B points were in place, and that there was a residual switch opening in the vicinity of the third stretcher bar (on the closed side) that was between 6 and 8 mm.

- 5 A still photograph taken by a Network Rail engineer in May 2006, during a routine inspection of the track, gives evidence that an excessive gap was still in existence at that time (Figure 46).

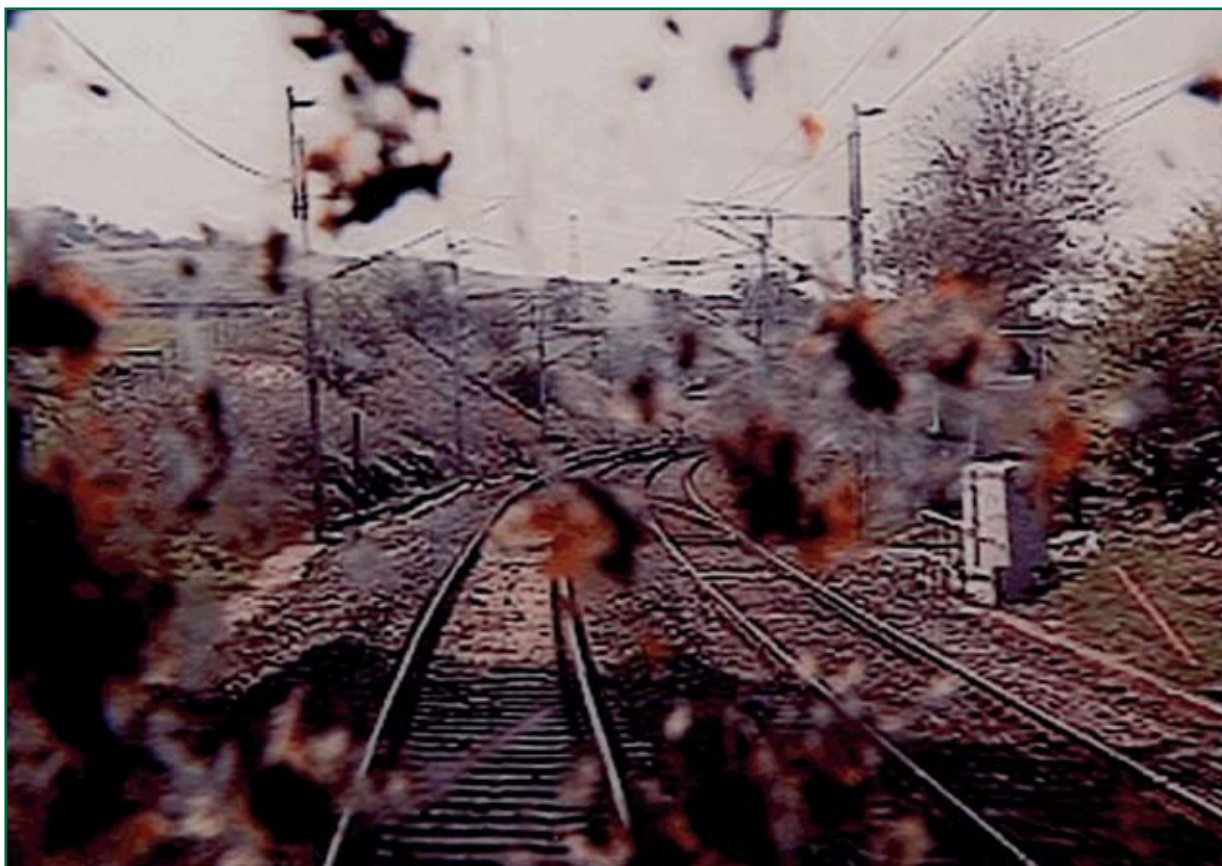
*Figure 47: Approach to Lambrigg viewed from the up line in May 2006. Scrap rail behind location cabinet is visible*

- 12 The NMT is fitted with forward and rearward facing video systems. These are provided for Network Rail engineers to relate geometrical records to physical locations, and are neither used nor intended for condition analysis. In May 2006 the NMT front-facing video was taken in good lighting conditions on a run on the up line. It shows points 2B to have all three permanent way stretcher bars present. The approach to the former crossing at Lambrigg, where the site access was located, can be seen clearly and a length of rail can be seen behind the location cabinets on the down side (Figure 47).

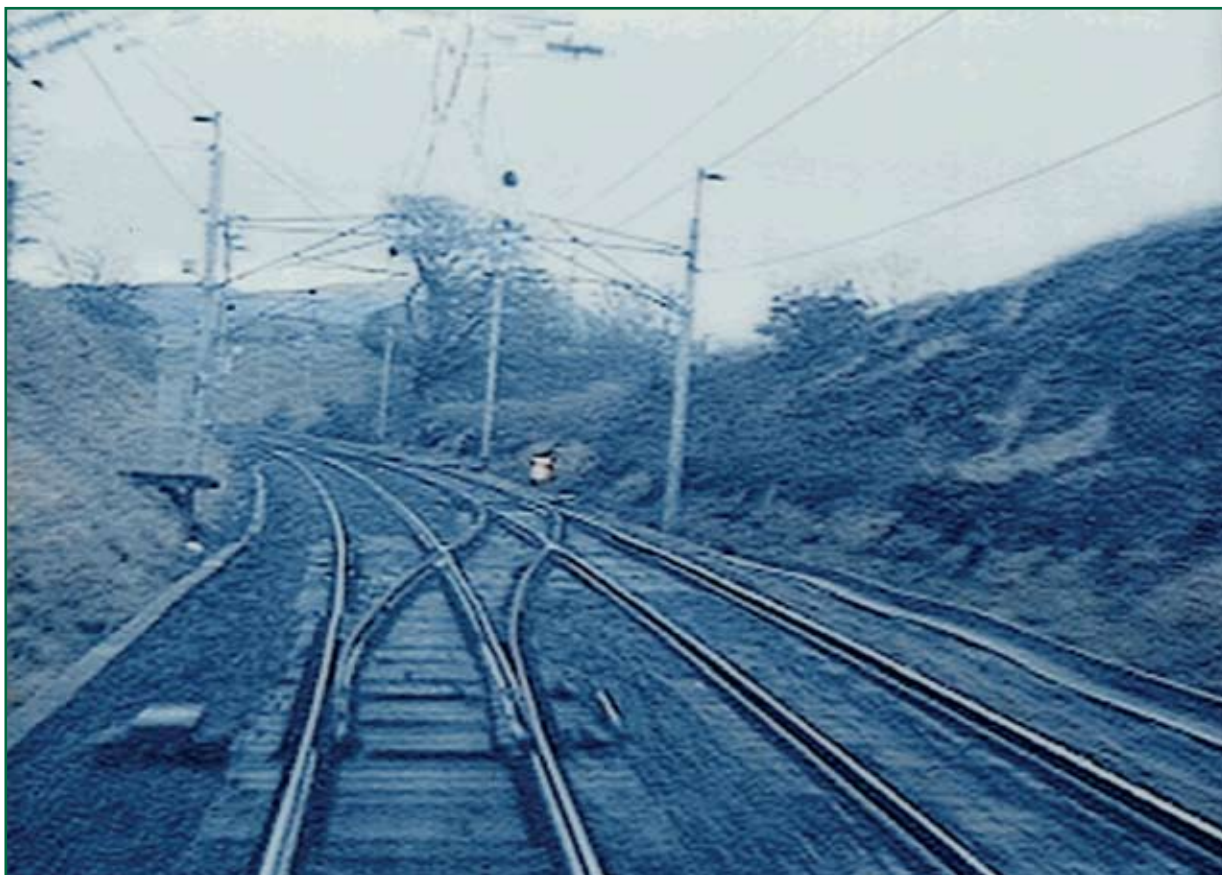
*Figure 48: Points 2B viewed from the front of the NMT on 10 January 2007*

- 14 On 10 January 2007, the NMT ran in slightly better lighting conditions than the previous week and the front-facing camera was working. Points 2B appear to have all three permanent way stretchers present (Figure 48). The NMT is fitted with a laser-based six-foot scanning system. This measures the distance from the scanner to any object in its path beneath the train. The data from this system was analysed by the RAIB to derive the relative positions of the switch and stock rail at 2B points. The six-foot scanner data shows the minimum free wheel clearance (Appendix D, paragraph 12) to be of the order of 60 mm.
