Rail Accident Investigation Branch

# Rail Accident Report

## **Derailed at Grayrigg 23 February 2007**

# Derailment at Grayrigg, 23 February 2007

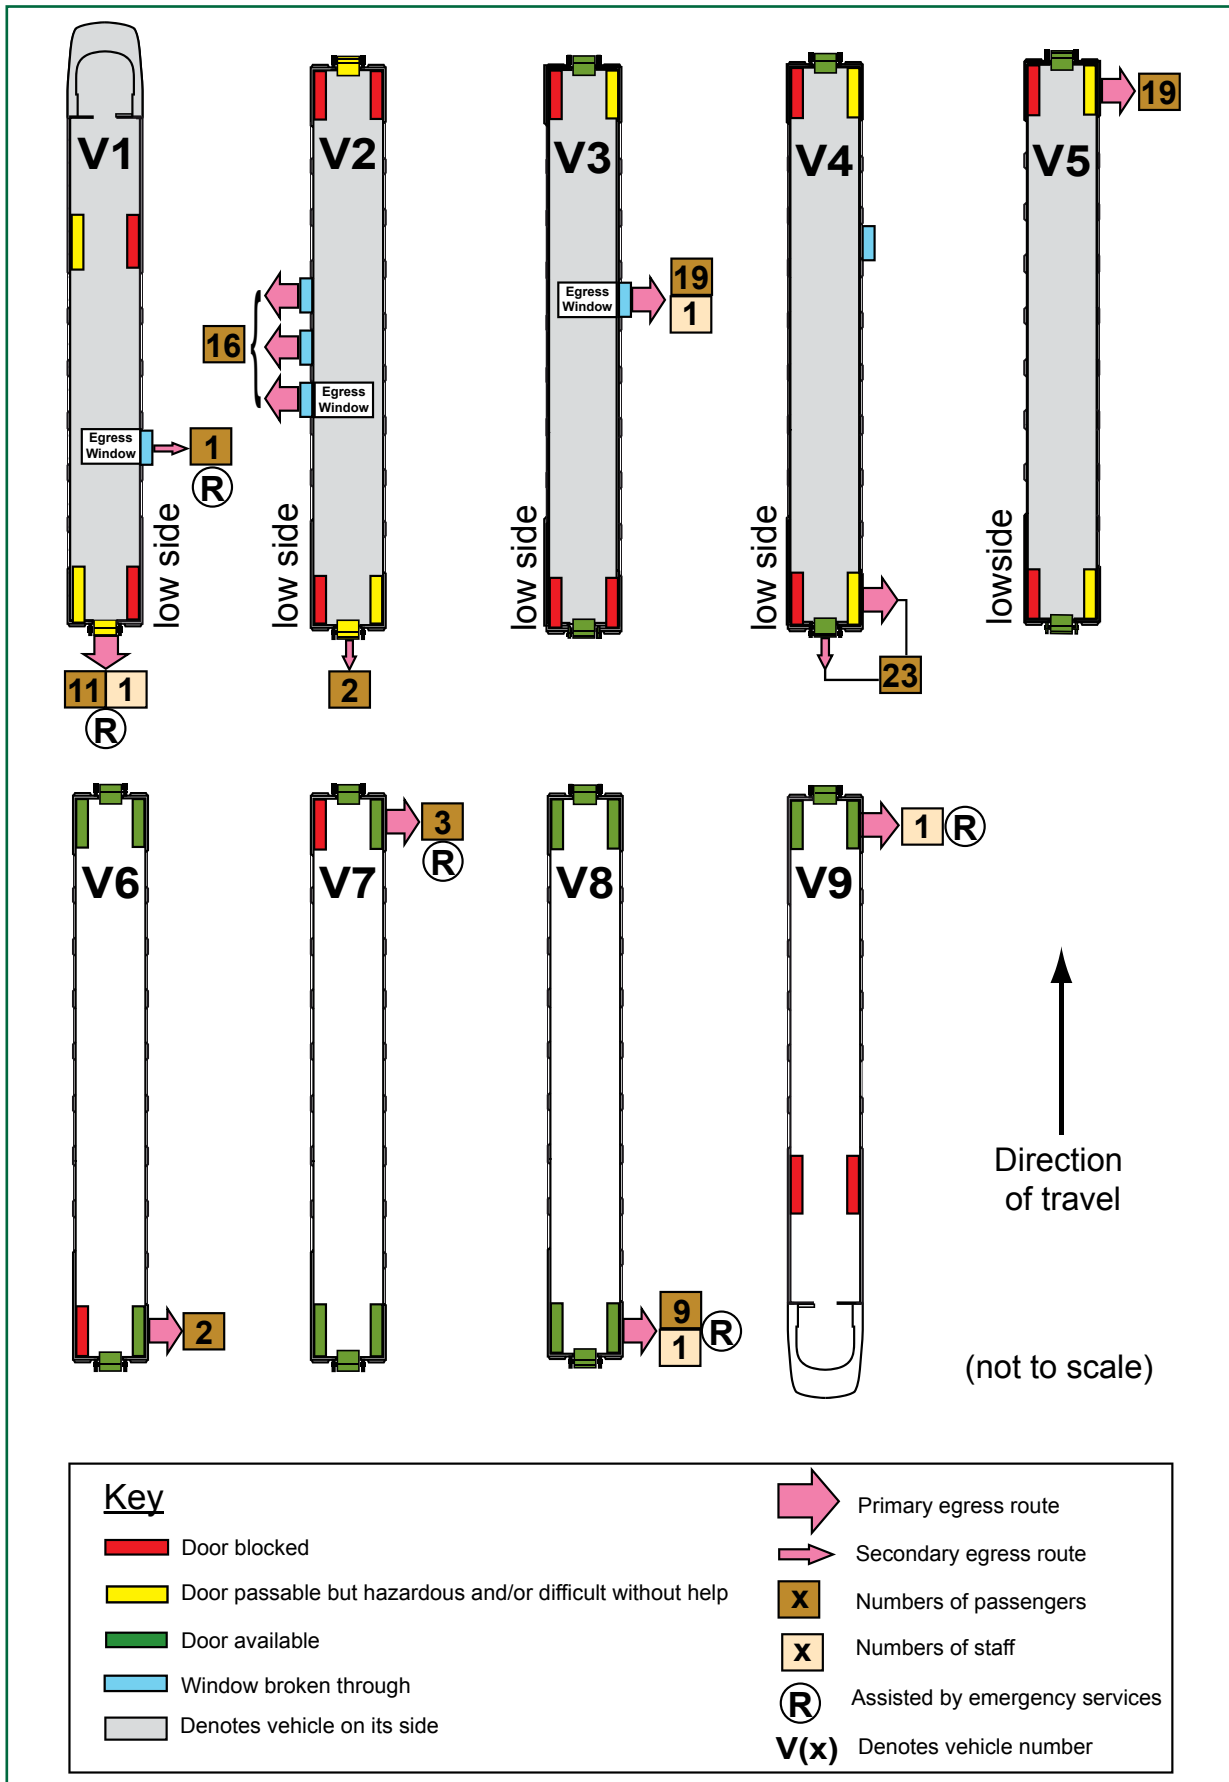
Figure 51: Summary of egress routes

- 565 Egress windows were used in vehicles two and three as shown in Appendix Q. In vehicle two, most passengers exited through the three broken windows on the left-hand side, either by jumping down onto the embankment or by means of a ladder obtained from the nearby farm. In vehicle three, passengers broke the right-hand side egress window, having tried unsuccessfully to open the trailing right-hand door, and climbed out onto the high side. They then used ladders to descend to ground level. There were two abortive attempts to break out of egress windows. In vehicle one a passenger abandoned his attempt to break out when glass showered down on injured passengers below the window. In vehicle four, passengers broke through the egress window on the high side but then most of them opted to use the trailing right-hand door when it was found to be available.
