SS Richard Montgomery

Surveys 2008 & 2009

Summary Report

September 2011

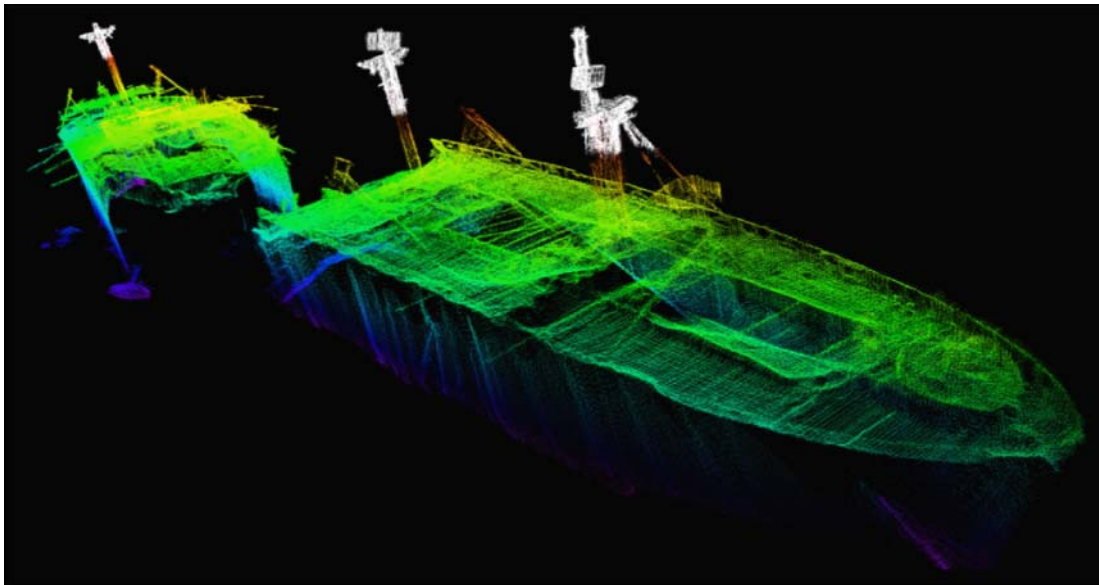
Figure 1 Multibeam & laser data, 2009

3.2 Both surveys were conducted using a Reson Seabat 7125 multibeam sonar unit to provide geo-referenced, three dimensional images of the wreck. Both surveys also included laser scanning of those sections of the wreck that are visible above the water. The two sets of data were then knitted together to provide one seamless image of the entire wreck.
